**MILLWATER SUBDIVISION -
ARRANS POINT PRECINCT 7
STAGE 2B**

Geotechnical Completion Report

Tonkin & Taylor Ltd

July 2017

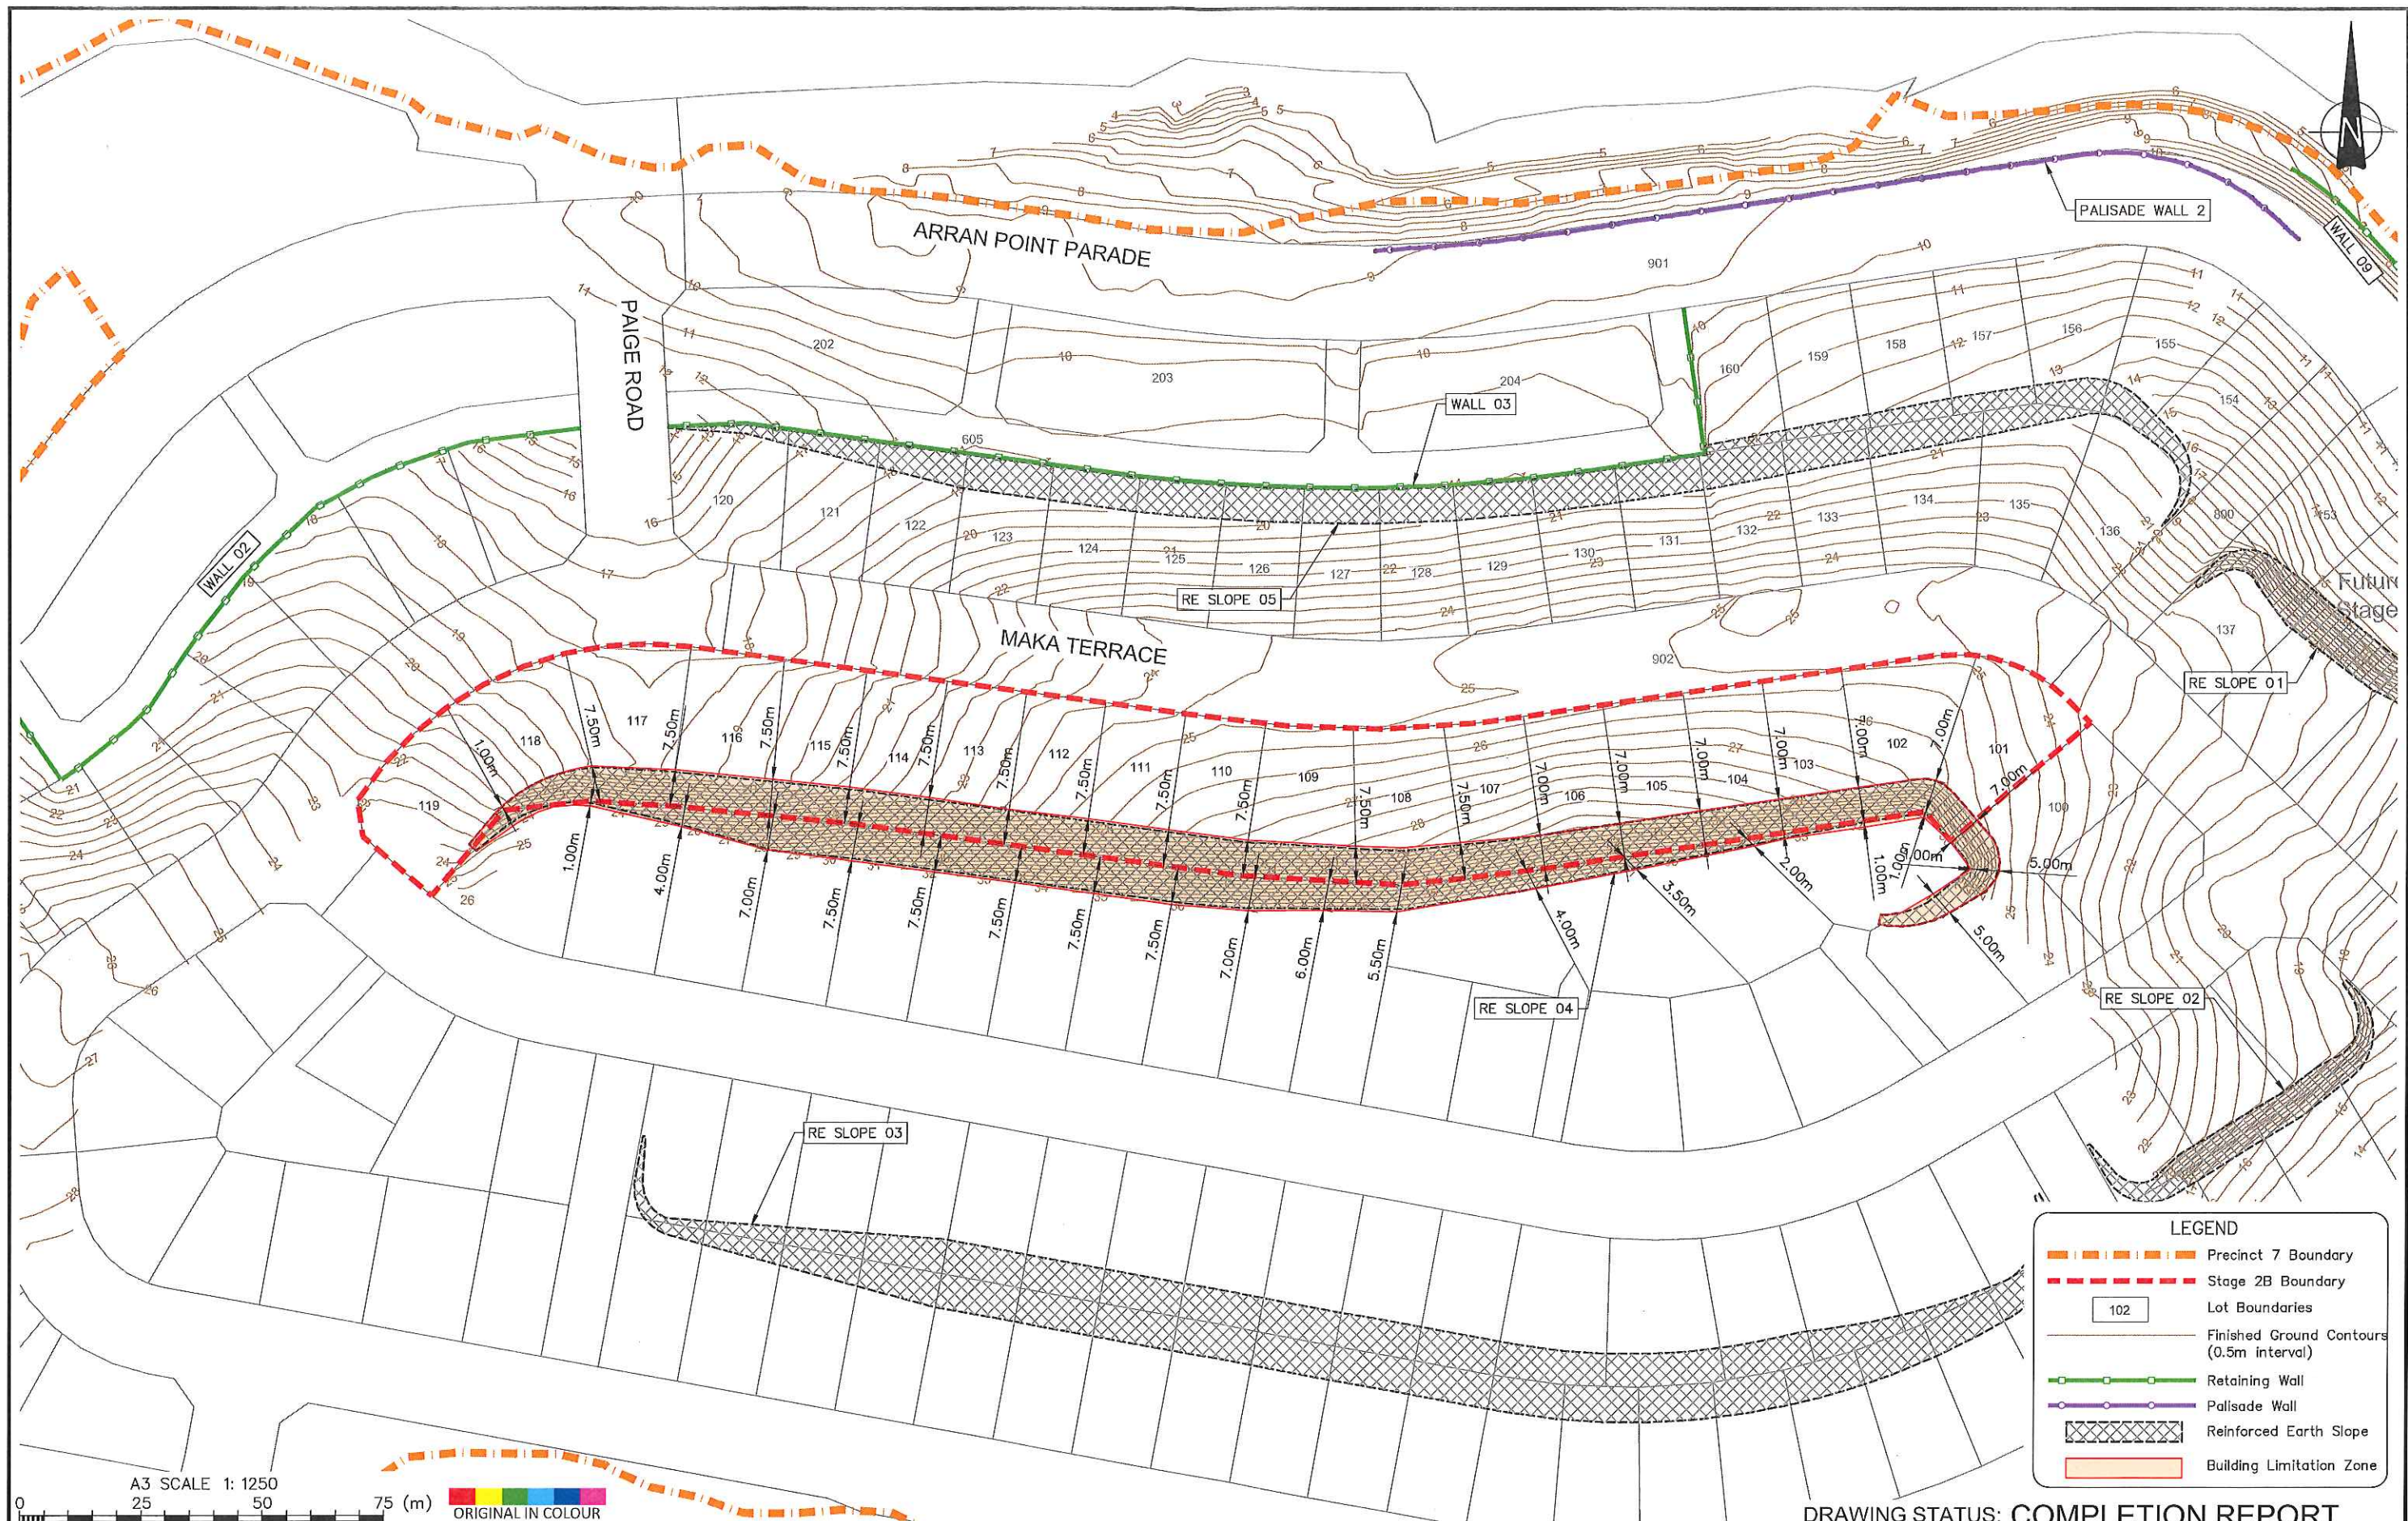
The slope face will be subject to a planting covenant preventing construction within this area. Protection of the geogrids from damage also precludes construction across the slope face and immediately adjacent to the slope crest. Accordingly, a building restriction zone has been applied across the slope (See Sections 5.3 and 6.6, and T+T Drawing 21854.0037-APP7S2B-110 in Appendix A2).

- 6.4.2 The completed earthworks give due regard to land slope and foundation stability considerations.
- 6.5 **For Lots 101 to 119 inclusive:**
 - 6.5.1 These Lots contain a "Building Line Limitation" relating to the reinforced earth slope which forms the 1 in 1.5 (V:H) slope along the Lot boundaries. The limitation zone is shown on T+T Drawing 21854.0037-APP7S2B-110 in Appendix A2. Excavation, filling and/or construction within this zone is not to be undertaken, to ensure stability of the slope is not compromised.
