**MILLWATER - PRECINCT 2
STAGE 4B**

Geotechnical Completion Report

Tonkin & Taylor Ltd

June 2017

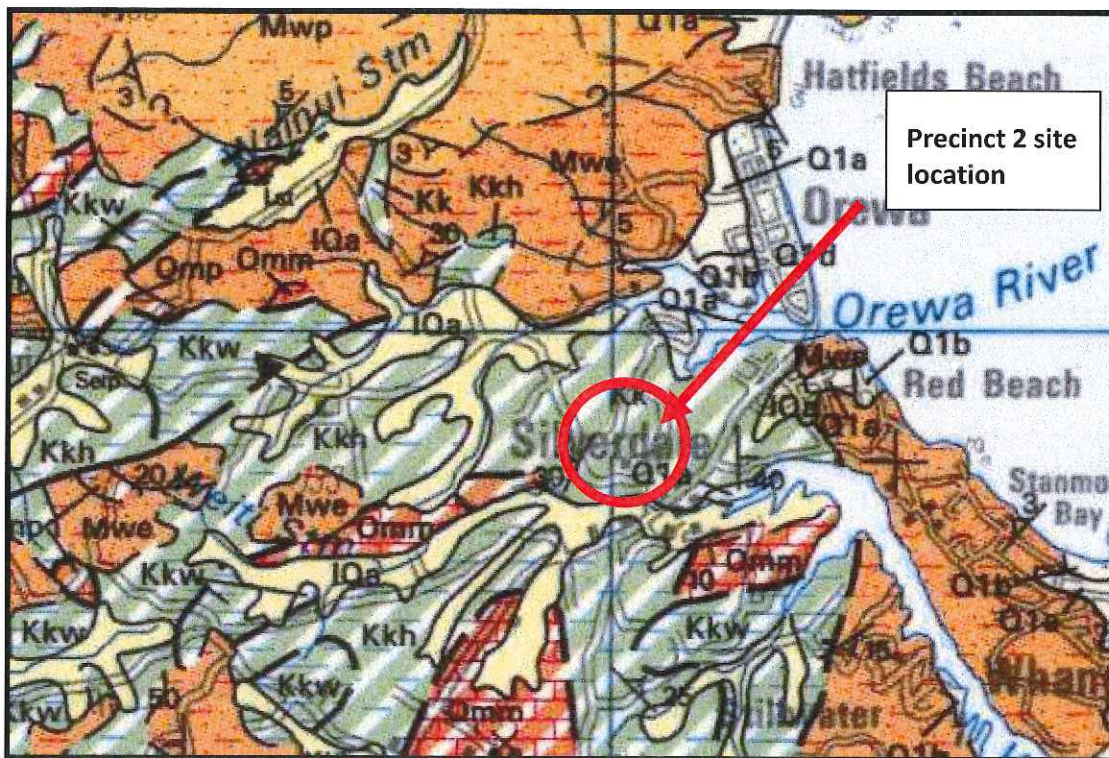
Figure 1 - Local Geology (from Edbrooke)

Land south of the Orewa River is located on an area of extensively deformed and sheared mudstones and muddy to sandy limestones described as Onerahi Chaos – Northland Allochthon material. Recent stream alluvium and slope colluvium derived from residual Northland Allochthon material is mapped towards the base of the gullies at the bottom of the slopes. Recent stream alluvium and discontinuous areas of older Pleistocene Age alluvium are also likely to be present overlying the Northland Allochthon.

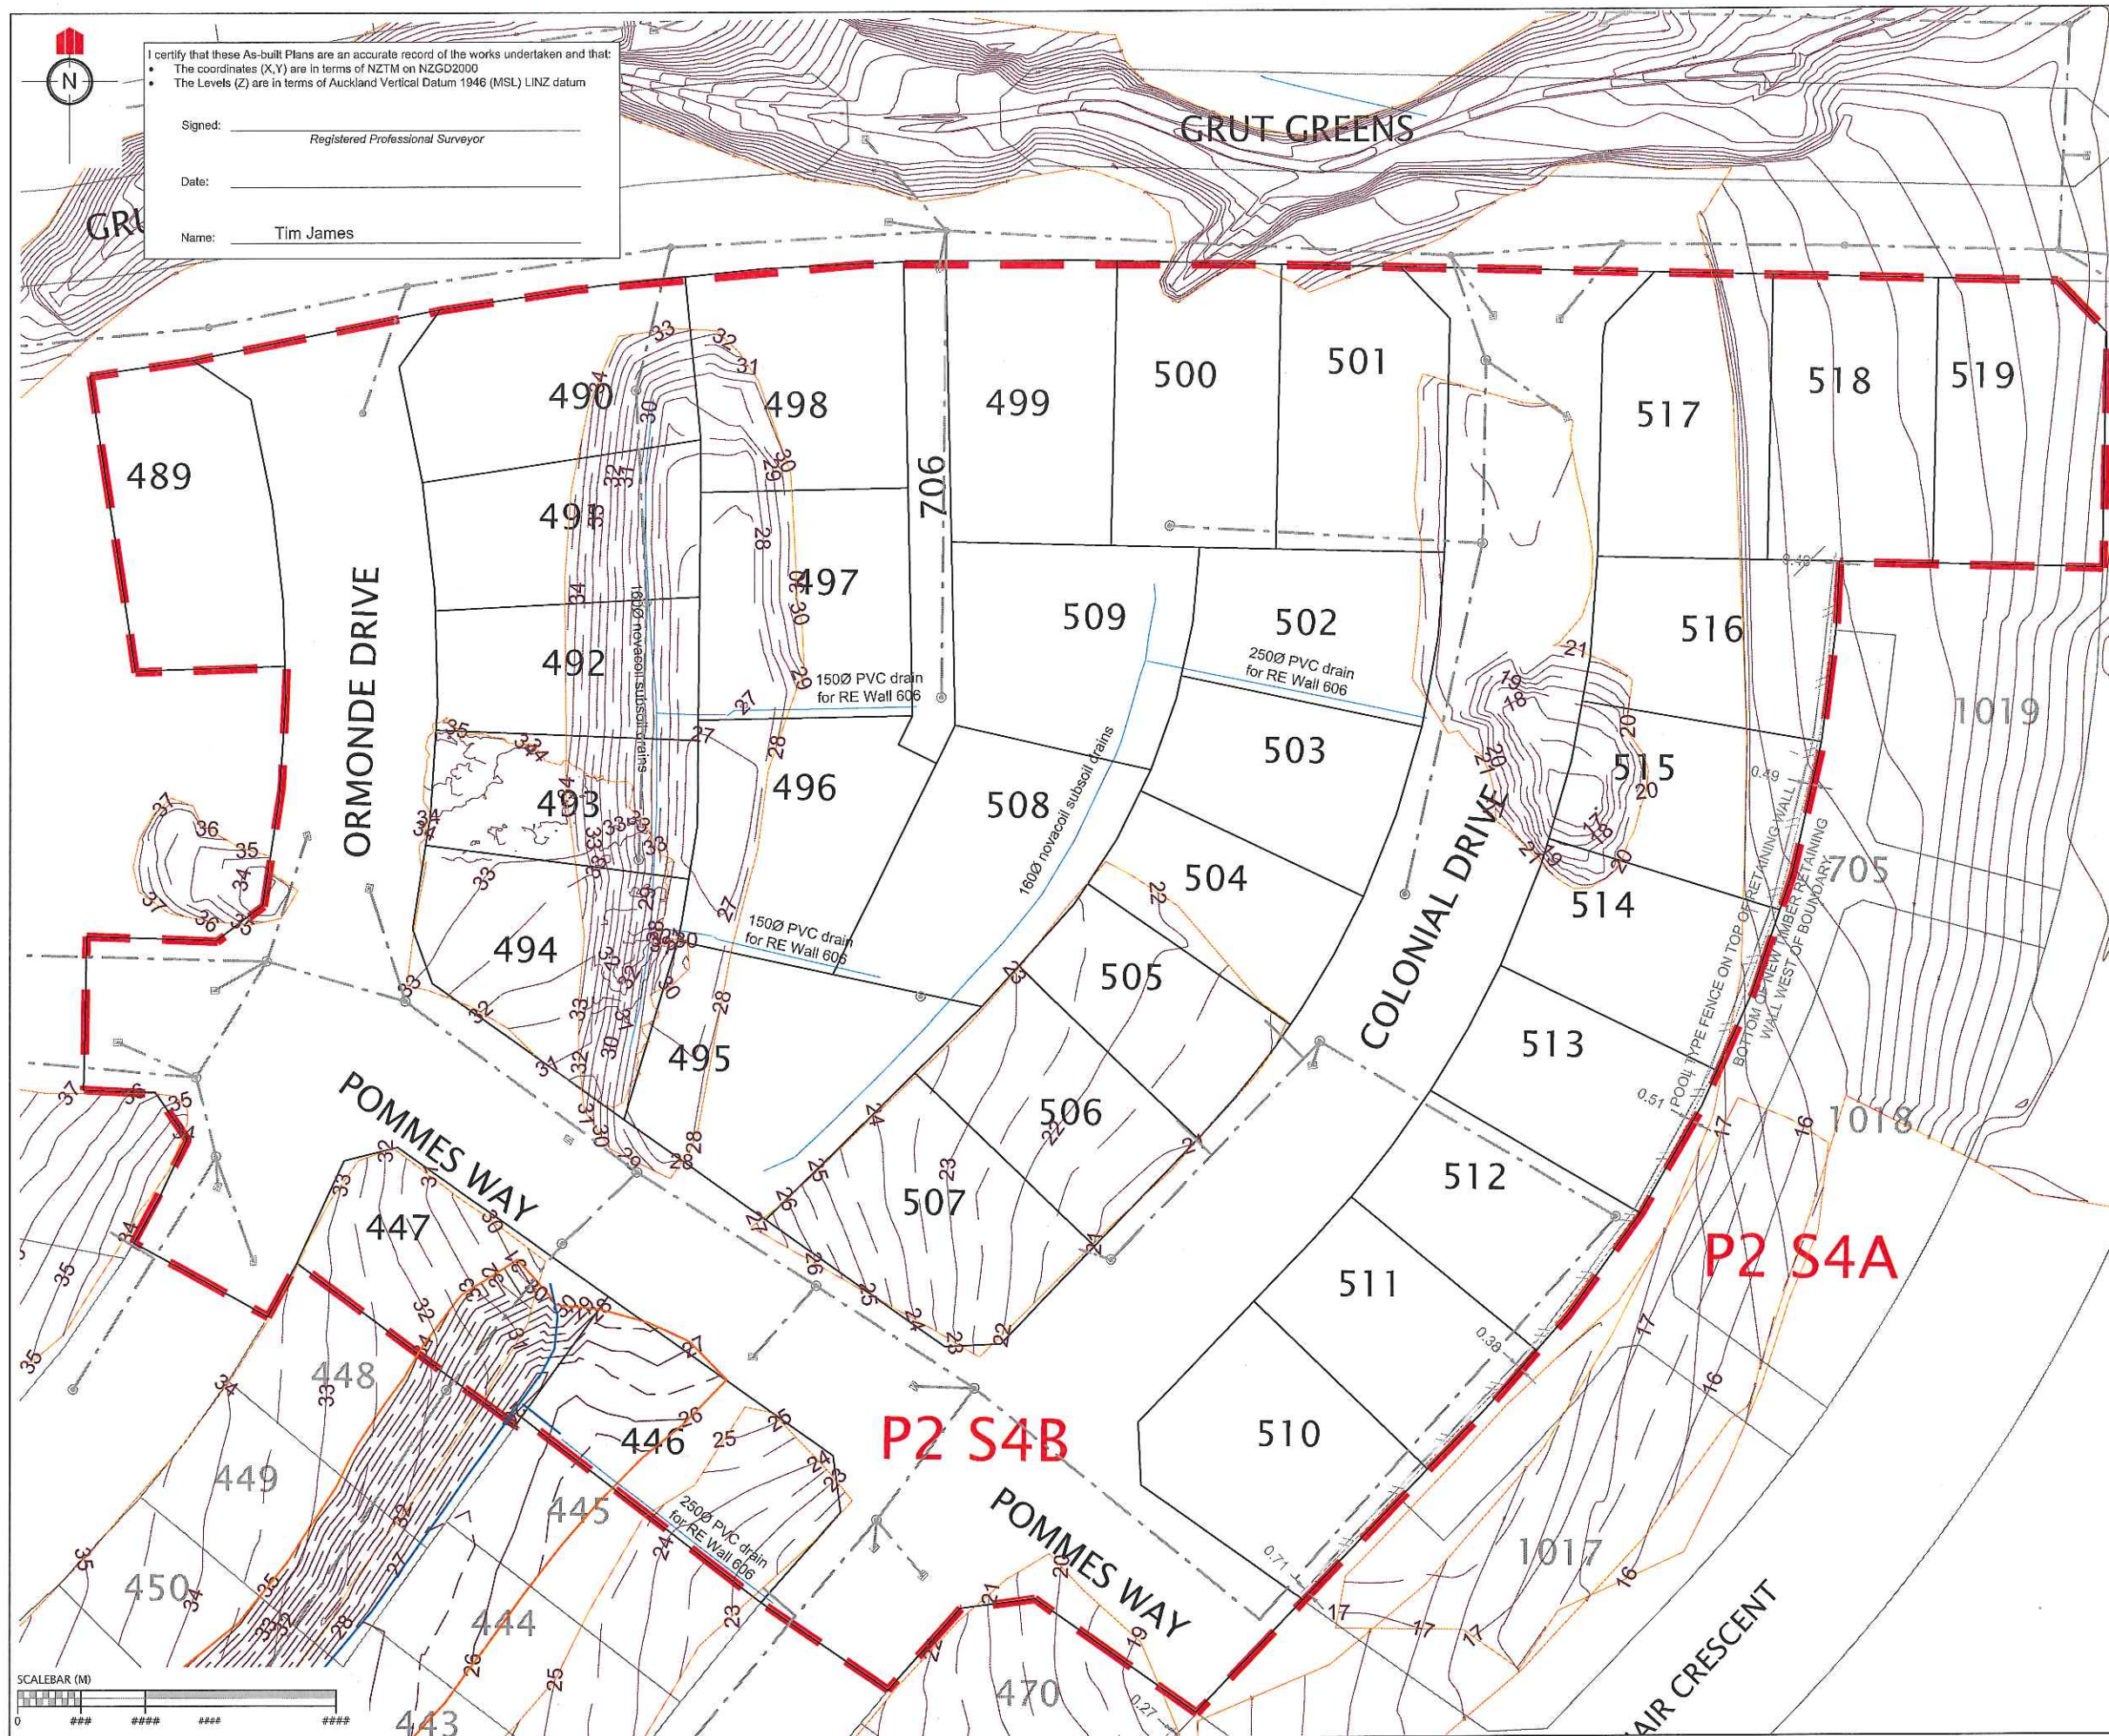
MILLWATER PRECINCT 2 STAGE 4B			
SHEAR KEY, UNDERCUTS & SUBSOIL DRAINS AS-BUILT PLAN			
AUCKLAND COUNCIL			
DESIGNED: JB	ASBUILT		
CHECKED:	DRAWN: KR		
APPROVED:	SURVEYED: WOODS		
JOB NUMBER: 33219	SCALE: 1:750 @ A3		
ISSUED: JUNE 2017			
DWG. NO. 33219-04B-120-AB	REV.

- a 160mm diameter perforated Hiway grade Nexus drain pipe: This was run along the base of the rear of the excavation and connected to the gully subsoil drainage in several locations (as per the Woods As-Built plan 33219-04B-120-AB). Additional Nexus drain pipes were also installed along mid-height benches where appropriate and connected into the key drainage outlet system.
- b SAP50 scoria: A layer of minimum 300mm thickness of SAP 50 was placed across the entire rear face, and extended to within 1.0m of the top of the key. It should be noted that the top of the key at this stage generally coincided with the original ground surface.
- c Bidim A19 geotextile filtercloth: This was placed over the surface of the SAP 50 scoria to prevent contamination of the drainage aggregate with overlying bulk earthworks materials.

This drainage system is relatively deep and located so that it is unlikely to be encountered during future residential site development and is expected to be maintenance free. Any deep excavations should take account of the presence of these drains nonetheless. If a drain is encountered, damaged, or identified as defective, repairs should be observed by a Chartered Professional (Geotechnical) Engineer familiar with this report, and notified to Auckland Council.

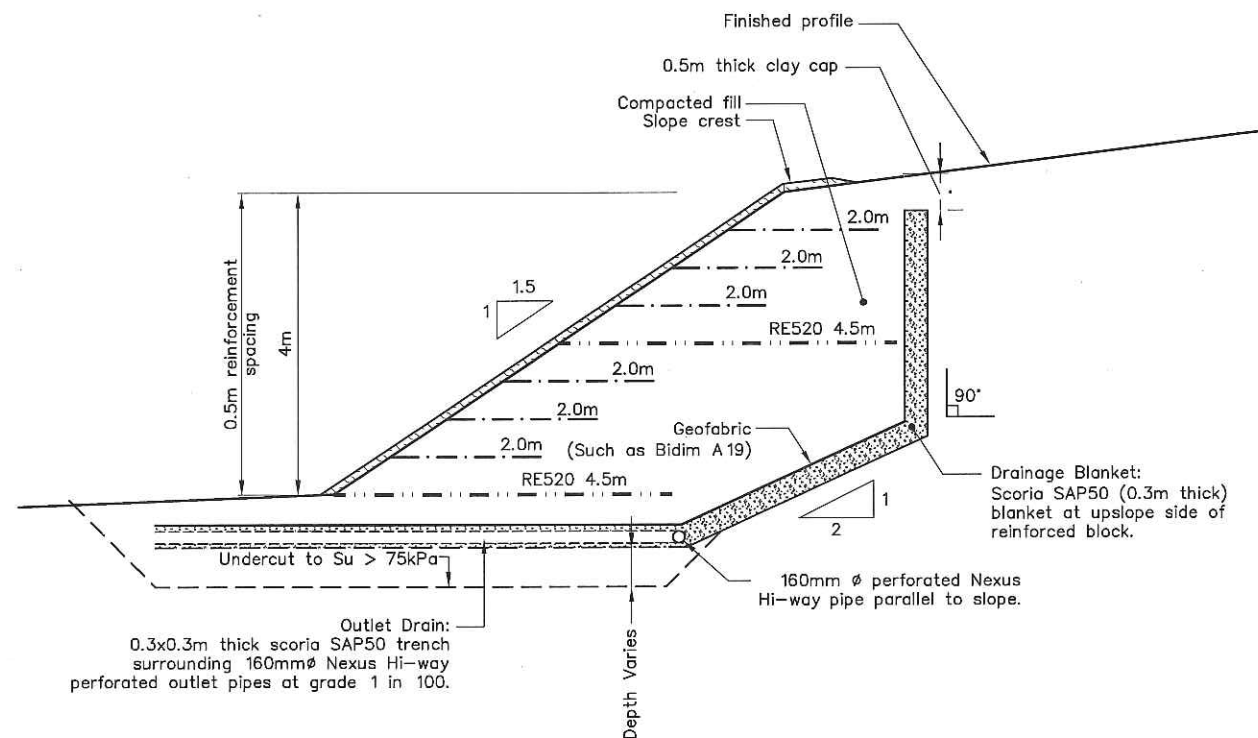
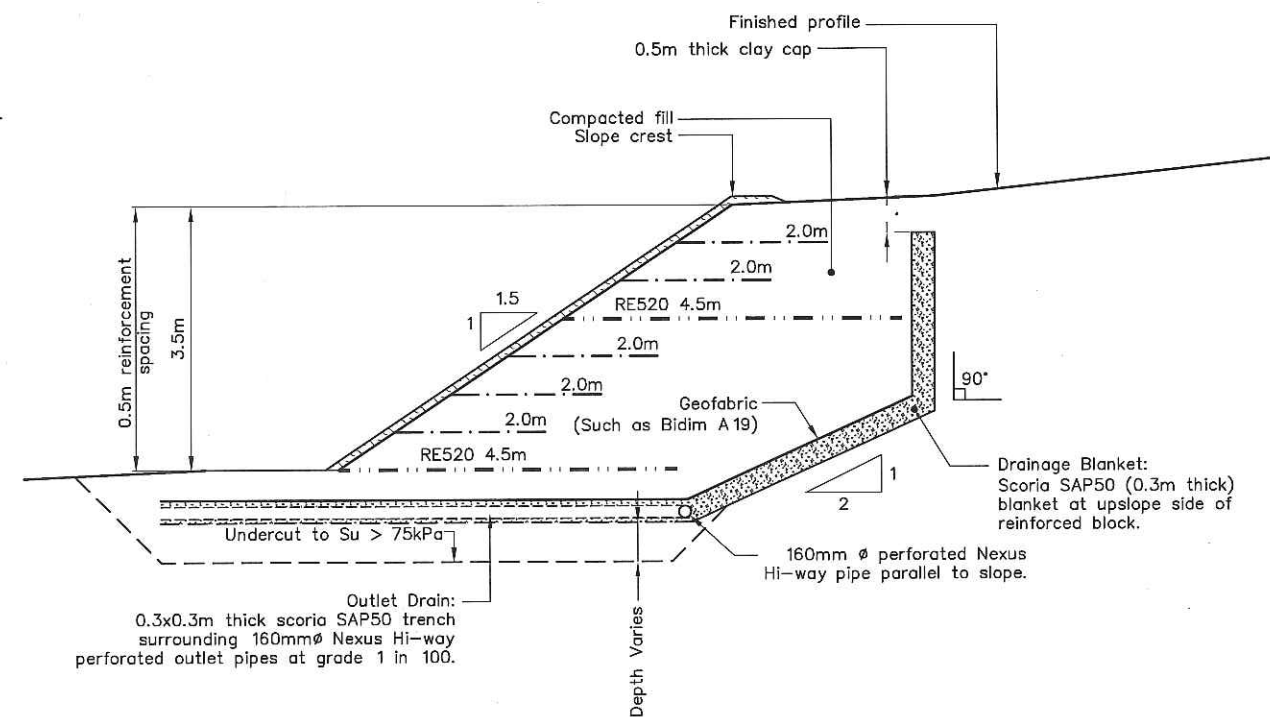
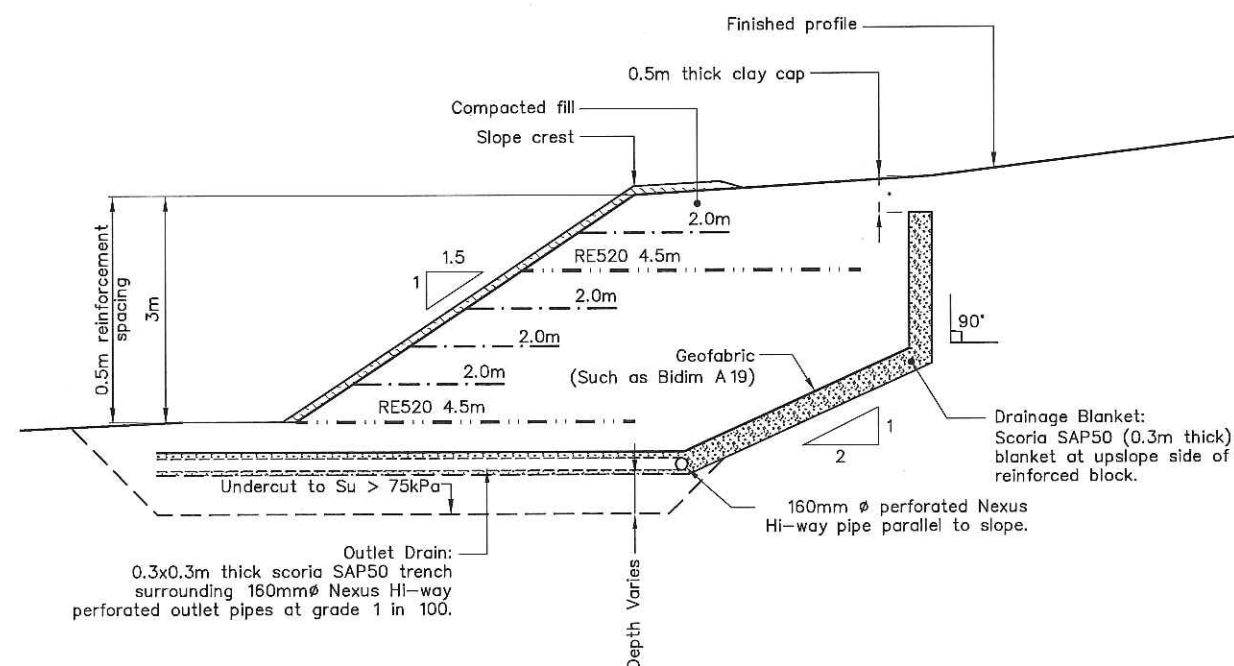
TYPICAL REINFORCED EARTH SLOPE DETAIL (4m HIGH)
SCALE 1: 100

- a Foundation preparation;
- b Placement and compaction of fill to the required levels;
- c Placement of the geogrid layers, ensuring that the grid is held tightly in place;
- d Spreading of fill across the surface of the geogrid with lightweight plant;
- e Compaction and placement of further fill up to the level of the next grid layer;
- f Installation of Enkamat across the face of any slopes steeper than 1 in 2 (V:H) to assist in retention of the topsoil facing while vegetation is established.

The fill was placed and compacted beyond the limit of the final slope face and then trimmed back to ensure full compaction of the slope face was achieved, taking care not to damage the geogrid.

As noted in Section 3.1, a drainage blanket was installed at the rear of the reinforced block of soil and comprised a minimum of 300mm thickness of SAP50 scoria, covered in Bidim A19 geotextile filtercloth

- 6.5.2 The presence of geogrids within the reinforced earth slopes is brought to the attention of future building and services designers. The topmost grid is located between 1 to 2 metres below the surface at the top of the slope, and does not generally extend more than 2 metres back from the crest of the slope. It is not expected that the grids will be encountered during future development of these Lots, however, the presence of the grids should be recognized. Any exposure and/or damage and subsequent repair to the grids during any future development must be observed and certified by a Chartered Professional Engineer (Geotechnical) familiar with the contents of this report.
