**MILLWATER - PRECINCT 2
STAGE 4E**

Geotechnical Completion Report

Prepared by
Tonkin & Taylor Ltd

Job Number
21854.001/S4E.v1

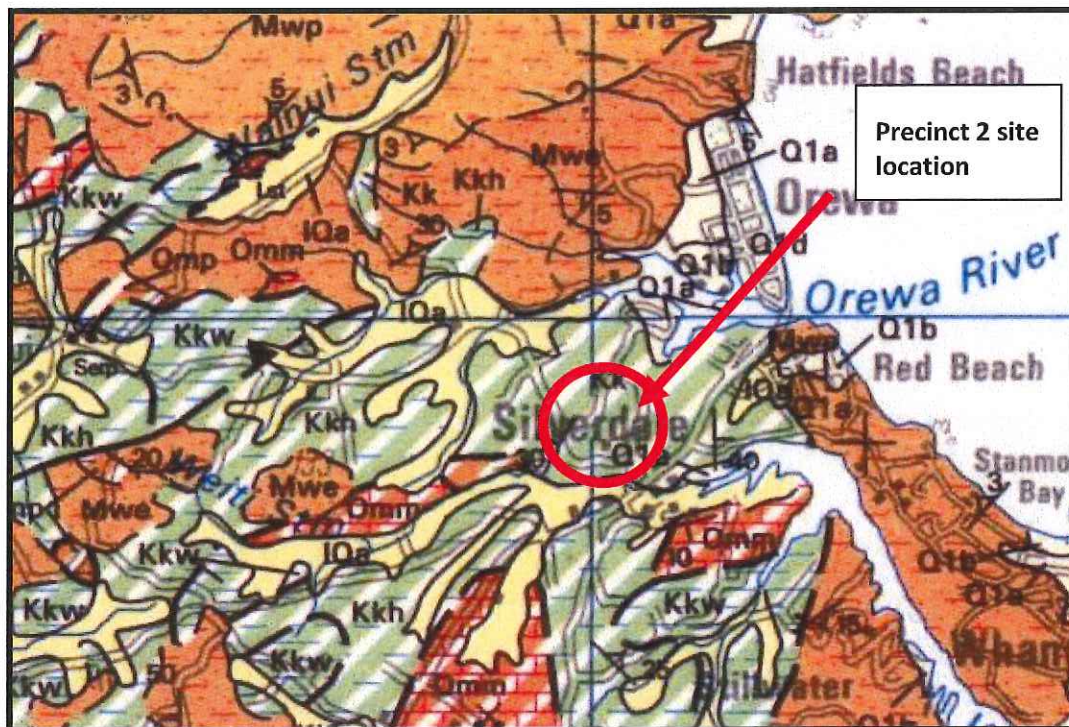
Figure 1 - Local Geology (from Edbrooke)

Land south of the Orewa River is located on an area of extensively deformed and sheared mudstones and muddy to sandy limestones described as Onerahi Chaos – Northland Allochthon material. Recent stream alluvium and slope colluvium derived from residual Northland Allochthon material is mapped towards the base of the gullies at the bottom of the slopes. Recent stream alluvium and discontinuous areas of older Pleistocene Age alluvium are also likely to be present overlying the Northland Allochthon.
