**MILLWATER - PRECINCT 3 STAGE 1  
Geotechnical Completion Report**

**Tonkin & Taylor Ltd**

**March 2014**

**T&T Ref: 21854.008/S1**

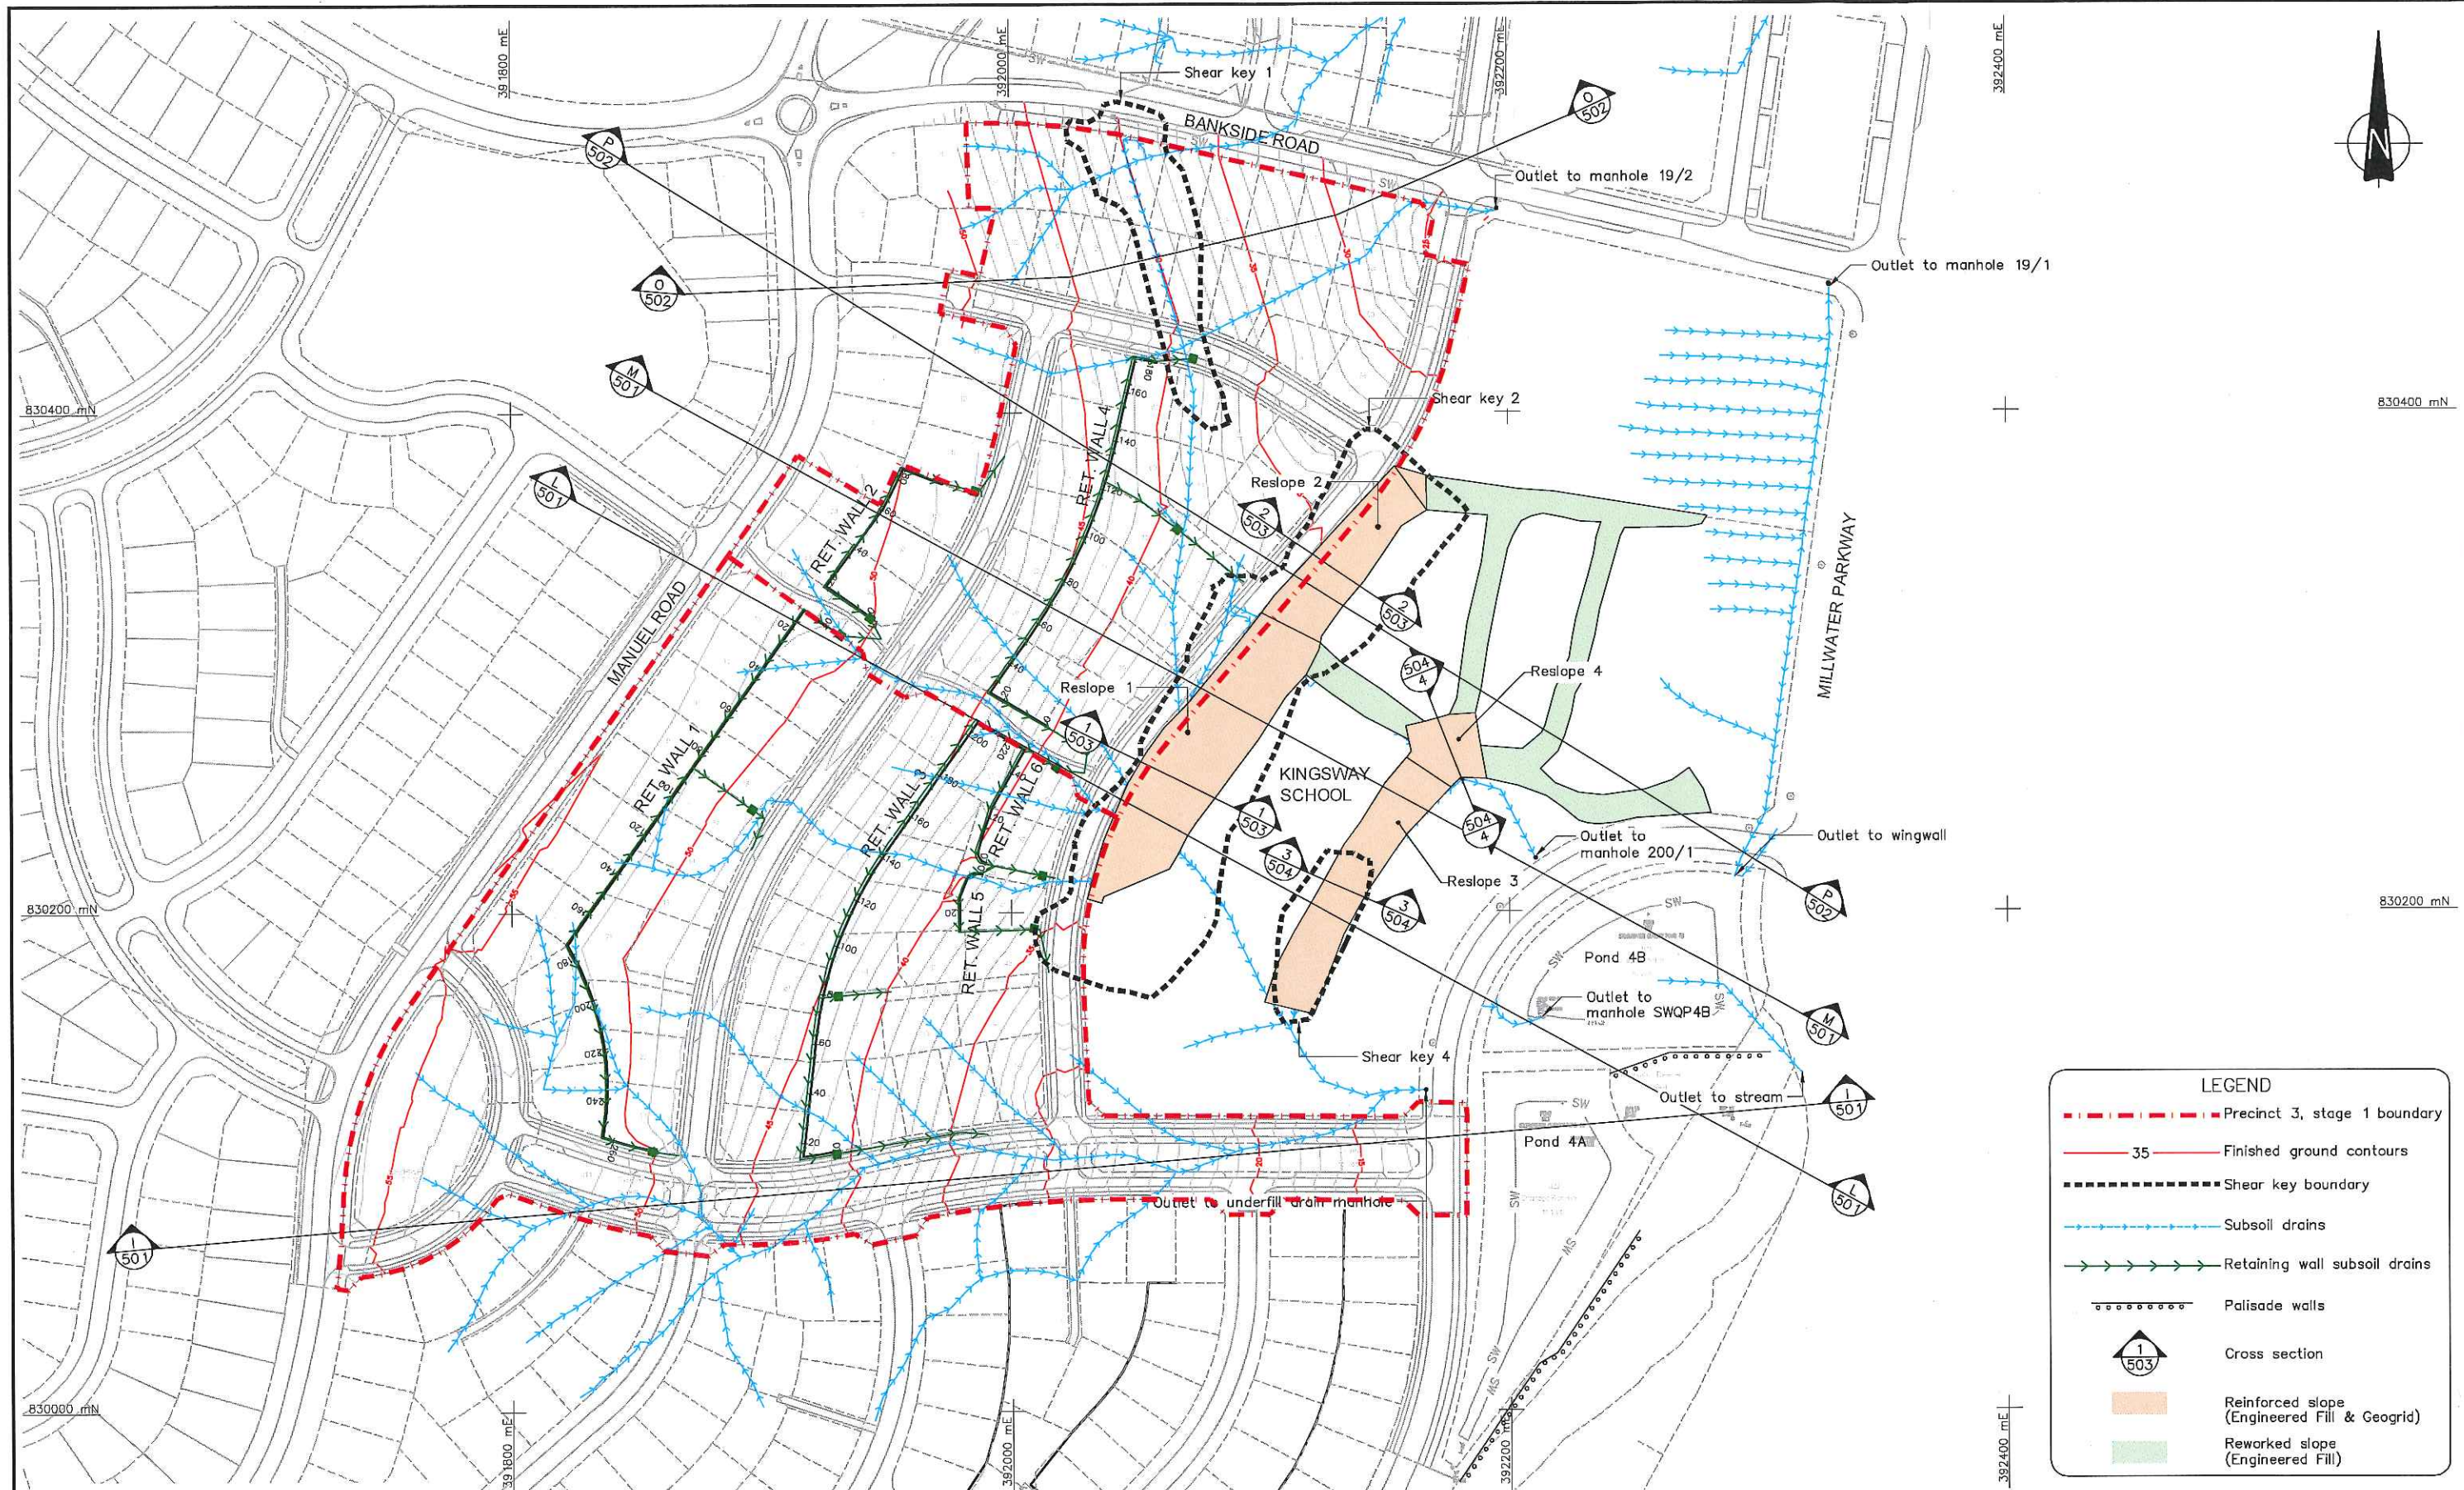
Two shear keys were excavated within Stage 1 during the initial bulk earthworks in the locations shown on T&T Drawing 21854.008-500, included in Appendix A2. Excavations were inspected and mapped by a Geologist or Engineering Geologist to check that the keys had been extended sufficiently into the underlying rock materials and that there was no adverse structure or feature exposed within the excavation. Any areas of suspect ground, including areas of identified land-slippage, were removed under the instruction of our site Geologist and replaced with compacted, engineered fill, placed in accordance with the compaction specification described in Section 2.3 above.
