**MILLWATER - PRECINCT 3 STAGE 2A  
Geotechnical Completion Report**

**Tonkin & Taylor Ltd**

**September 2014**

**T&T Ref: 21854.008/2A**

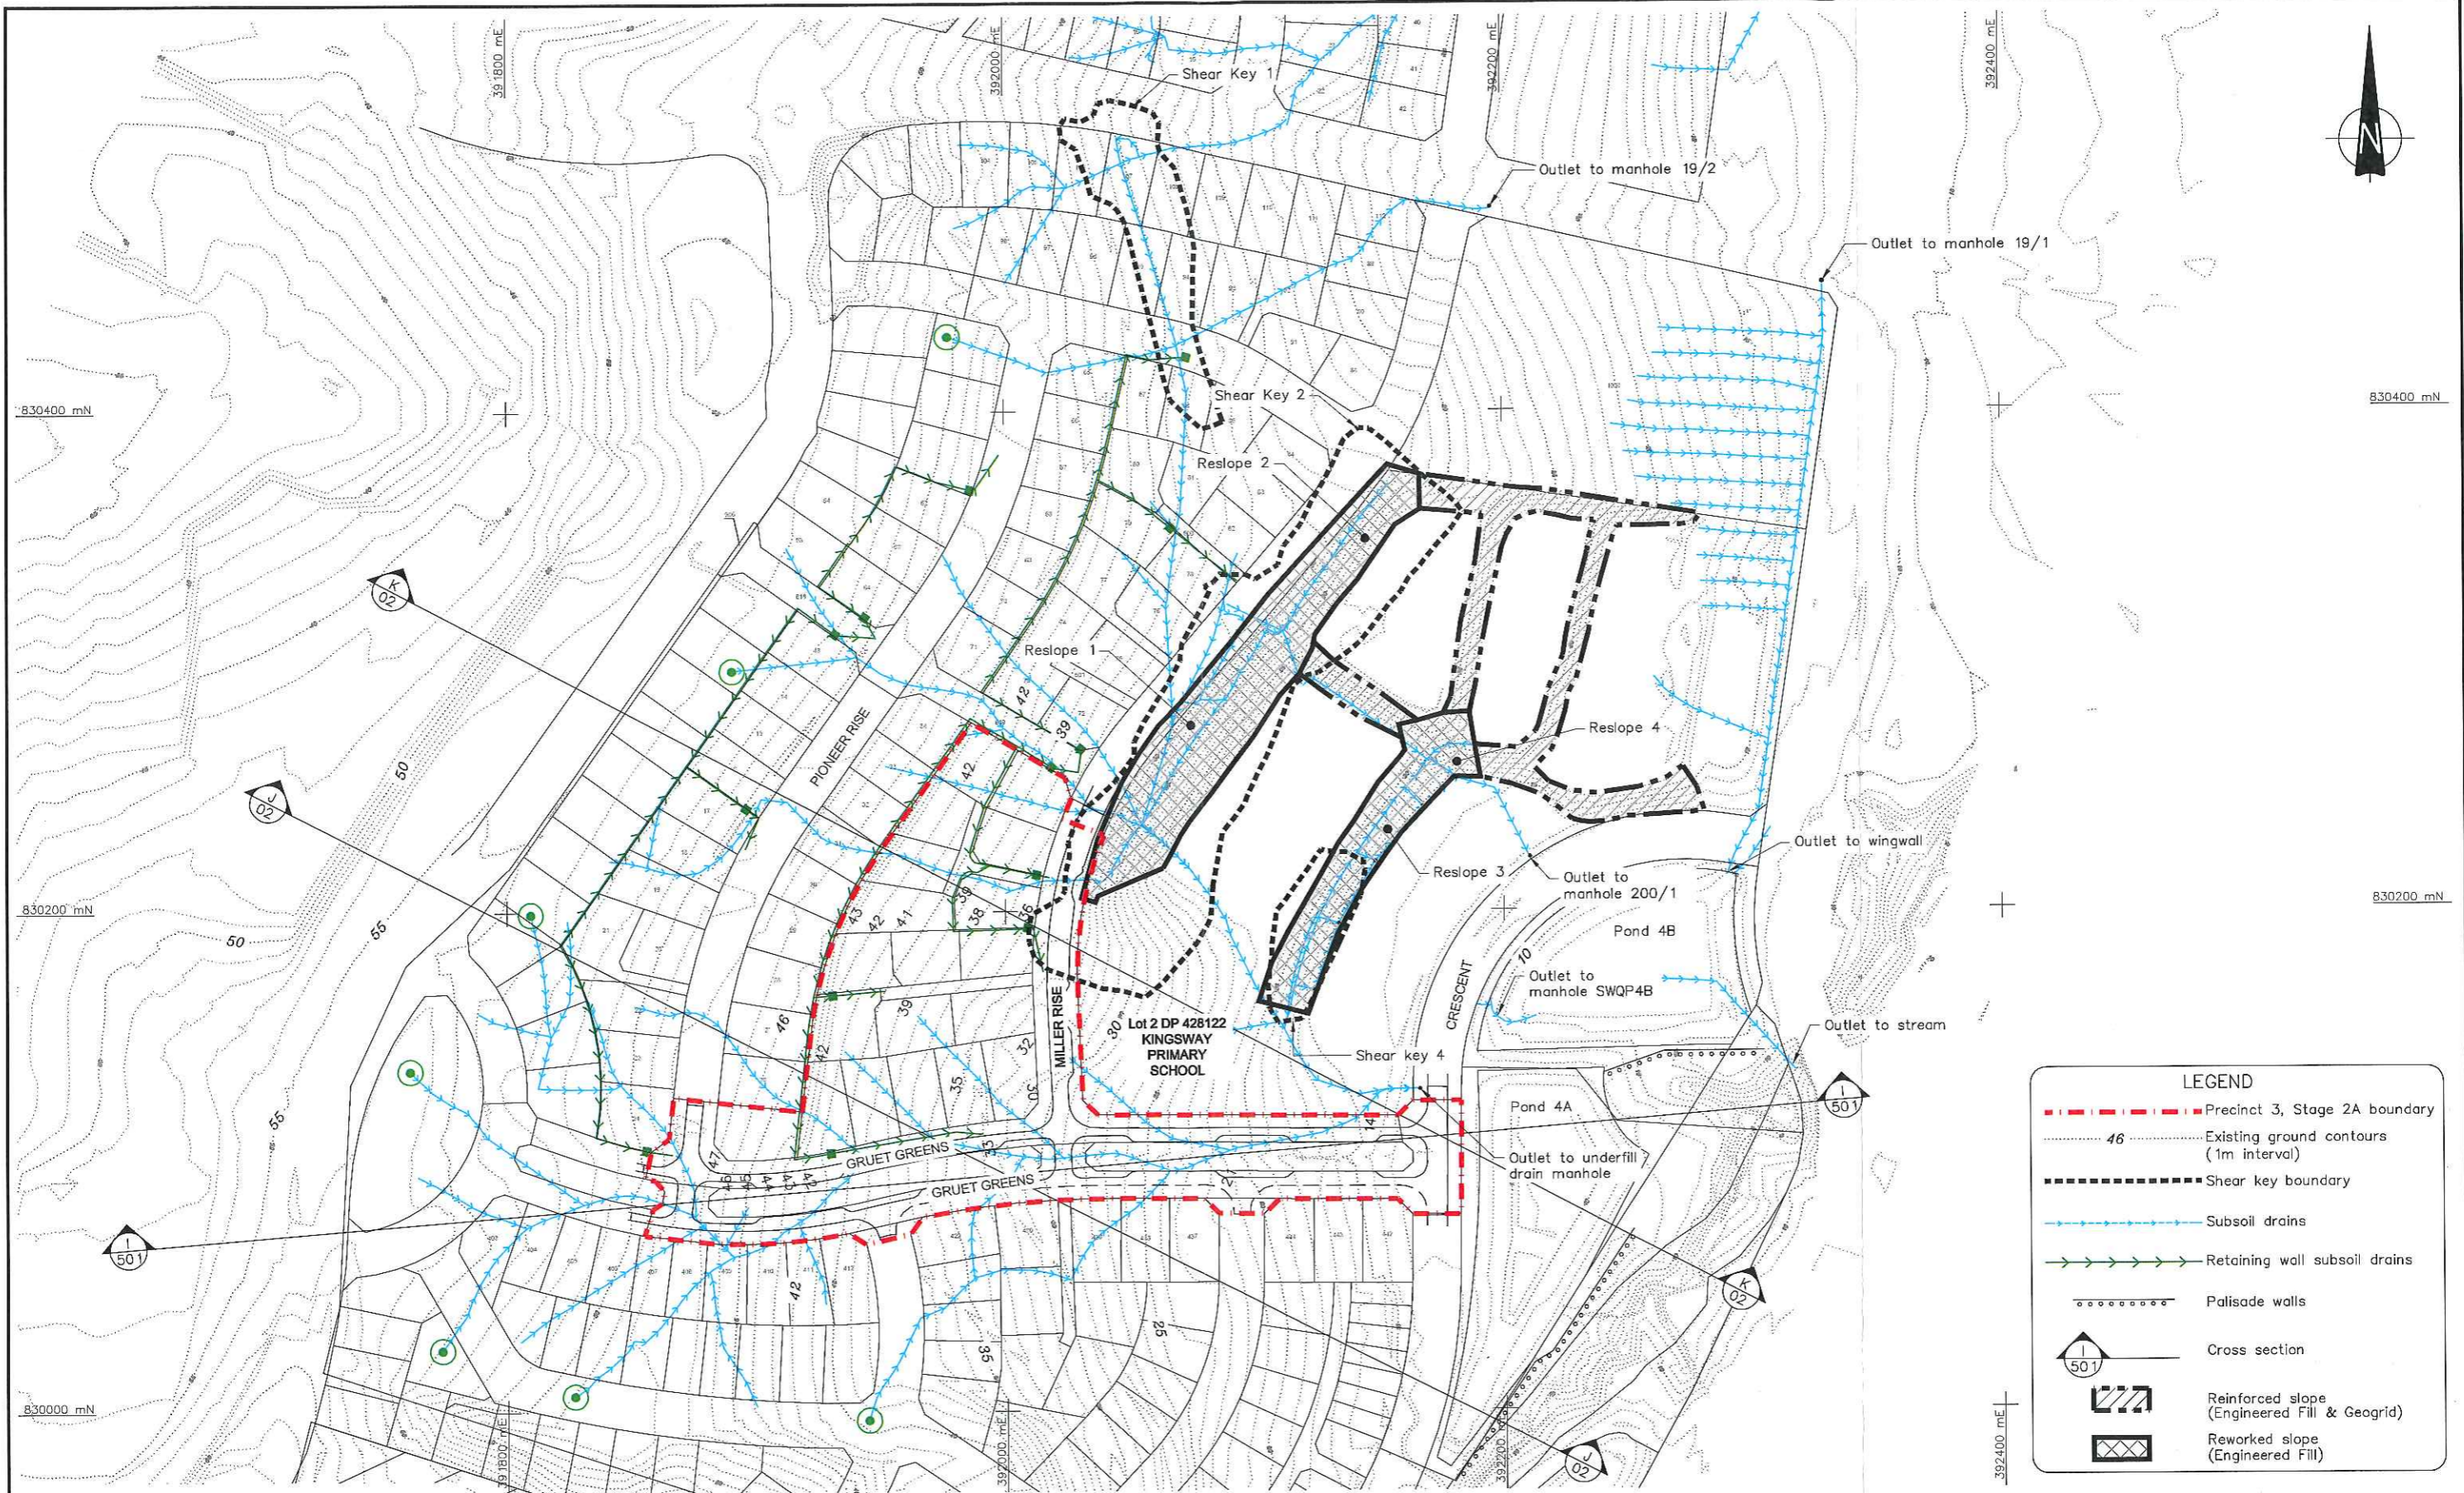
- 21854.008-2A-100 Geotechnical Works Plan

One shear key ("Shear Key 2") was excavated within Stage 2A during the initial bulk earthworks in the location shown on T&T Drawing 21854.008-500, included in Appendix A2. The excavation was inspected and mapped by an Engineering Geologist to check that the key had been extended sufficiently into the underlying rock materials and that there was no adverse structure or feature exposed within the base of the excavation. Any areas of suspect ground, including areas of identified land-slippage, were removed under the instruction of our site Geologist and replaced with compacted, engineered fill, placed in accordance with the compaction specification described in Section 2.3 above.
