Job Number
21854.0031/AHP5S3B+4.v2

Title: MILLWATER SUBDIVISION ARRANS HILL PRECINCT 5 - STAGES 3B & 4, Geotechnical Completion Report					
Date	Version	Description	Prepared by:	Reviewed by:	Authorised by:
September 2019	1	Geotechnical Completion Report	JKK	APS	APS
February 2020	2	Geotechnical Completion Report	JKK	APS	APS

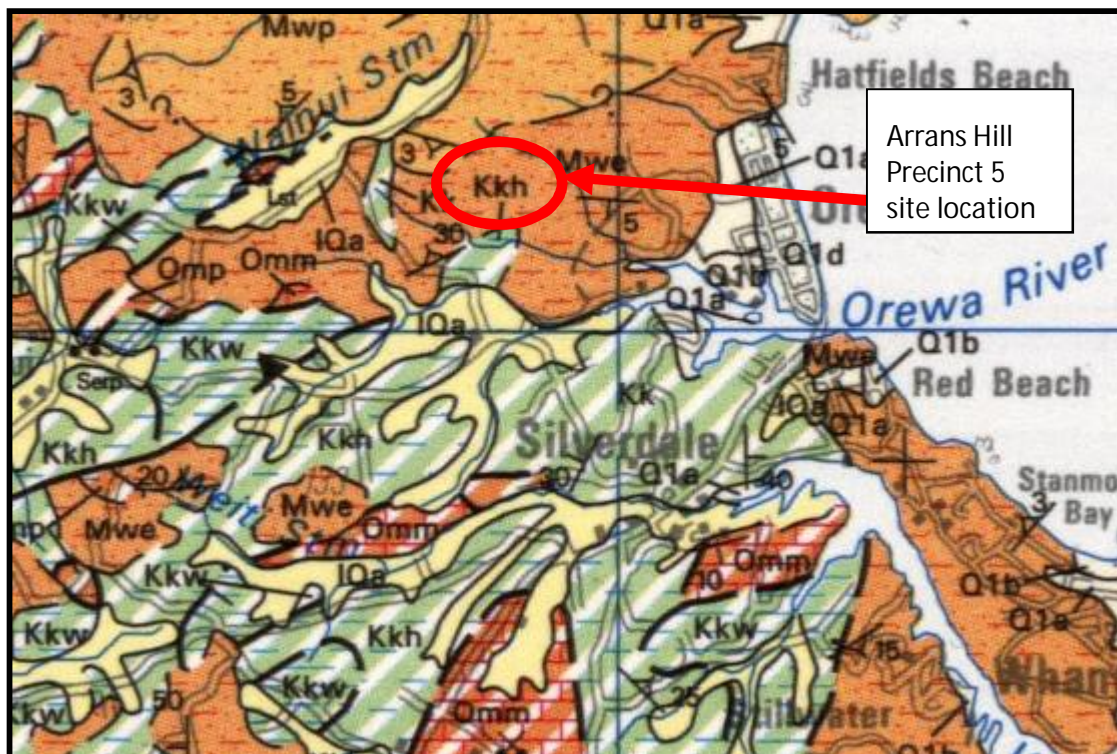
Figure 1 - Geological map of Arrans Hill Precinct 5 and Silverdale area (from Edbrooke, 2001)

Published geological mapping and information indicates the Arrans Hill Precinct 5 area is underlain by East Coast Bays Formation (ECBF) materials. In addition to the ECBF materials, our investigations identified the presence of alluvial and colluvial materials on site along the stream margins.

Alluvium and Colluvium are generally observed on the lower slopes, along the edges of the tidal tributaries of the Orewa River - along the southern and eastern boundary of the site. In places, it is locally discontinuous or absent.

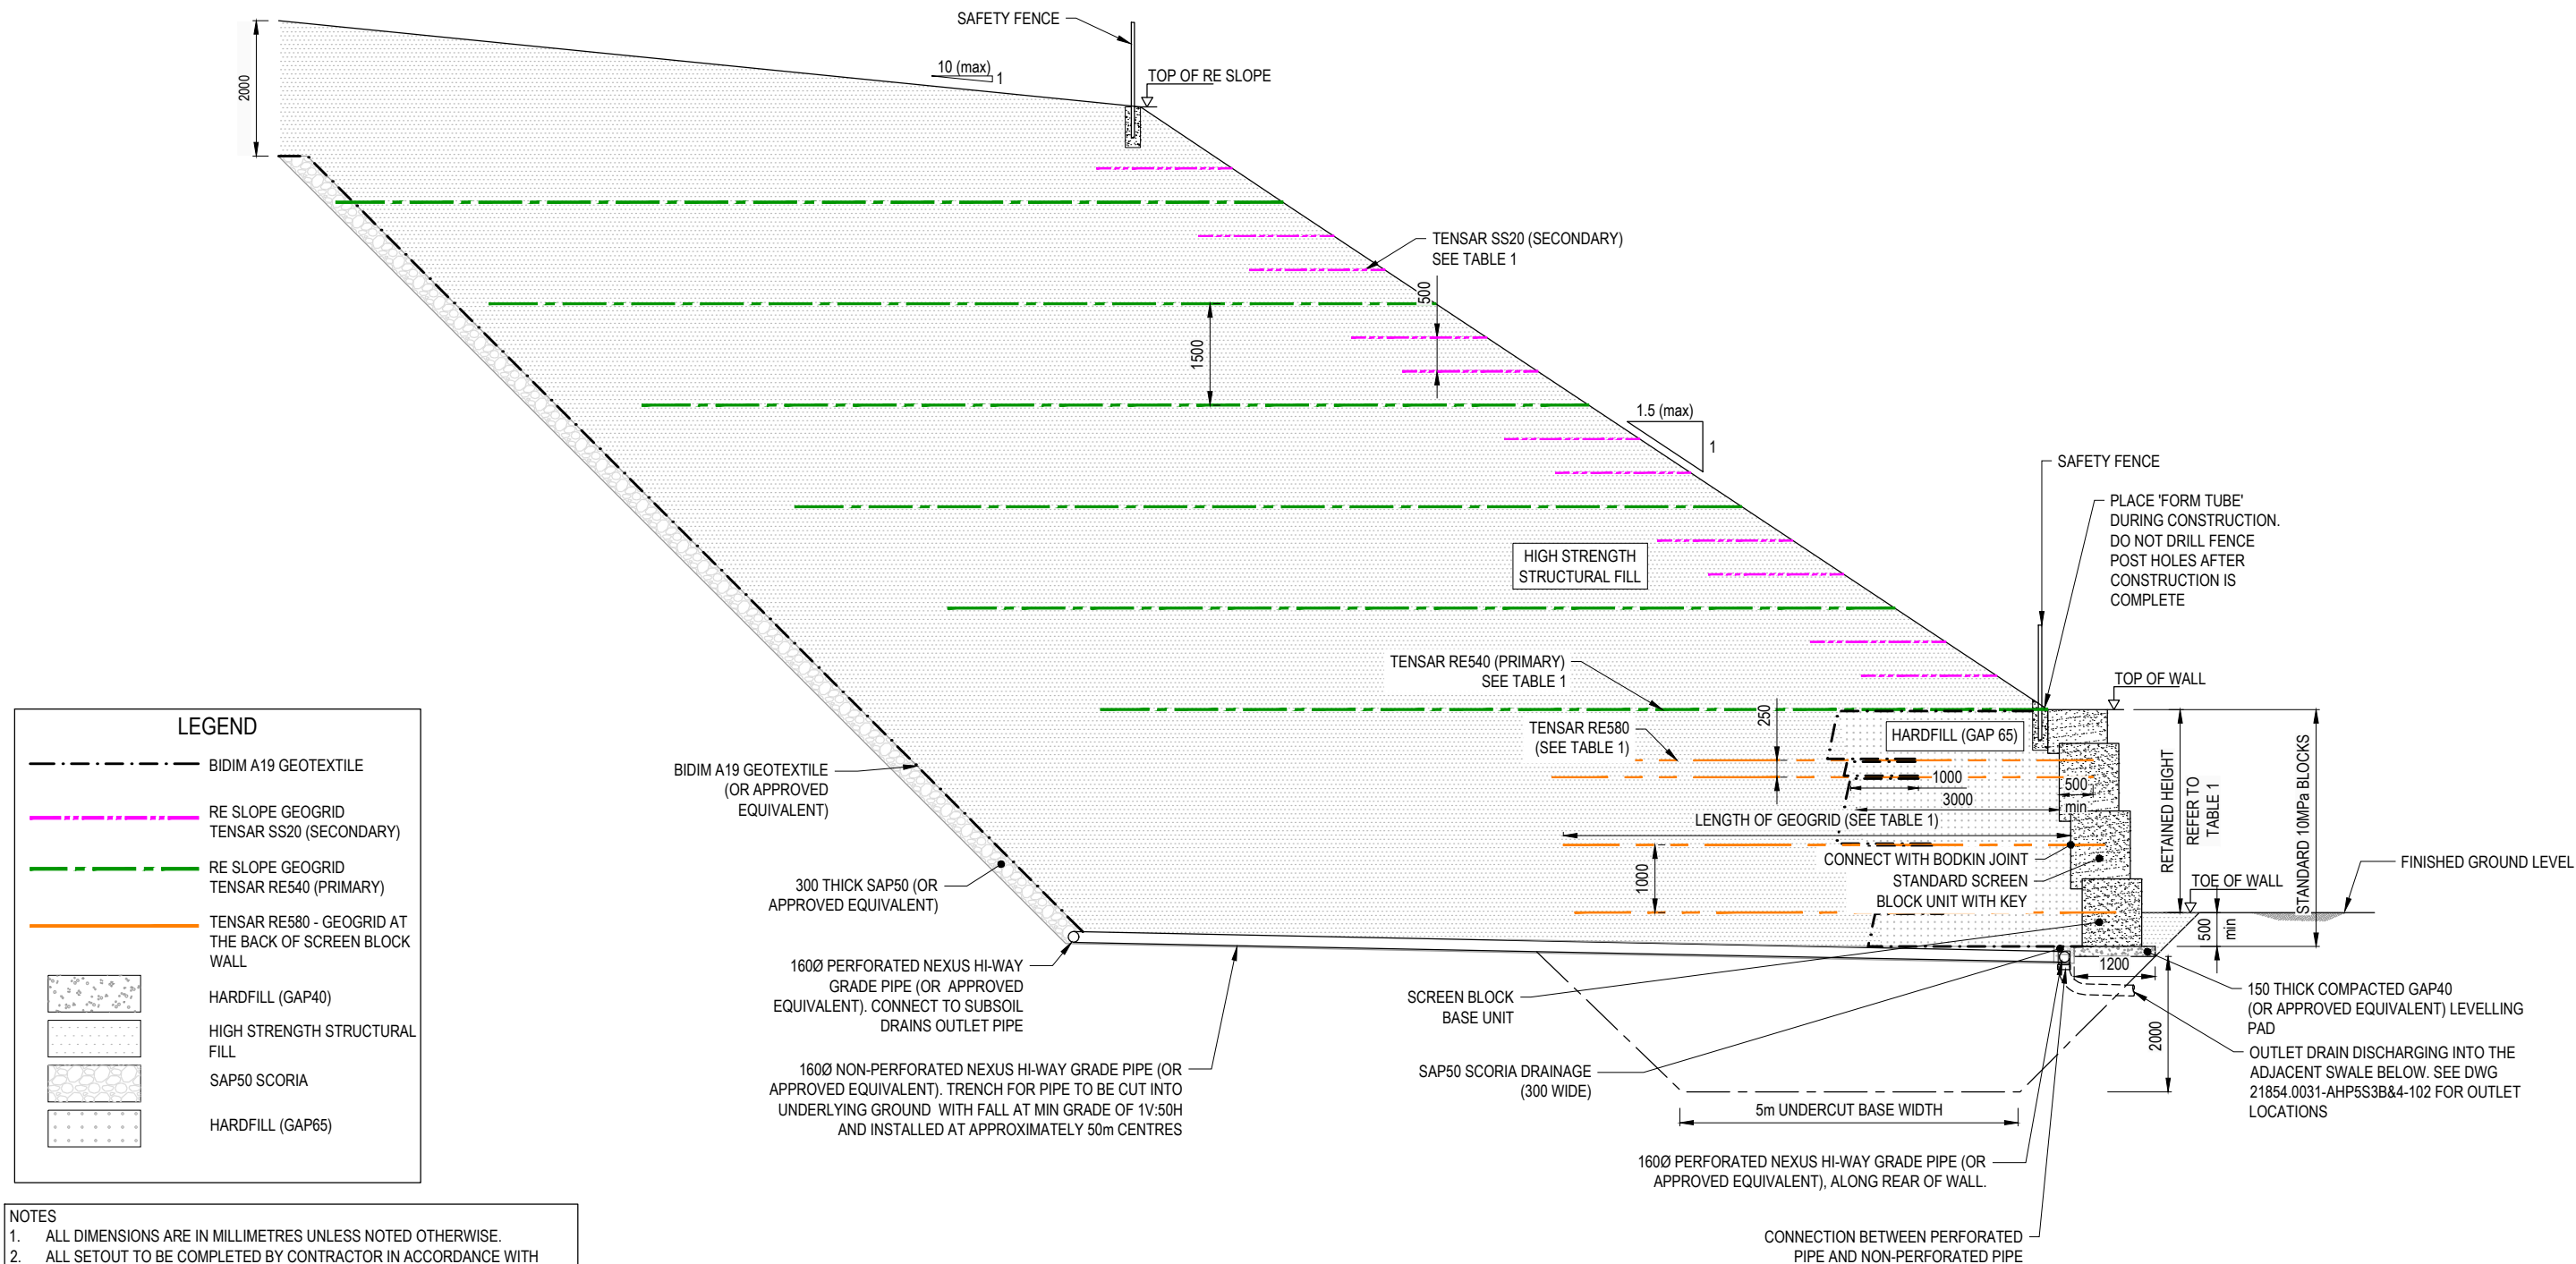
SECTION	6	SCREEN BLOCK WALL TYPICAL SECTION (H≤3m)
SCALE 1: 100	110	RETAINING WALL 06

WALL TYPE	TOTAL SLOPE/ RETAINED HEIGHT (m)	MAX BACKSLOPE	MAX FORWARD SLOPE	GEOGRID TYPE	GEOGRID LENGTH (m)	VERTICAL LOCATION ABOVE TOE OF WALL (m)
SCREEN BLOCK	$H \leq 3$	1V:1.5H	0°	TENSAR RE580	8.0	0.0, 1.0, 2.0, 2.25
RE SLOPE	$8 < H \leq 9$	1V:10H	N/A			MAX VERTICAL SPACING (m)
				TENSAR RE540 (PRIMARY)	14.0	1.5
				TENSAR SS20 (SECONDARY)	2.0	0.5

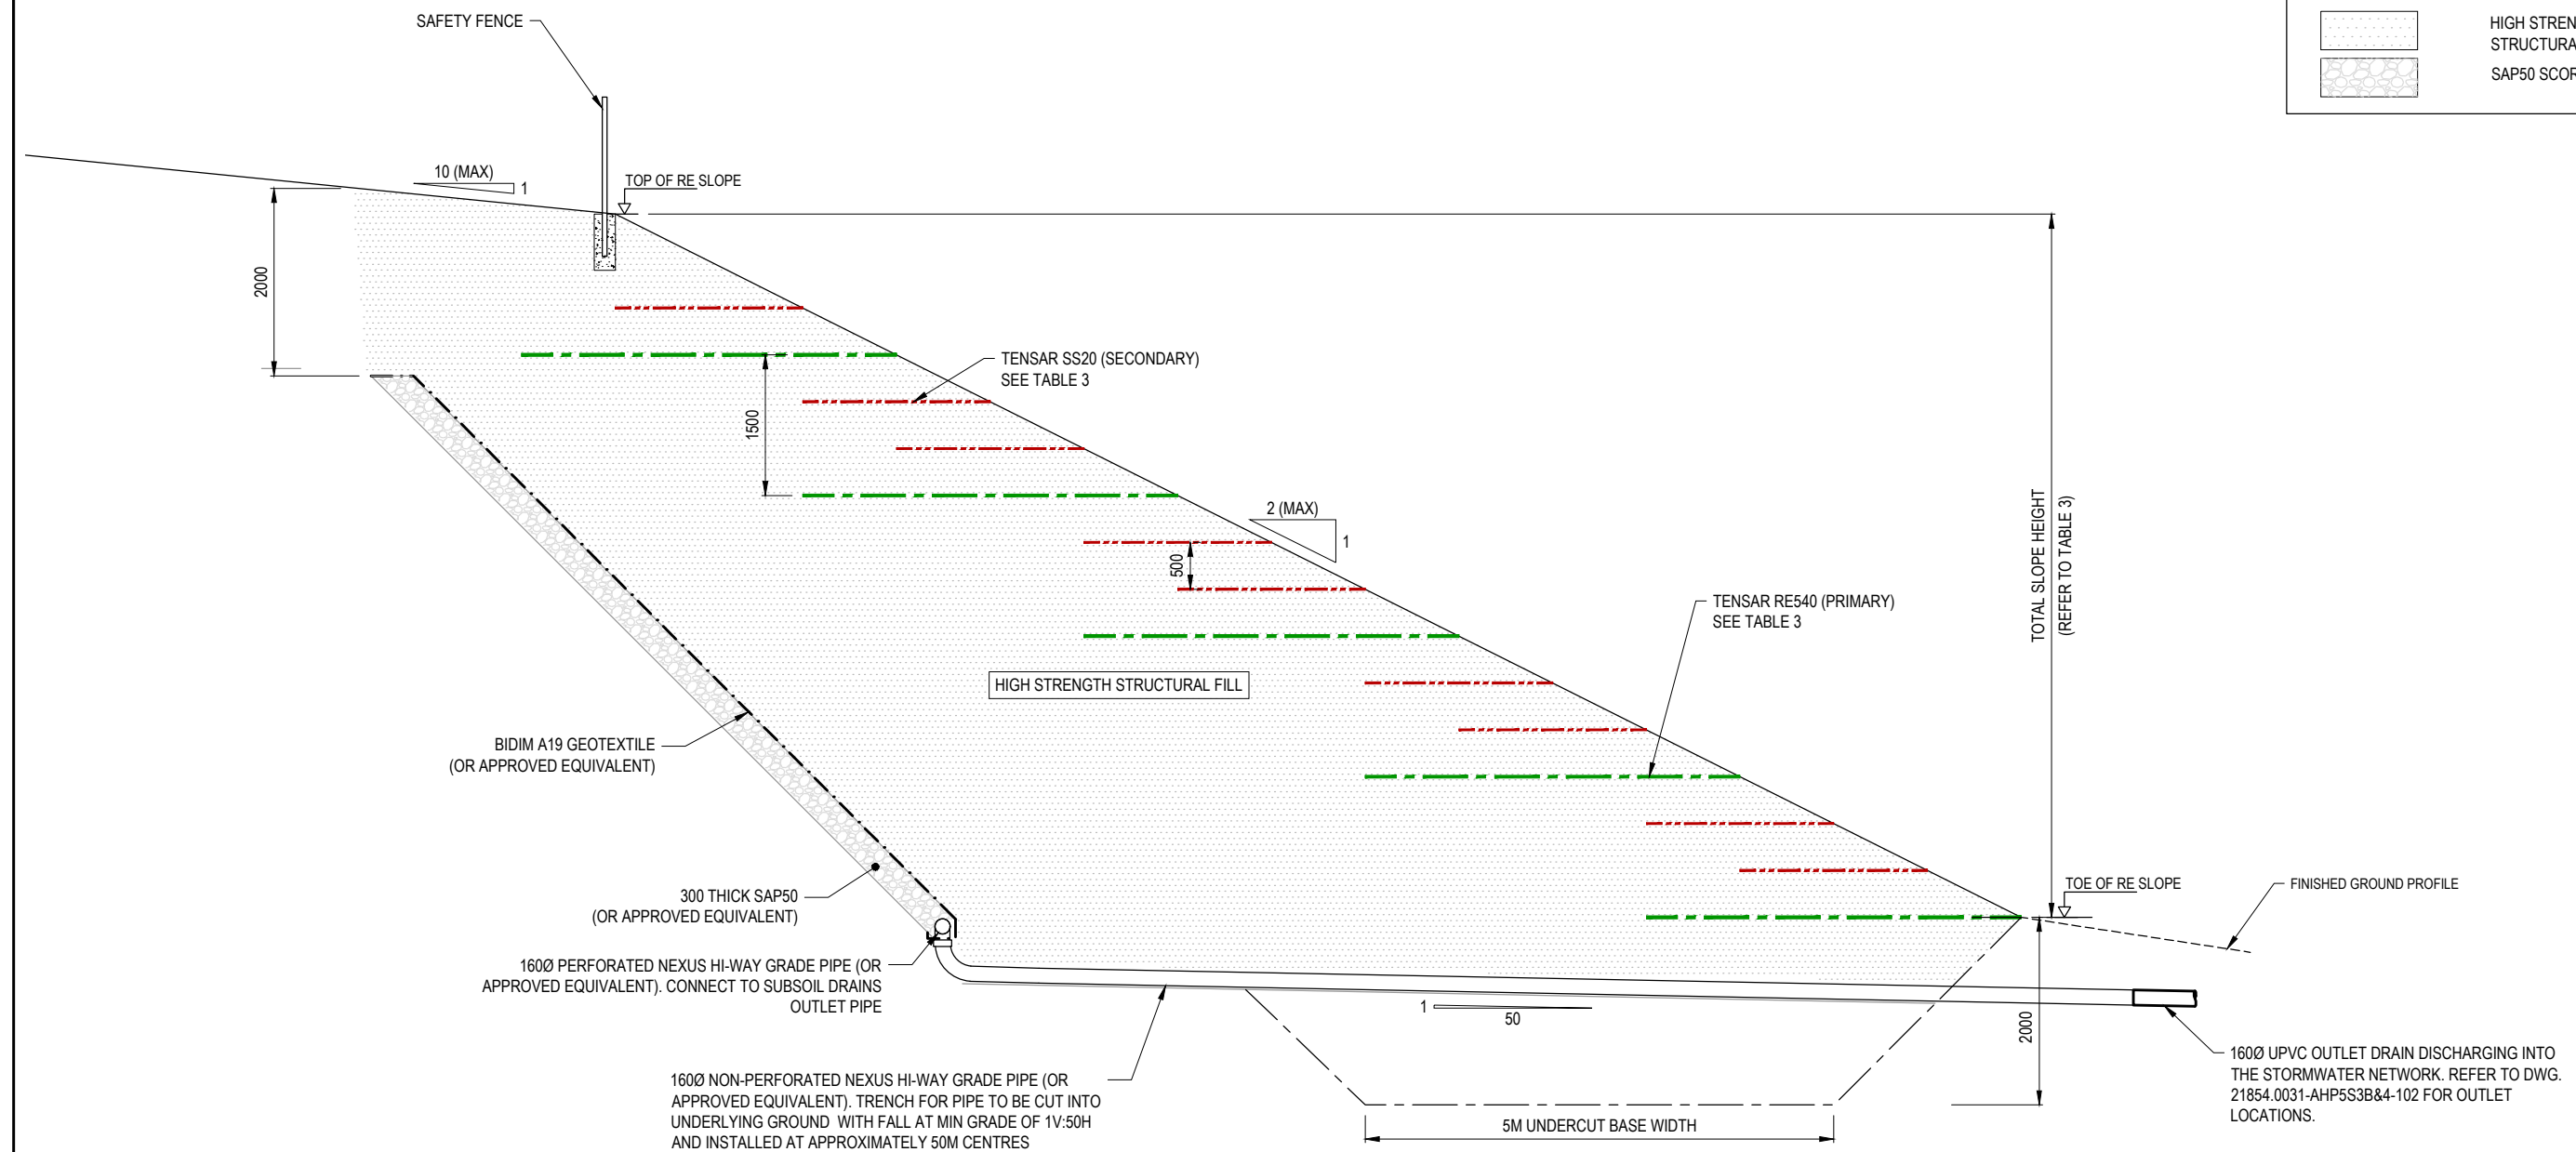
SECTION 8 RE SLOPE 5
SCALE 1:75 101

As noted in Section 3.1, a drainage blanket was installed at the rear of the reinforced block of soil and comprises a minimum of 300mm thickness of SAP50 scoria, covered in Bidim A19 geotextile filtercloth and a cap of engineered cohesive fill 2m in thickness. A 160mm diameter perforated Hiway grade Nexus drain pipe installed at the base of the drainage blanket provides regular discharge outlets for any groundwater captured in the drainage blanket. These drainage pipes are connected into the reticulated stormwater system (RE 5) or into the swale drain below Grand Drive (RE 7).

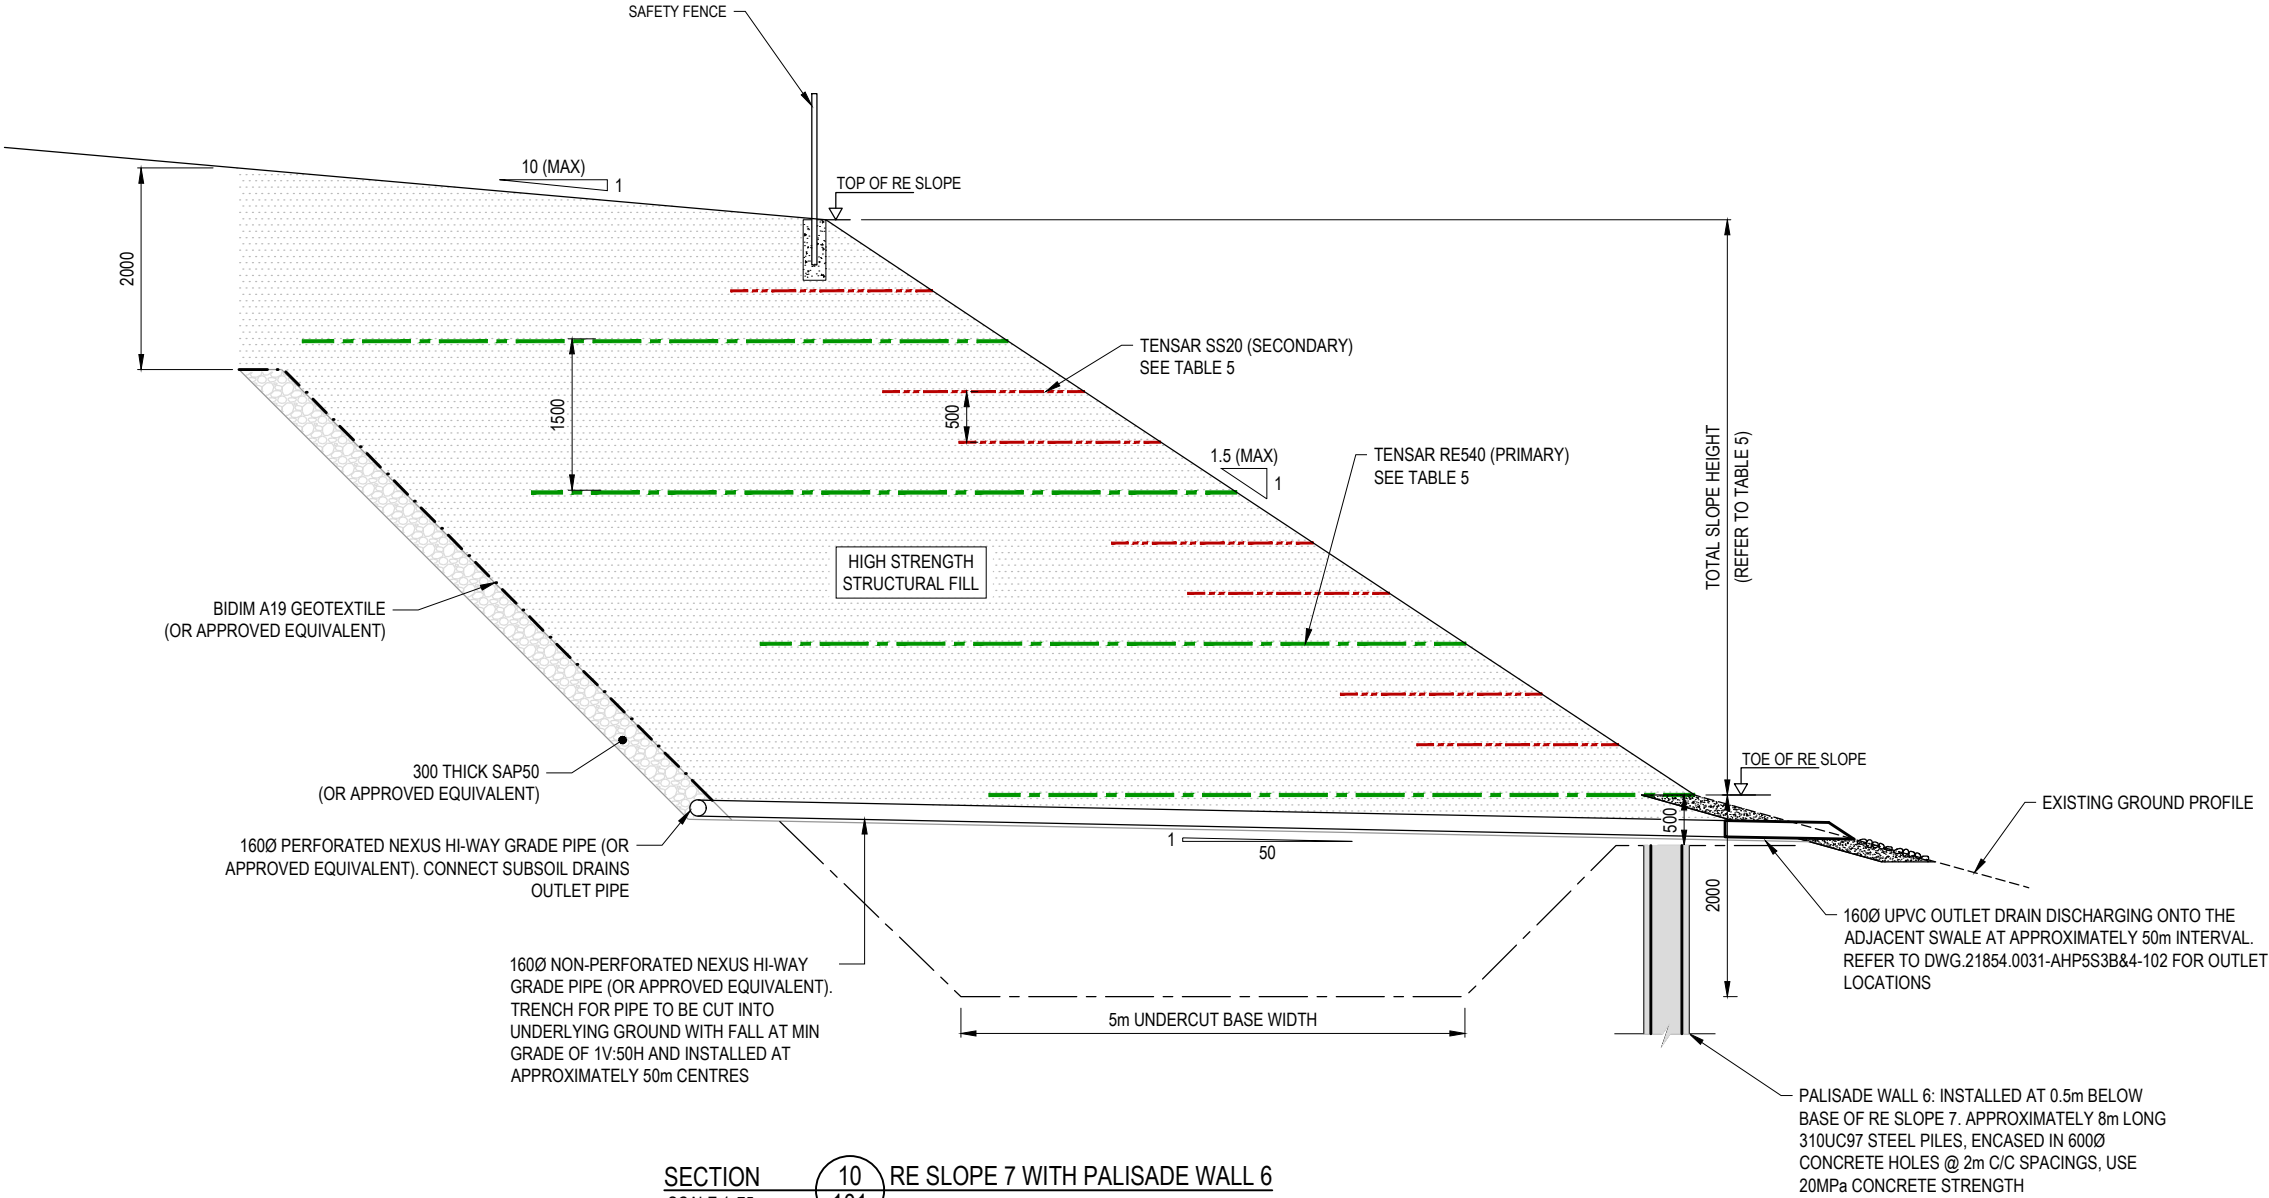
SECTION 10 RE SLOPE 7 WITH PALISADE WALL 6
SCALE 1: 75

Ground conditions exposed during construction of Palisade Walls 5 and 6 were generally as anticipated from the design stage of the development. The slope stability analysis results from the original design phase are discussed in Section 4.

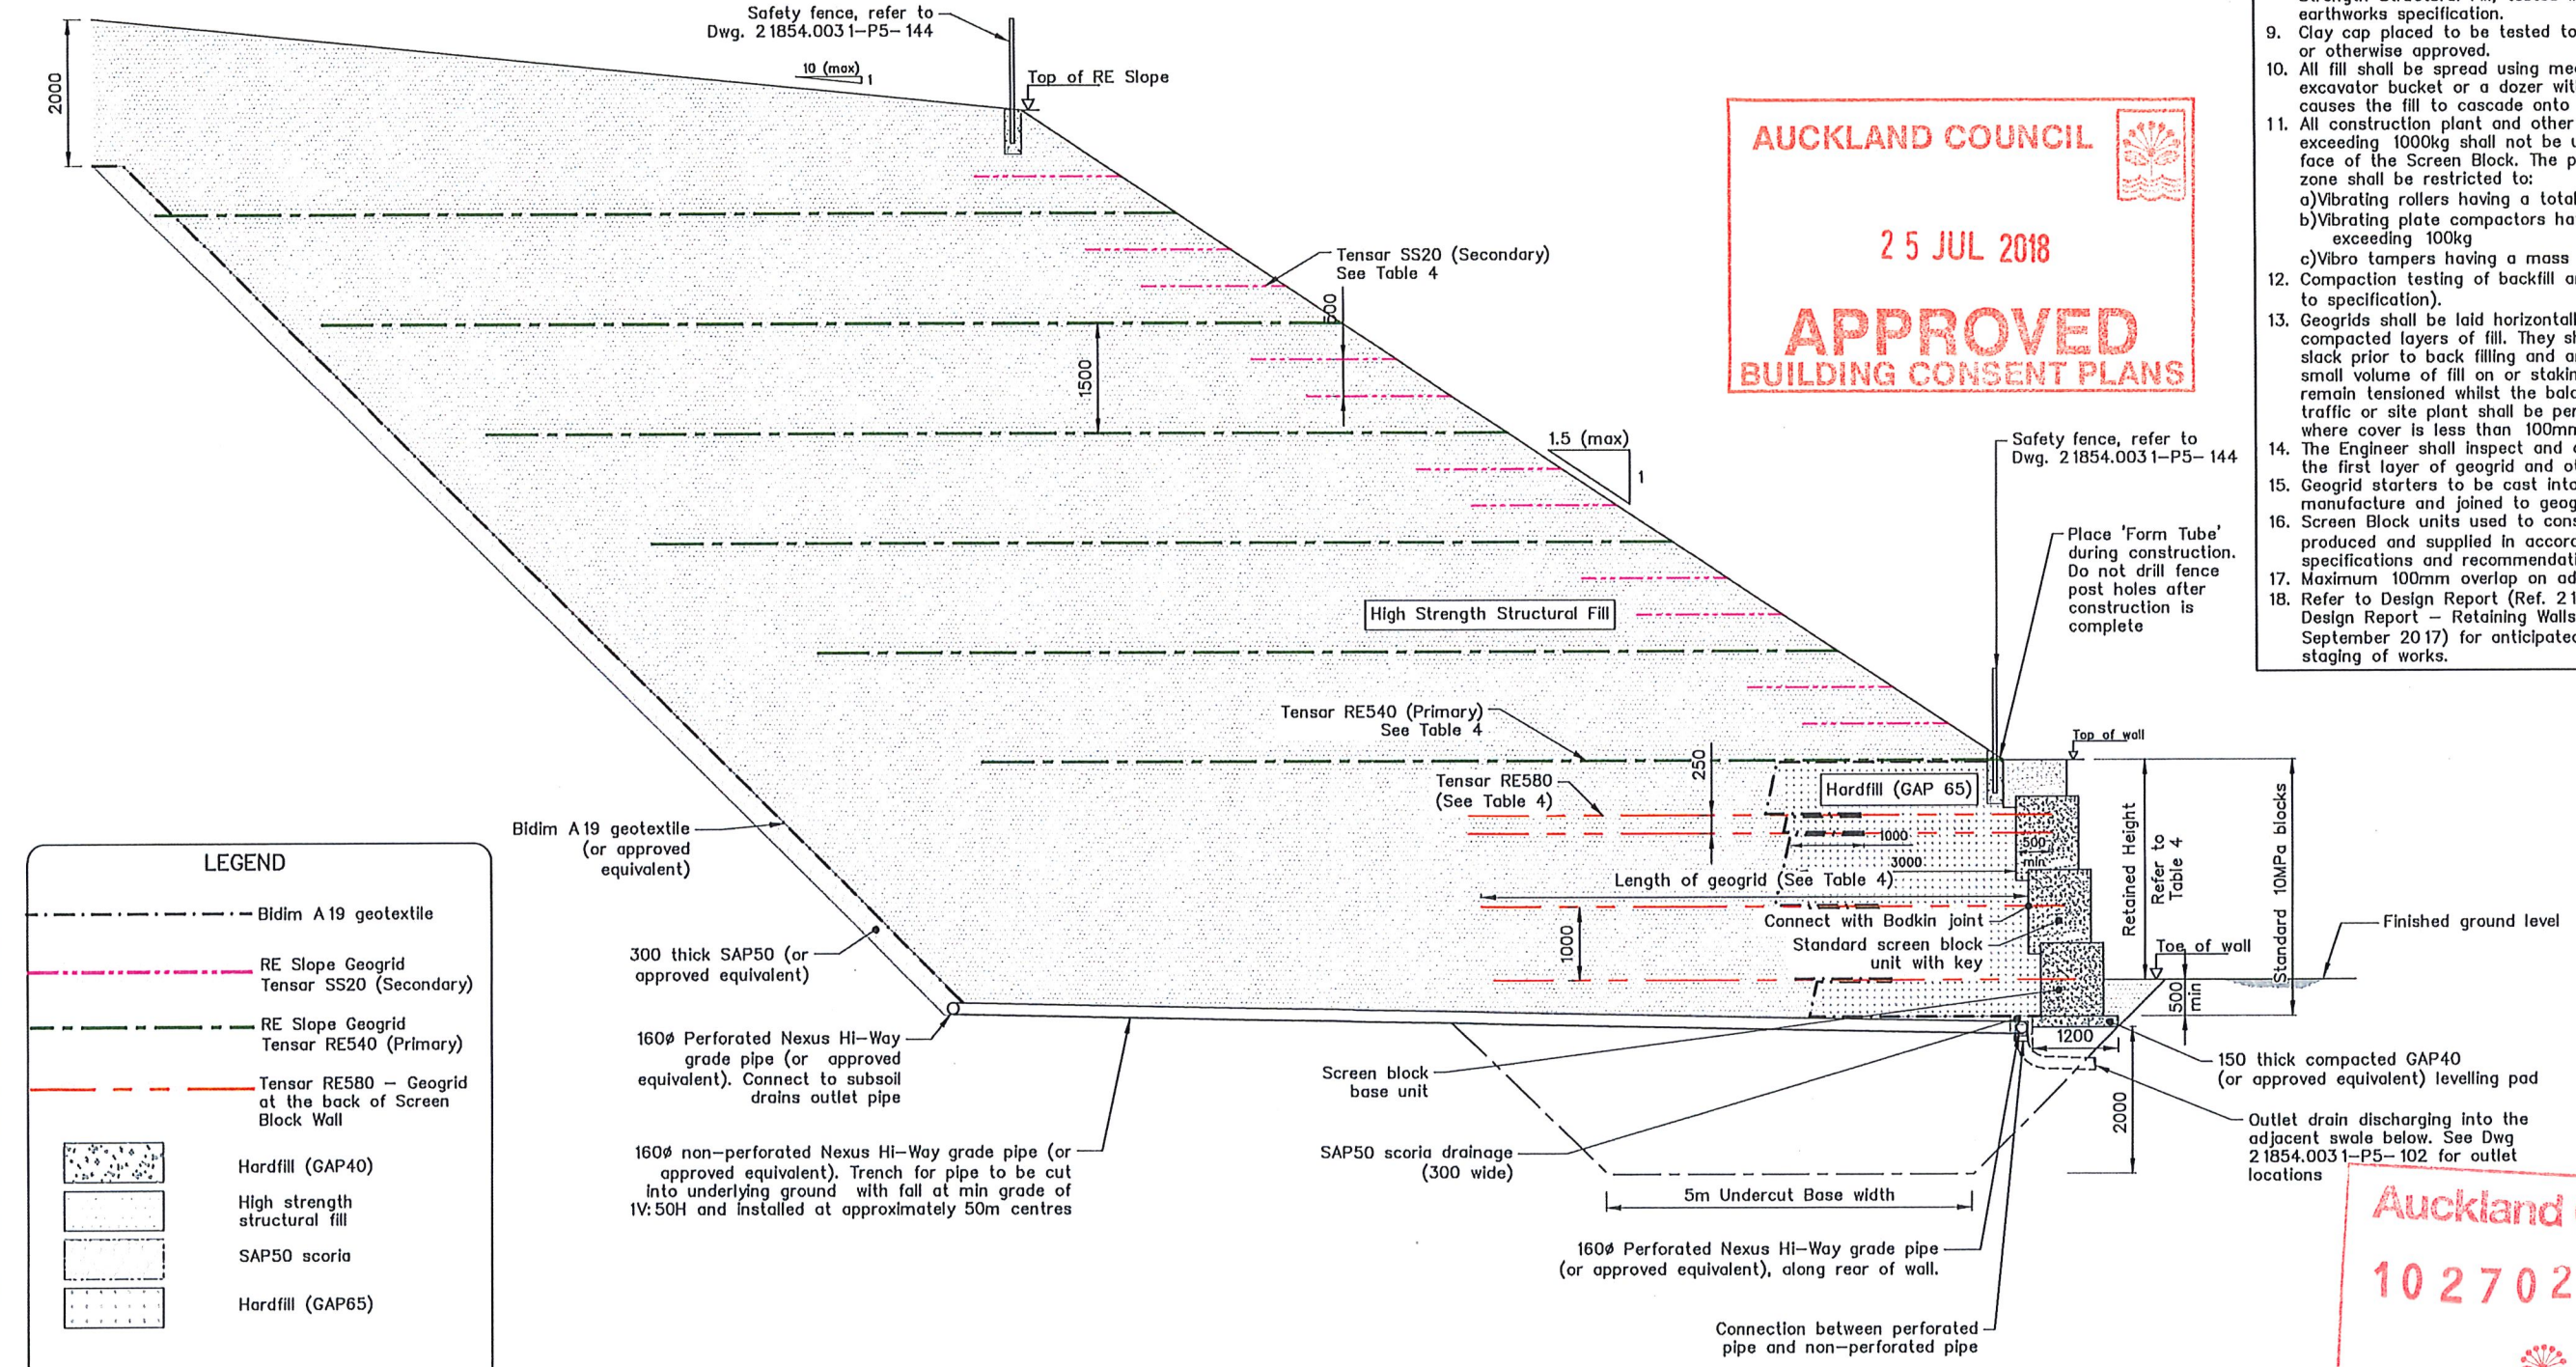
SECTION 15/123 15/124 SCREEN BLOCK WALL TYPICAL SECTION (H<3m) RETAINING WALLS 05 AND 06 SCALE 1:100

- Maximum 100mm overlap on adjoining grids.
 - Refer to Design Report (Ref. 21854.0031/v1, Geotechnical Design Report - Retaining Walls 3-7 and RE slope 2-9, September 2017) for anticipated construction sequencing and staging of works.

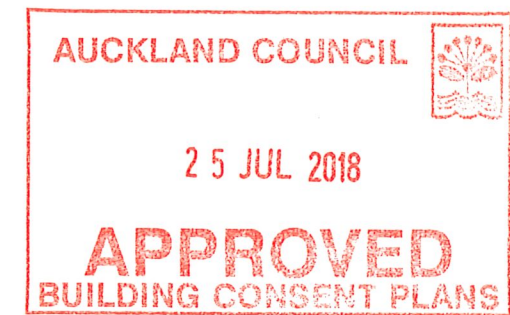
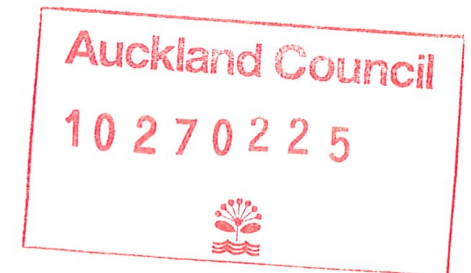
ELEVATION
SCALE 1:20

DESIGNED :	JXXL	May. 18	NOTES : 1. All dimensions are in millimetres unless noted otherwise. 2. Fence panels to be hot dip galvanised and black powder coated. 3. Fence panels must not have more than 100mm gap from ground level to base of installed panels. 4. Post to be 50mmØ hot dip galvanised pipe and black powder coated. 5. Posts to be installed vertically and packed out appropriately. 6. Fence panels and post to be installed in accordance with manufacturers recommendation and specification.
				DRAWN :	JC	May. 18	
				DESIGN CHECKED :	JR	5/18	
				DRAFTING CHECKED :	JR	5/18	
				CADFILE :	21854.0031-P5-110.dwg		
				APPROVED :	5/18		
A	Construction Issue			This drawing is not to be used for construction purposes unless signed as approved			REFERENCE :
REVISION DESCRIPTION		BY	DATE	COPYRIGHT ON THIS DRAWING IS RESERVED

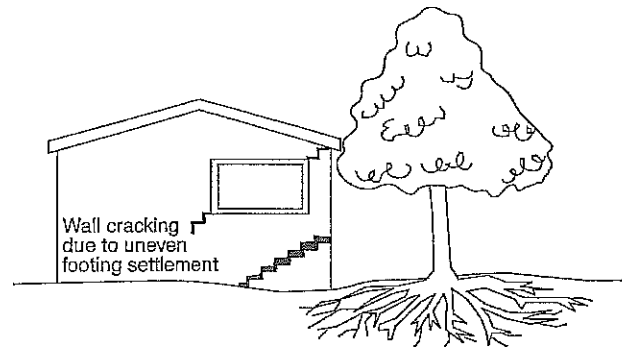
Trees can cause shrinkage and damage

As the weather pattern changes and the soil begins to dry out, the external footings will be first affected, beginning with the locations where the sun's effect is strongest. This has the effect of lowering the external footings. The doming is accentuated and cracking reduces or disappears where it occurred because of dishing, but other cracks open up. The roof lines may become convex.
