**MILLWATER - PRECINCT 2
STAGE 4A**

Geotechnical Completion Report

Prepared for
WFH Properties Ltd

Prepared by
Tonkin & Taylor Ltd

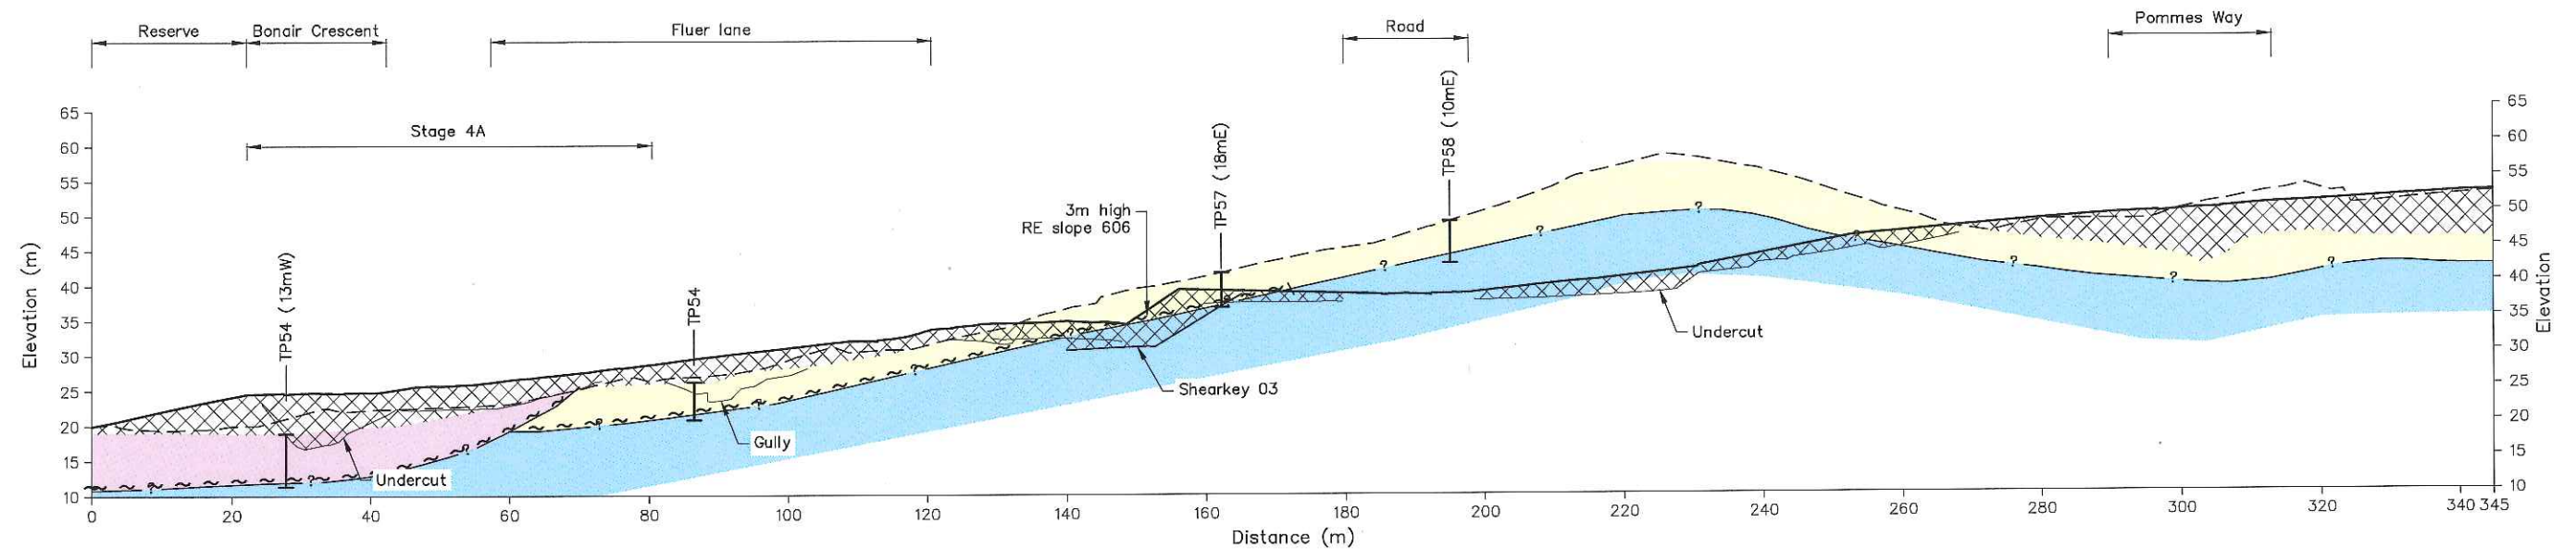
SECTION 7
SCALE 1:1000

CLIENT, PROJECT	WFH PROPERTIES LTD RESIDENTIAL SUBDIVISION		
TITLE	MILLWATER - PRECINCT 2 (STAGE 4A) Geological Cross Section 7		
SCALES (AT A3 SIZE)	1:1000	DWG. No.	21854.001-P2S4A-104
		REV.	1

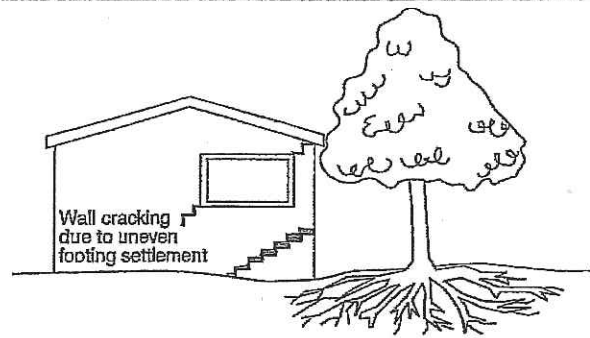
As the weather pattern changes and the soil begins to dry out, the external footings will be first affected, beginning with the locations where the sun's effect is strongest. This has the effect of lowering the external footings. The doming is accentuated and cracking reduces or disappears where it occurred because of dishing, but other cracks open up. The roof lines may become convex.

Doming and dishing are also affected by weather in other ways. In areas where warm, wet summers and cooler dry winters prevail, water migration tends to be toward the interior and doming will be accentuated, whereas where summers are dry and winters are cold and wet, migration tends to be toward the exterior and the underlying propensity is toward dishing.

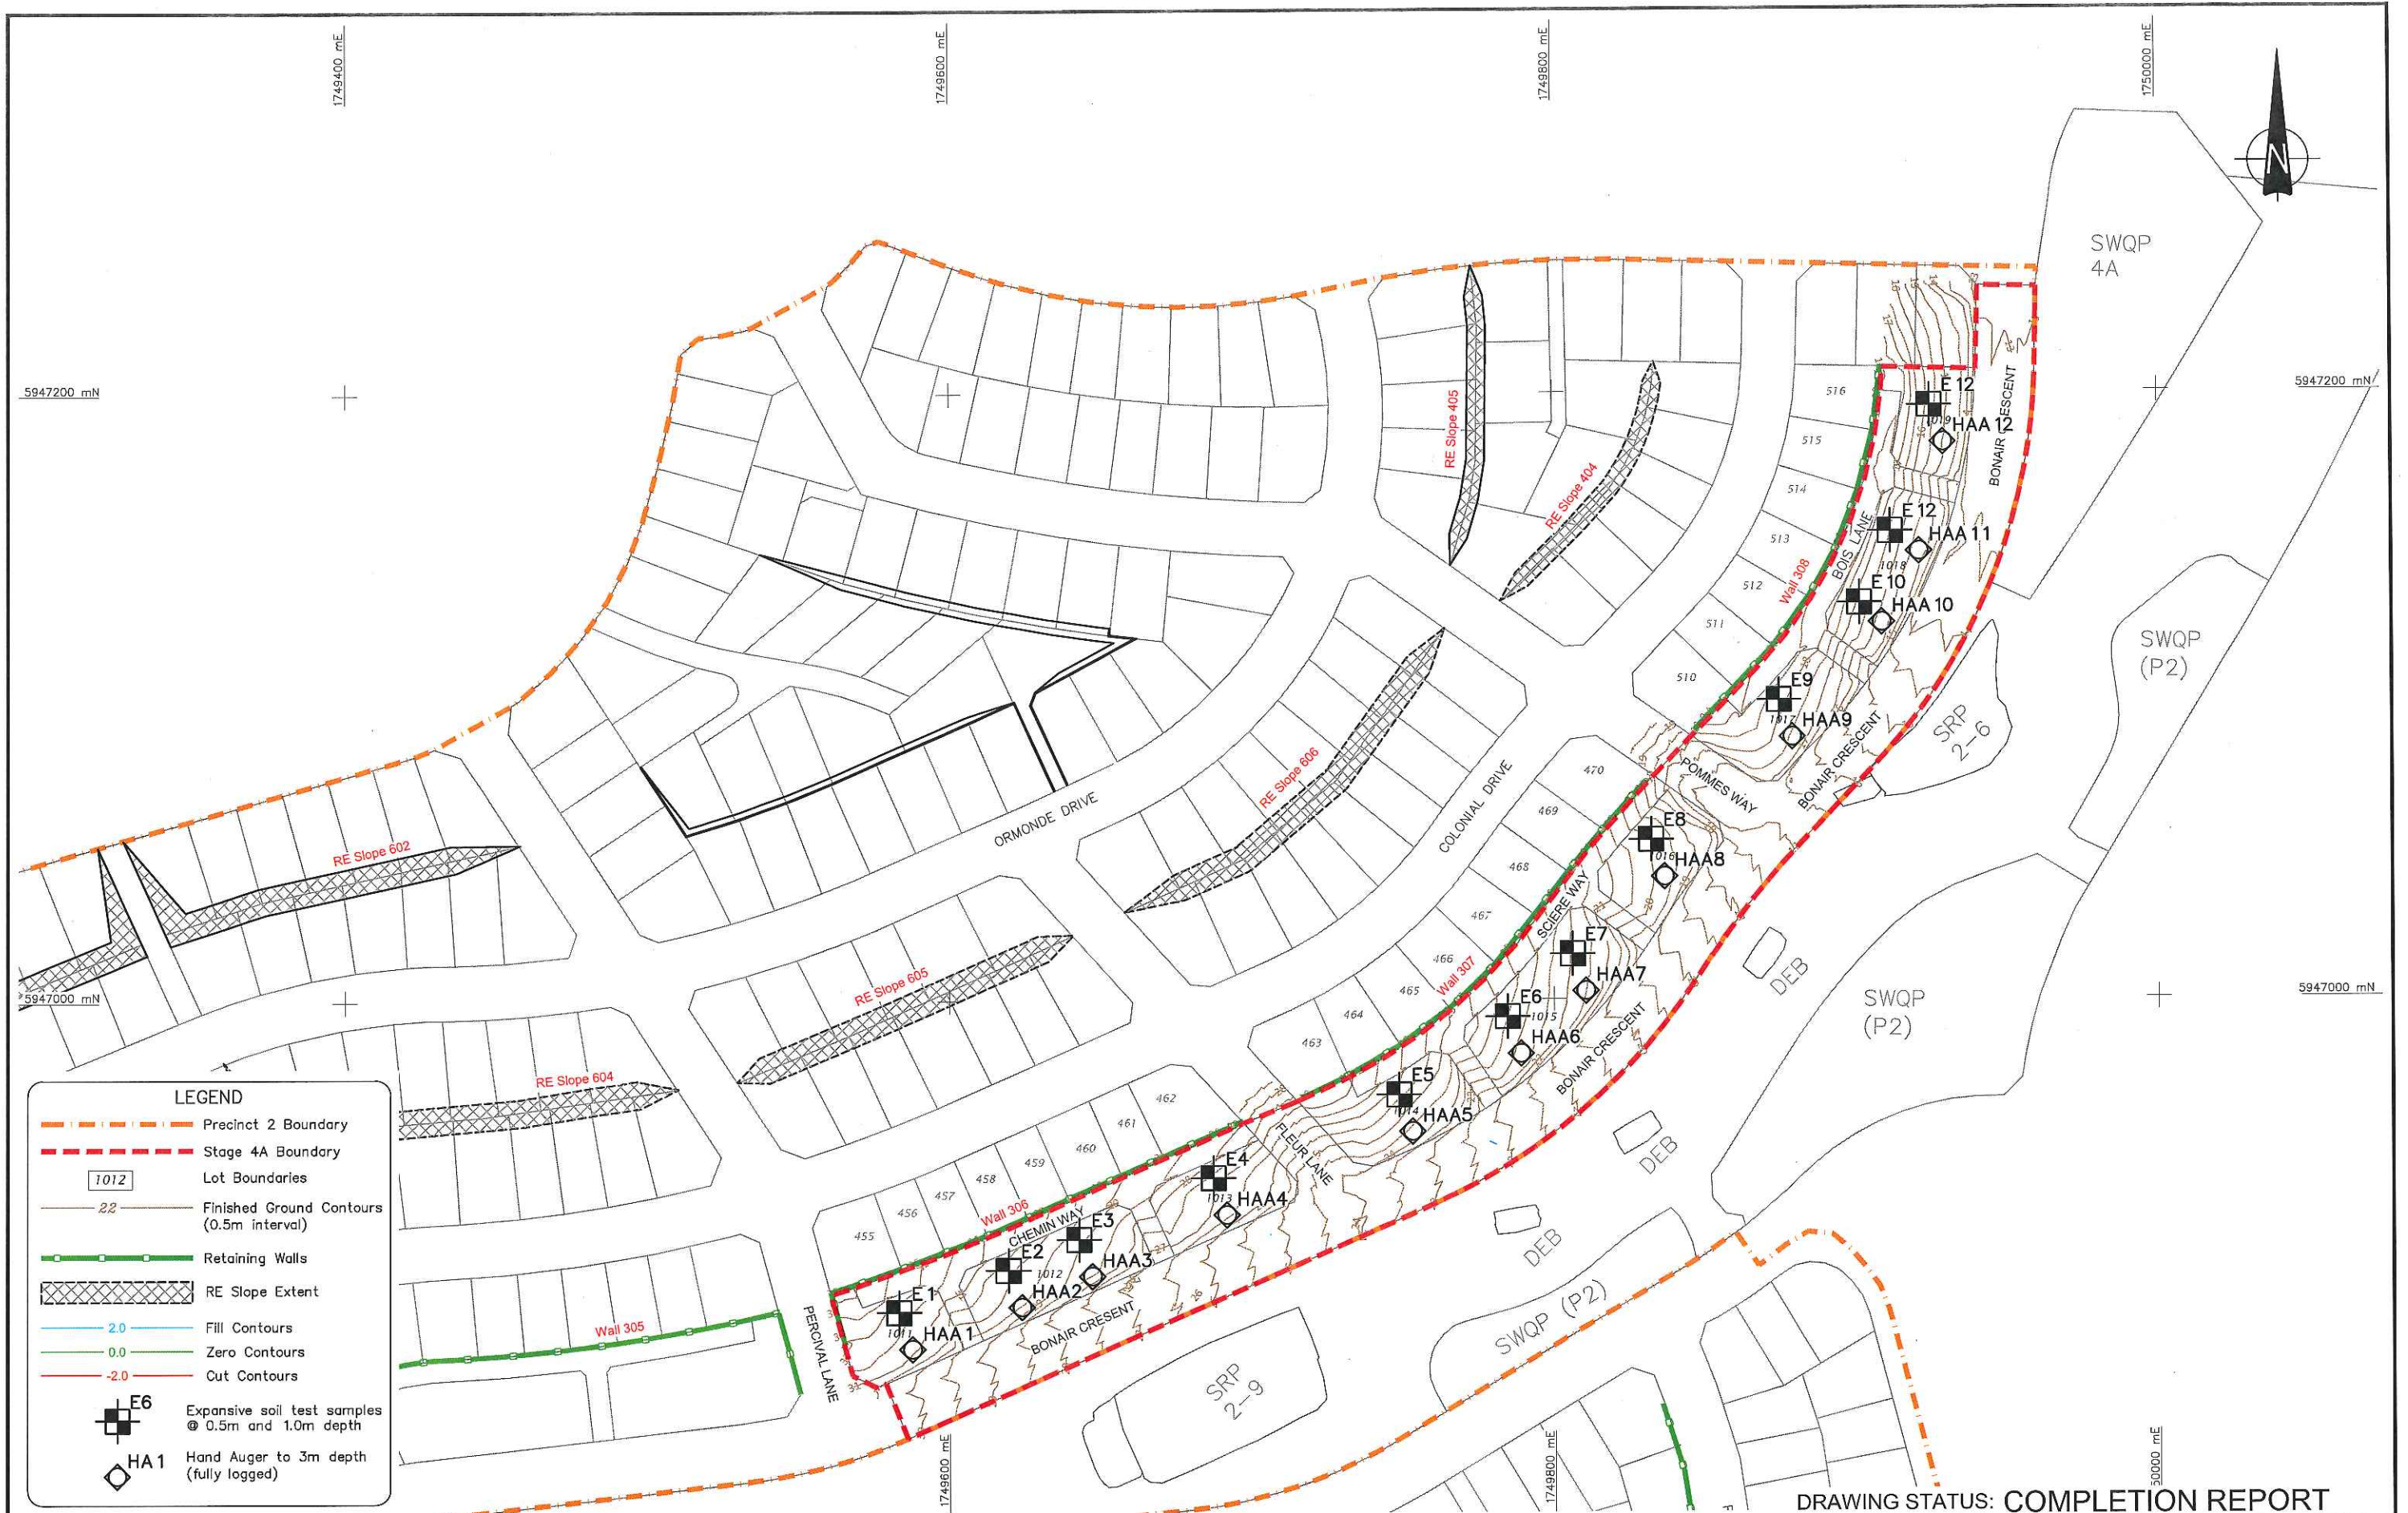
L:\21854\21854-001\WorkingMaterial\CAD\DWG\21854-001-P2S4A-111.dwg, 111, 11/05/2017 9:20:20 a.m., JC

- Precinct 2 Boundary
- Stage 4A Boundary
- Lot Boundaries
- Finished Ground Contours (0.5m interval)
- Retaining Walls
- RE Slope Extent
- Fill Contours
- Zero Contours
- Cut Contours
- Expansive soil test samples @ 0.5m and 1.0m depth
- Hand Auger to 3m depth (fully logged)
