## MILLWATER - PRECINCT 2 STAGE 4C

### Geotechnical Completion Report

Prepared by  
Tonkin & Taylor Ltd

Date  
August 2017

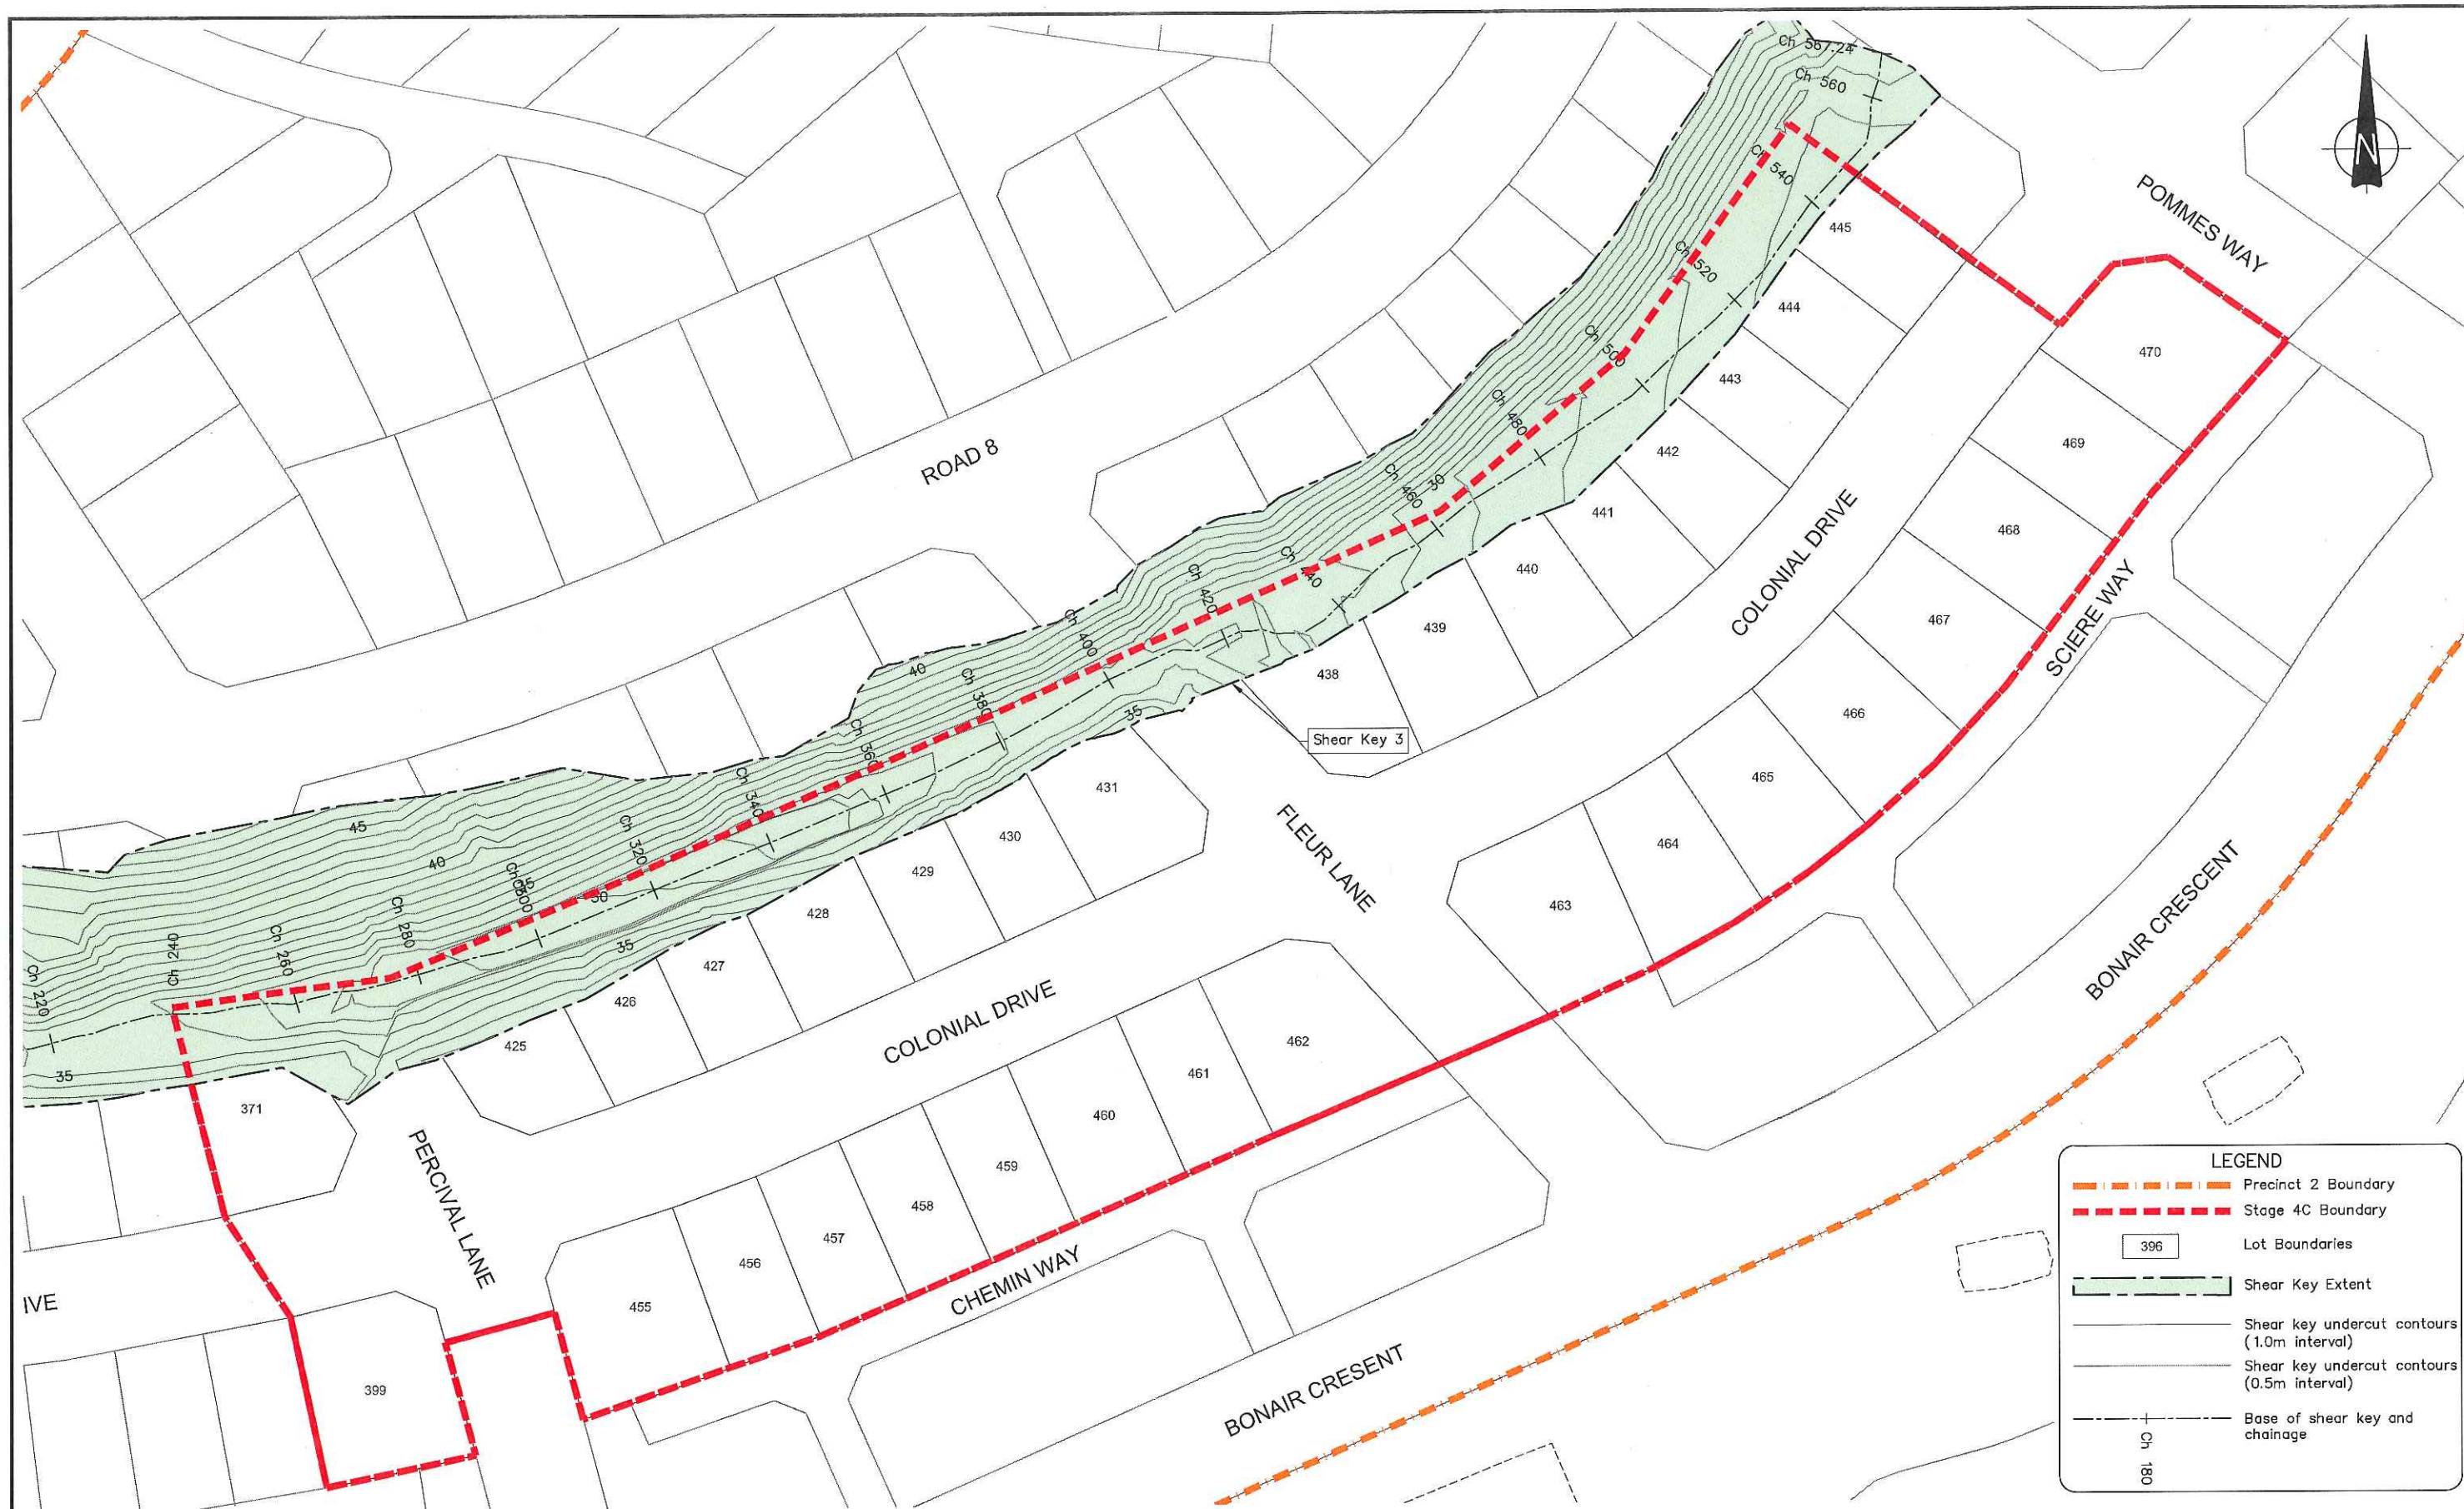
SHEAR KEY 03A PLAN  
SCALE 1: 1000

CLIENT, PROJECT	WFH PROPERTIES LTD RESIDENTIAL SUBDIVISION
TITLE	MILLWATER - PRECINCT 2 (STAGE 4C) Shear Key 03 Plan
SCALE (AT A3 SIZE)	1: 1000
DWG. No.	21854.001-P2S4C-106
REV.	1

Ground conditions exposed during shear key construction were generally as anticipated from the design stage of the development. The slope stability analysis results from the original design phase are discussed in Section 4.

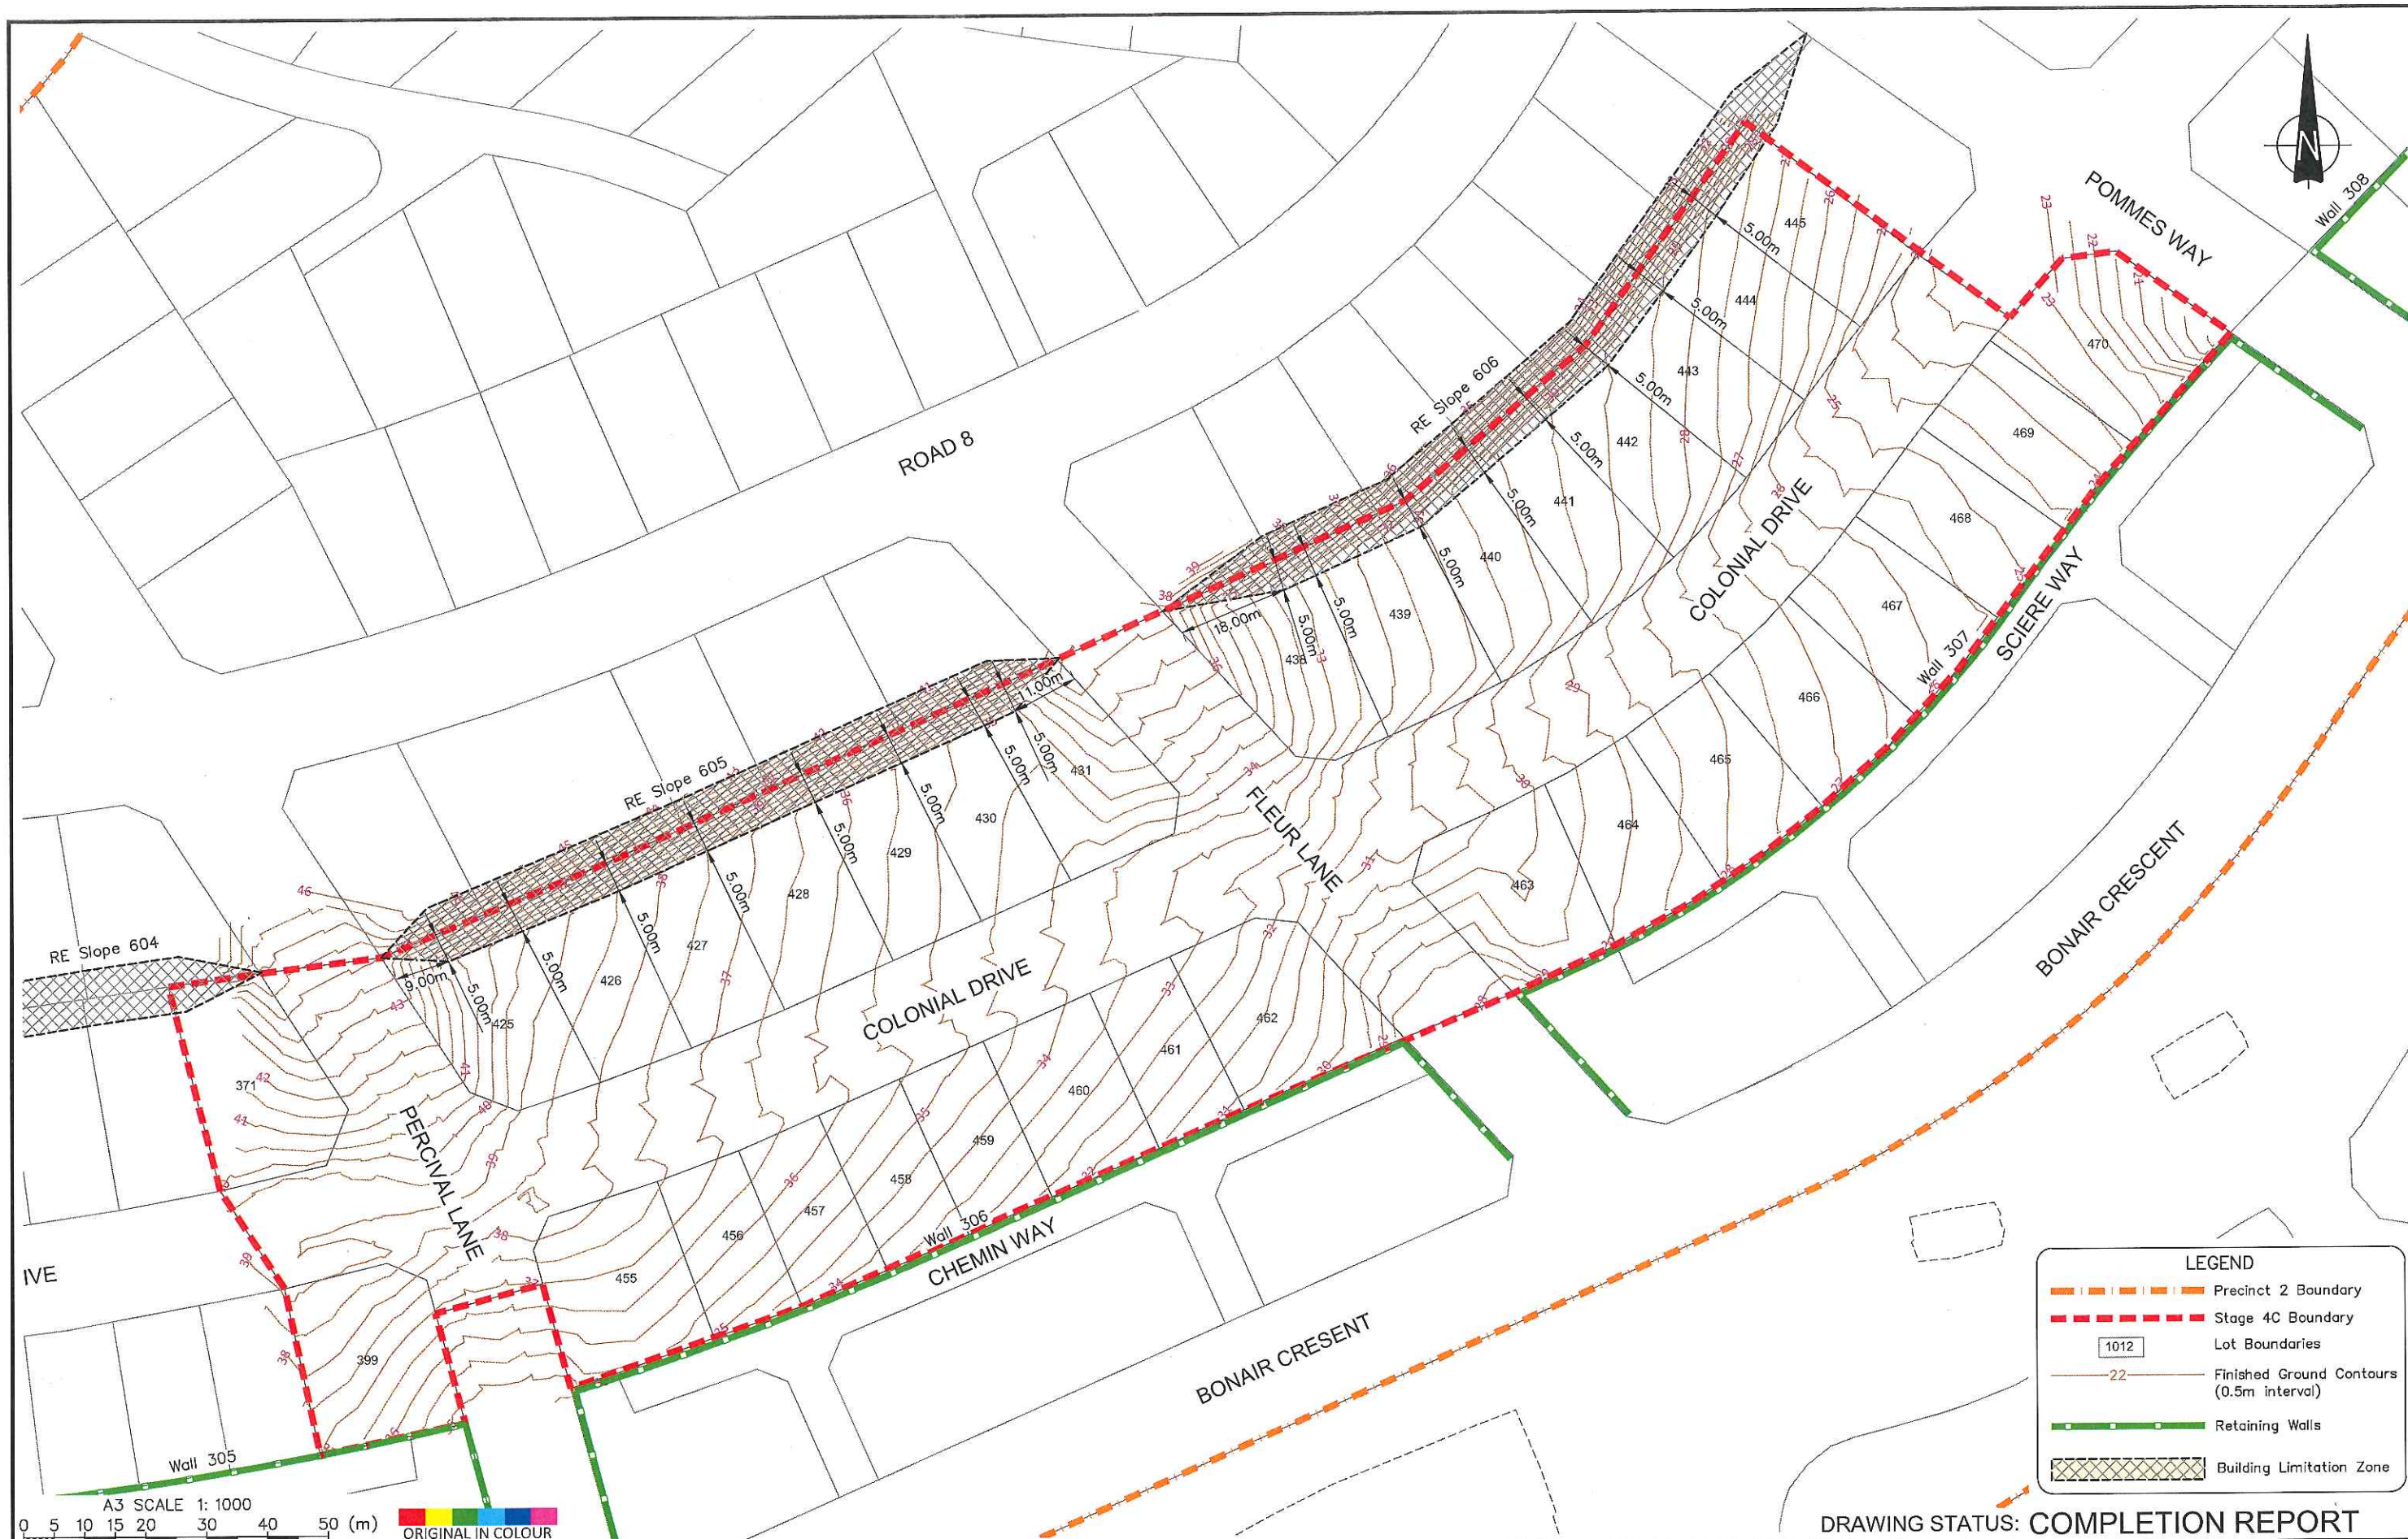
LEGEND	
	Precinct 2 Boundary
	Stage 4C Boundary
	Lot Boundaries
	Finished Ground Contours (0.5m interval)
	Retaining Walls
	Building Limitation Zone

CLIENT, PROJECT	WFH PROPERTIES LTD RESIDENTIAL SUBDIVISION
TITLE	MILLWATER - PRECINCT 2 (STAGE 4C) Building Limitation Plan
SCALES (AT A3 SIZE)	1: 1000
DWG. No.	21854.001-P2S4C-110
REV.	1
