MILLWATER - PRECINCT 2 STAGE 4D

Geotechnical Completion Report

Prepared by
Tonkin & Taylor Ltd

Date
August 2017

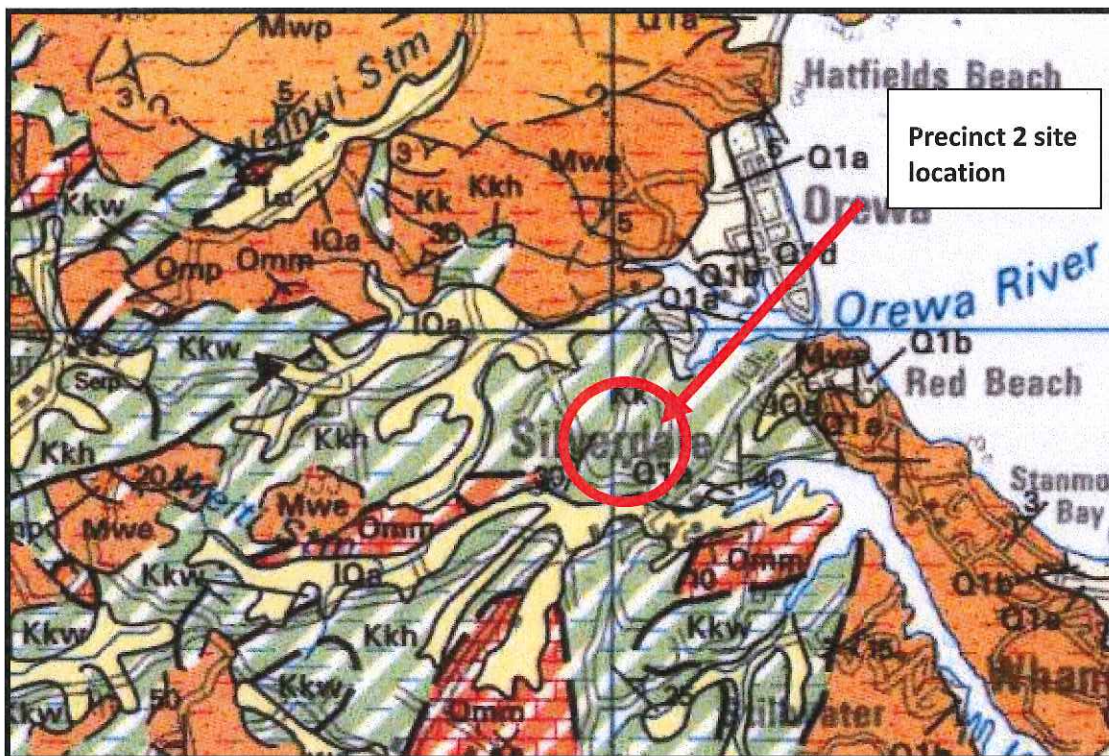
Figure 1 - Local Geology (from Edbrooke)

Land south of the Orewa River is located on an area of extensively deformed and sheared mudstones and muddy to sandy limestones described as Onerahi Chaos – Northland Allochthon material. Recent stream alluvium and slope colluvium derived from residual Northland Allochthon material is mapped towards the base of the gullies at the bottom of the slopes. Recent stream alluvium and discontinuous areas of older Pleistocene Age alluvium are also likely to be present overlying the Northland Allochthon.

Deformed sediments, commonly known as Onerahi Chaos - Northland Allochthon: forms hummocky rolling hills covering more than 100 km² west of Whangaparaoa Peninsula. Mixture of undifferentiated deposits of various and widely sized (cm-km), randomly oriented blocks comprising conglomerate limestone, mudstone, alternating sandstone and mudstone, and serpentinite in a matrix of closely fractured and crushed, moderately soft, grey, brown, and greenish grey mudstone and some sandstone (calcareous or siliceous). Some of the large blocks, especially of limestone, have been mapped individually.

Published geological mapping and information indicates the Precinct 2 area is underlain by Northland Allochthon materials. In addition to the Northland Allochthon, our investigations identified the presence of alluvial materials on site.

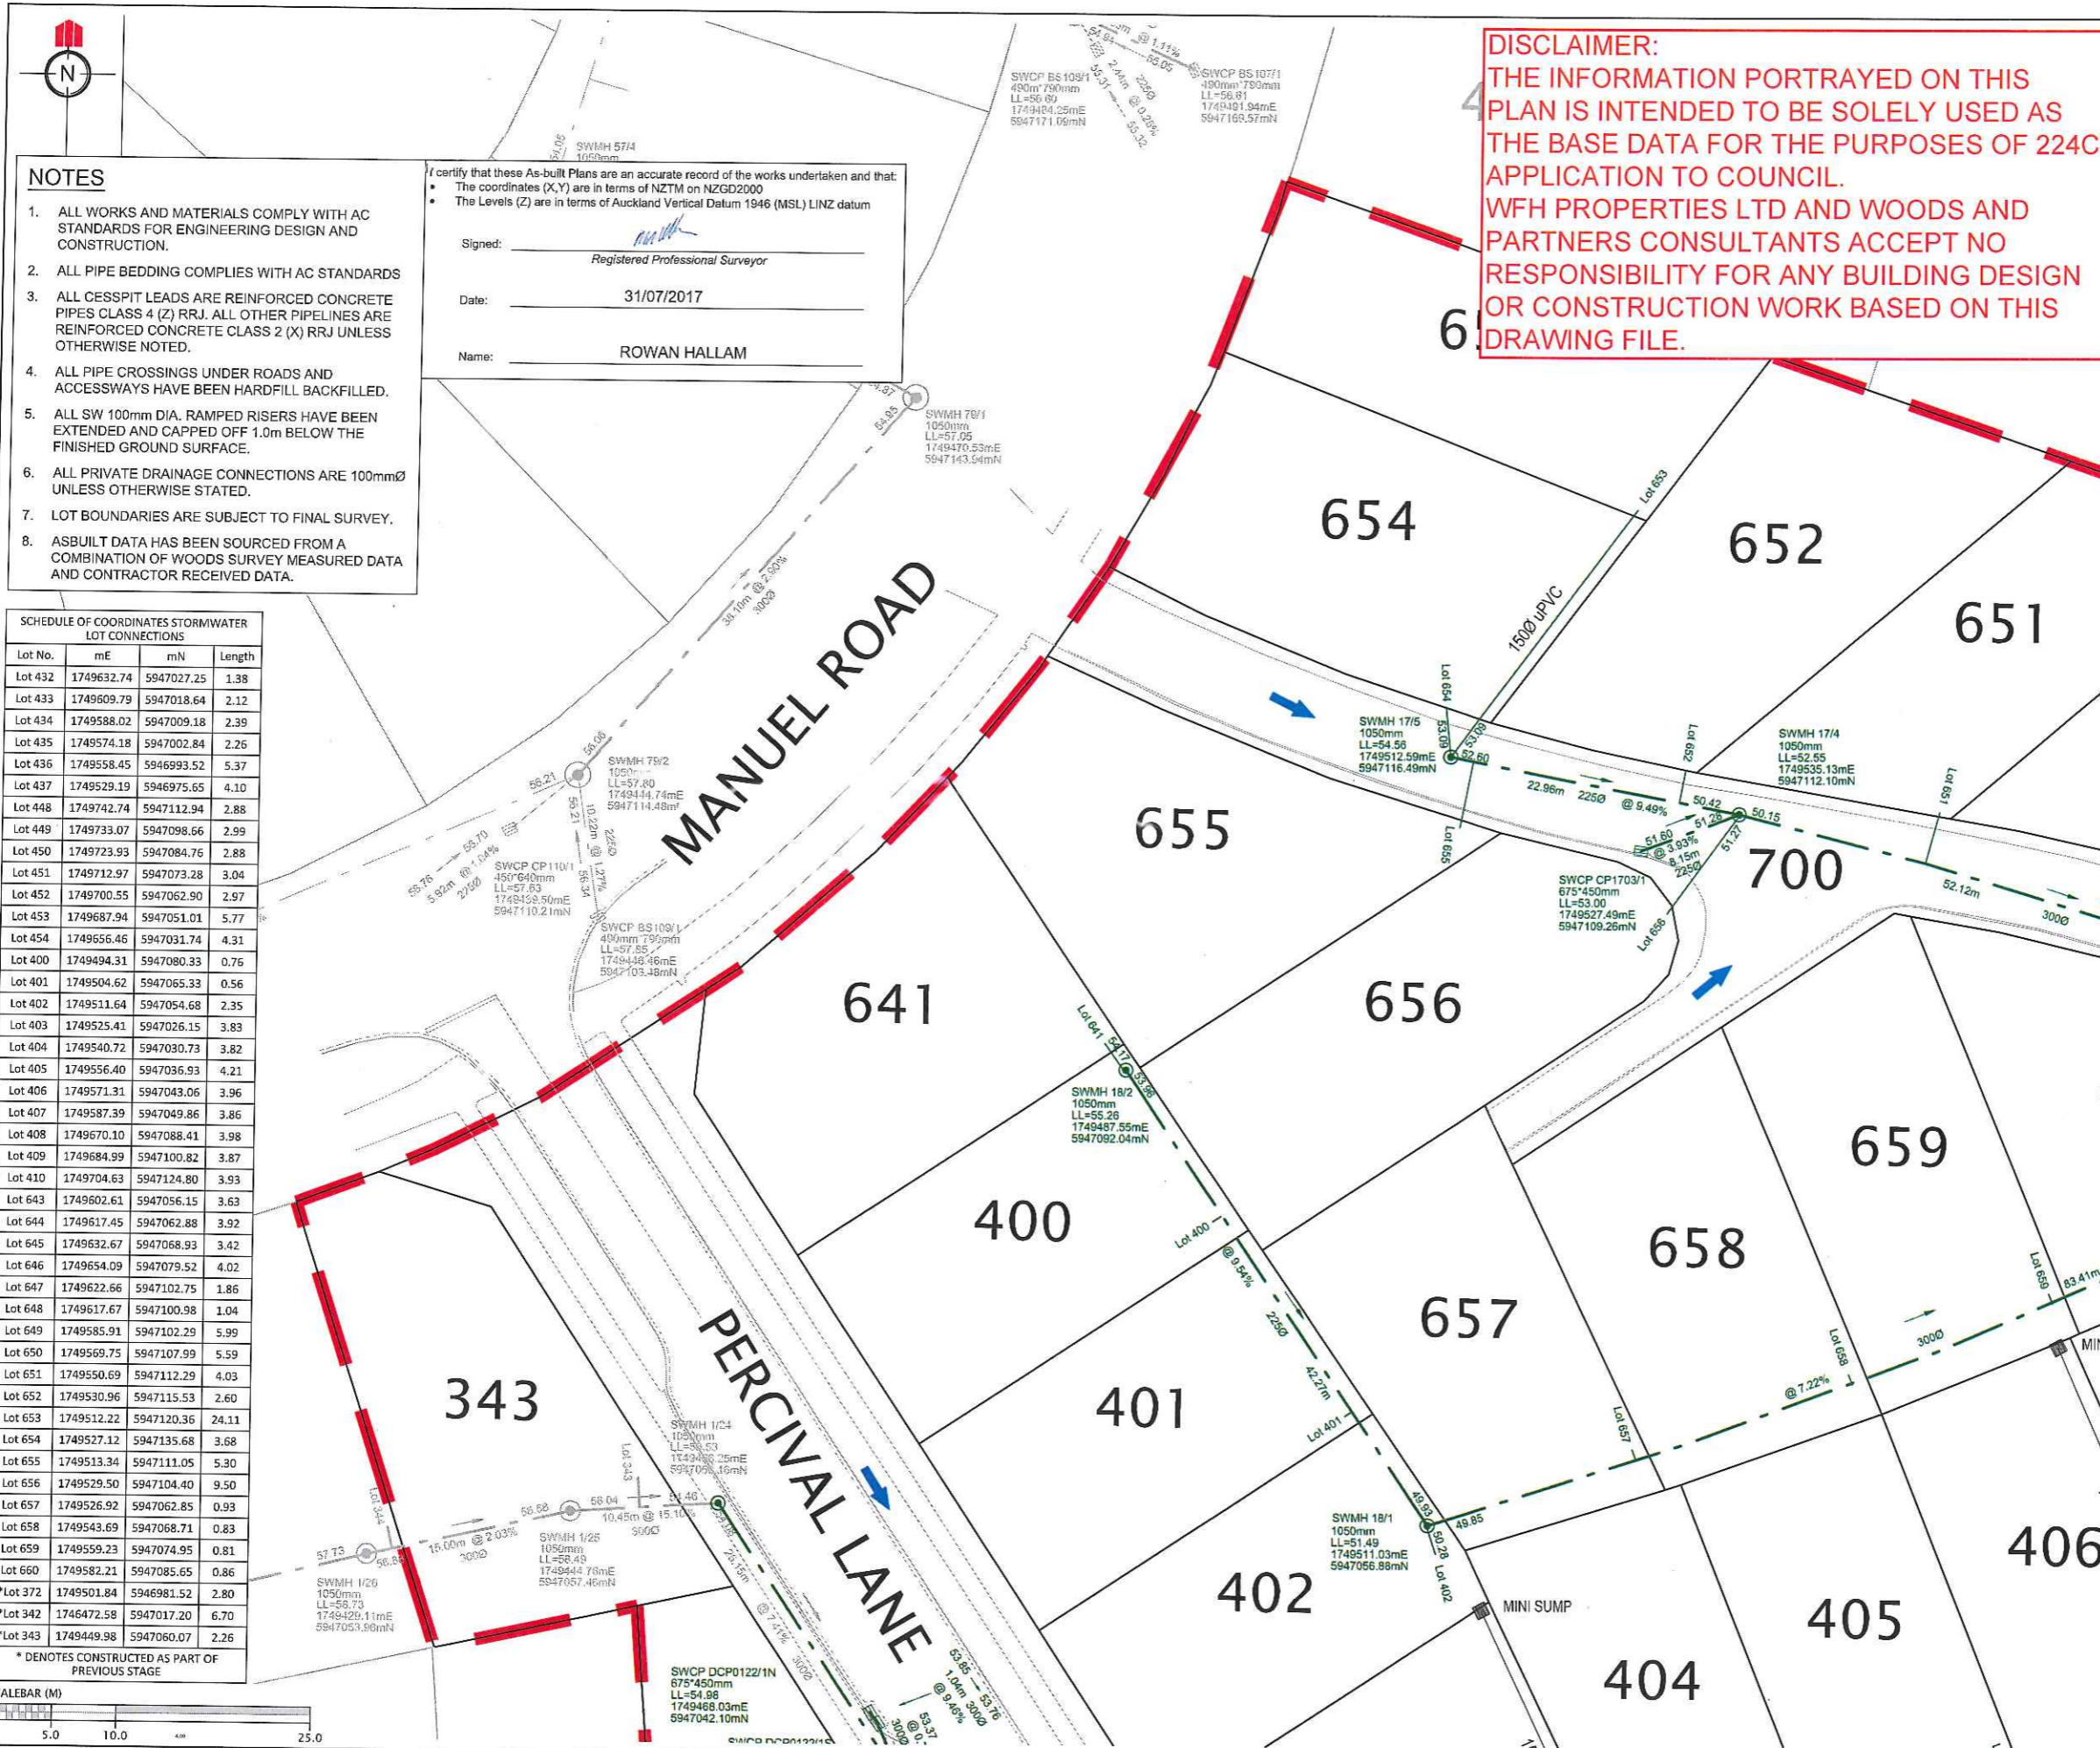
DWG. NO. 33221-04D-300-AB

- ALL WORKS AND MATERIALS COMPLY WITH AC STANDARDS FOR ENGINEERING DESIGN AND CONSTRUCTION.
- ALL PIPE BEDDING COMPLIES WITH AC STANDARDS
- ALL CESSPIT LEADS ARE REINFORCED CONCRETE PIPES CLASS 4 (Z) RRJ. ALL OTHER PIPELINES ARE REINFORCED CONCRETE CLASS 2 (X) RRJ UNLESS OTHERWISE NOTED.
- ALL PIPE CROSSINGS UNDER ROADS AND ACCESSWAYS HAVE BEEN HARDFILL BACKFILLED.
- ALL SW 100mm DIA. RAMPED RISERS HAVE BEEN EXTENDED AND CAPPED OFF 1.0m BELOW THE FINISHED GROUND SURFACE.
- ALL PRIVATE DRAINAGE CONNECTIONS ARE 100mmØ UNLESS OTHERWISE STATED.
- LOT BOUNDARIES ARE SUBJECT TO FINAL SURVEY.
- ASBUILT DATA HAS BEEN SOURCED FROM A COMBINATION OF WOODS SURVEY MEASURED DATA AND CONTRACTOR RECEIVED DATA.

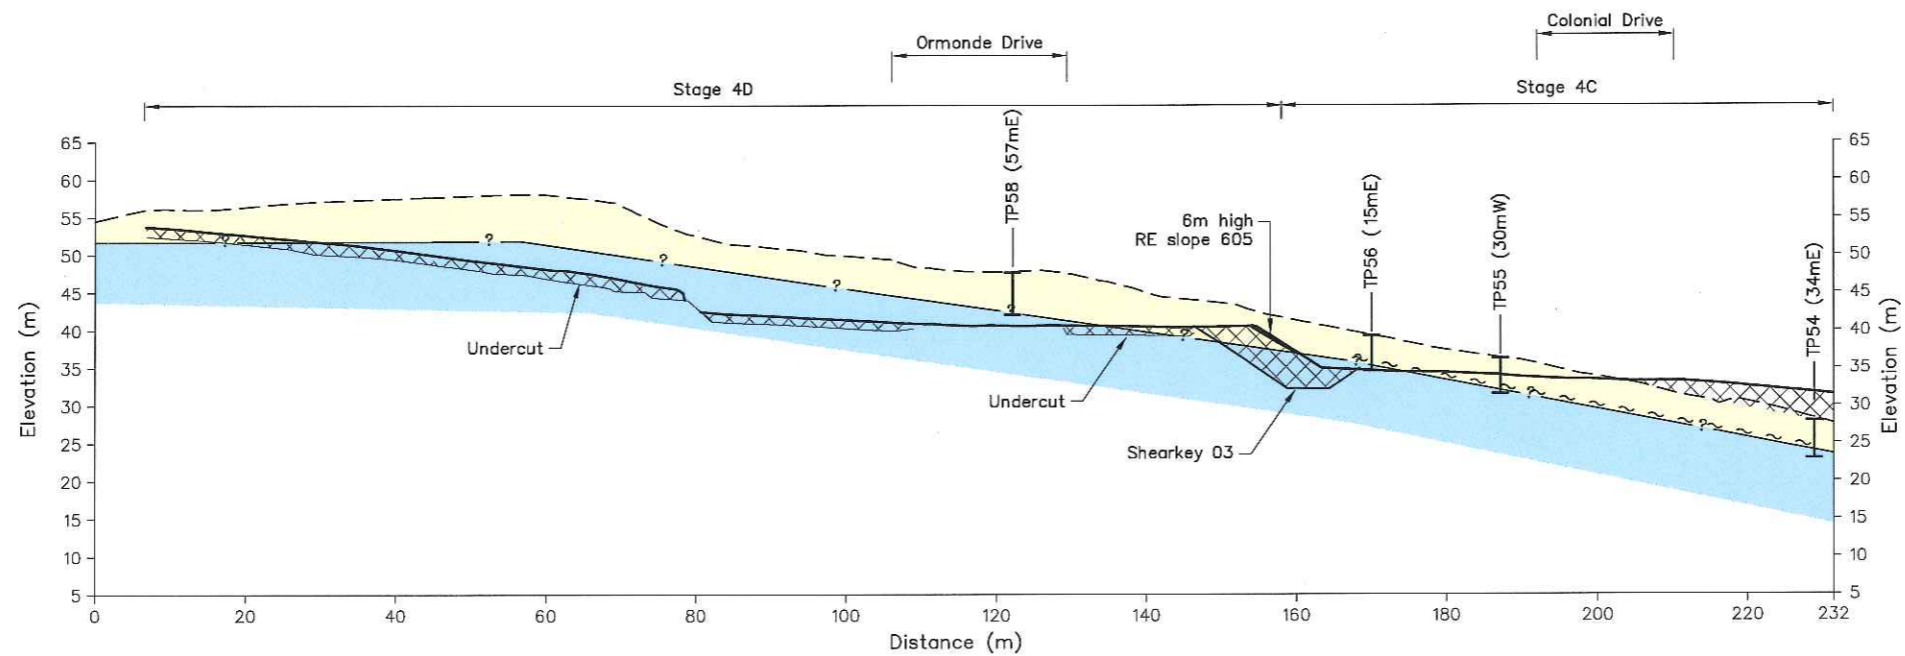
SECTION 6
SCALE 1:1000

LEGEND	
	Engineered Fill
	Alluvium
	Northland Allochthon Residual Soil
	Northland Allochthon Rock
	Original Ground Level
	Finished Ground Level
	Inferred geology interface

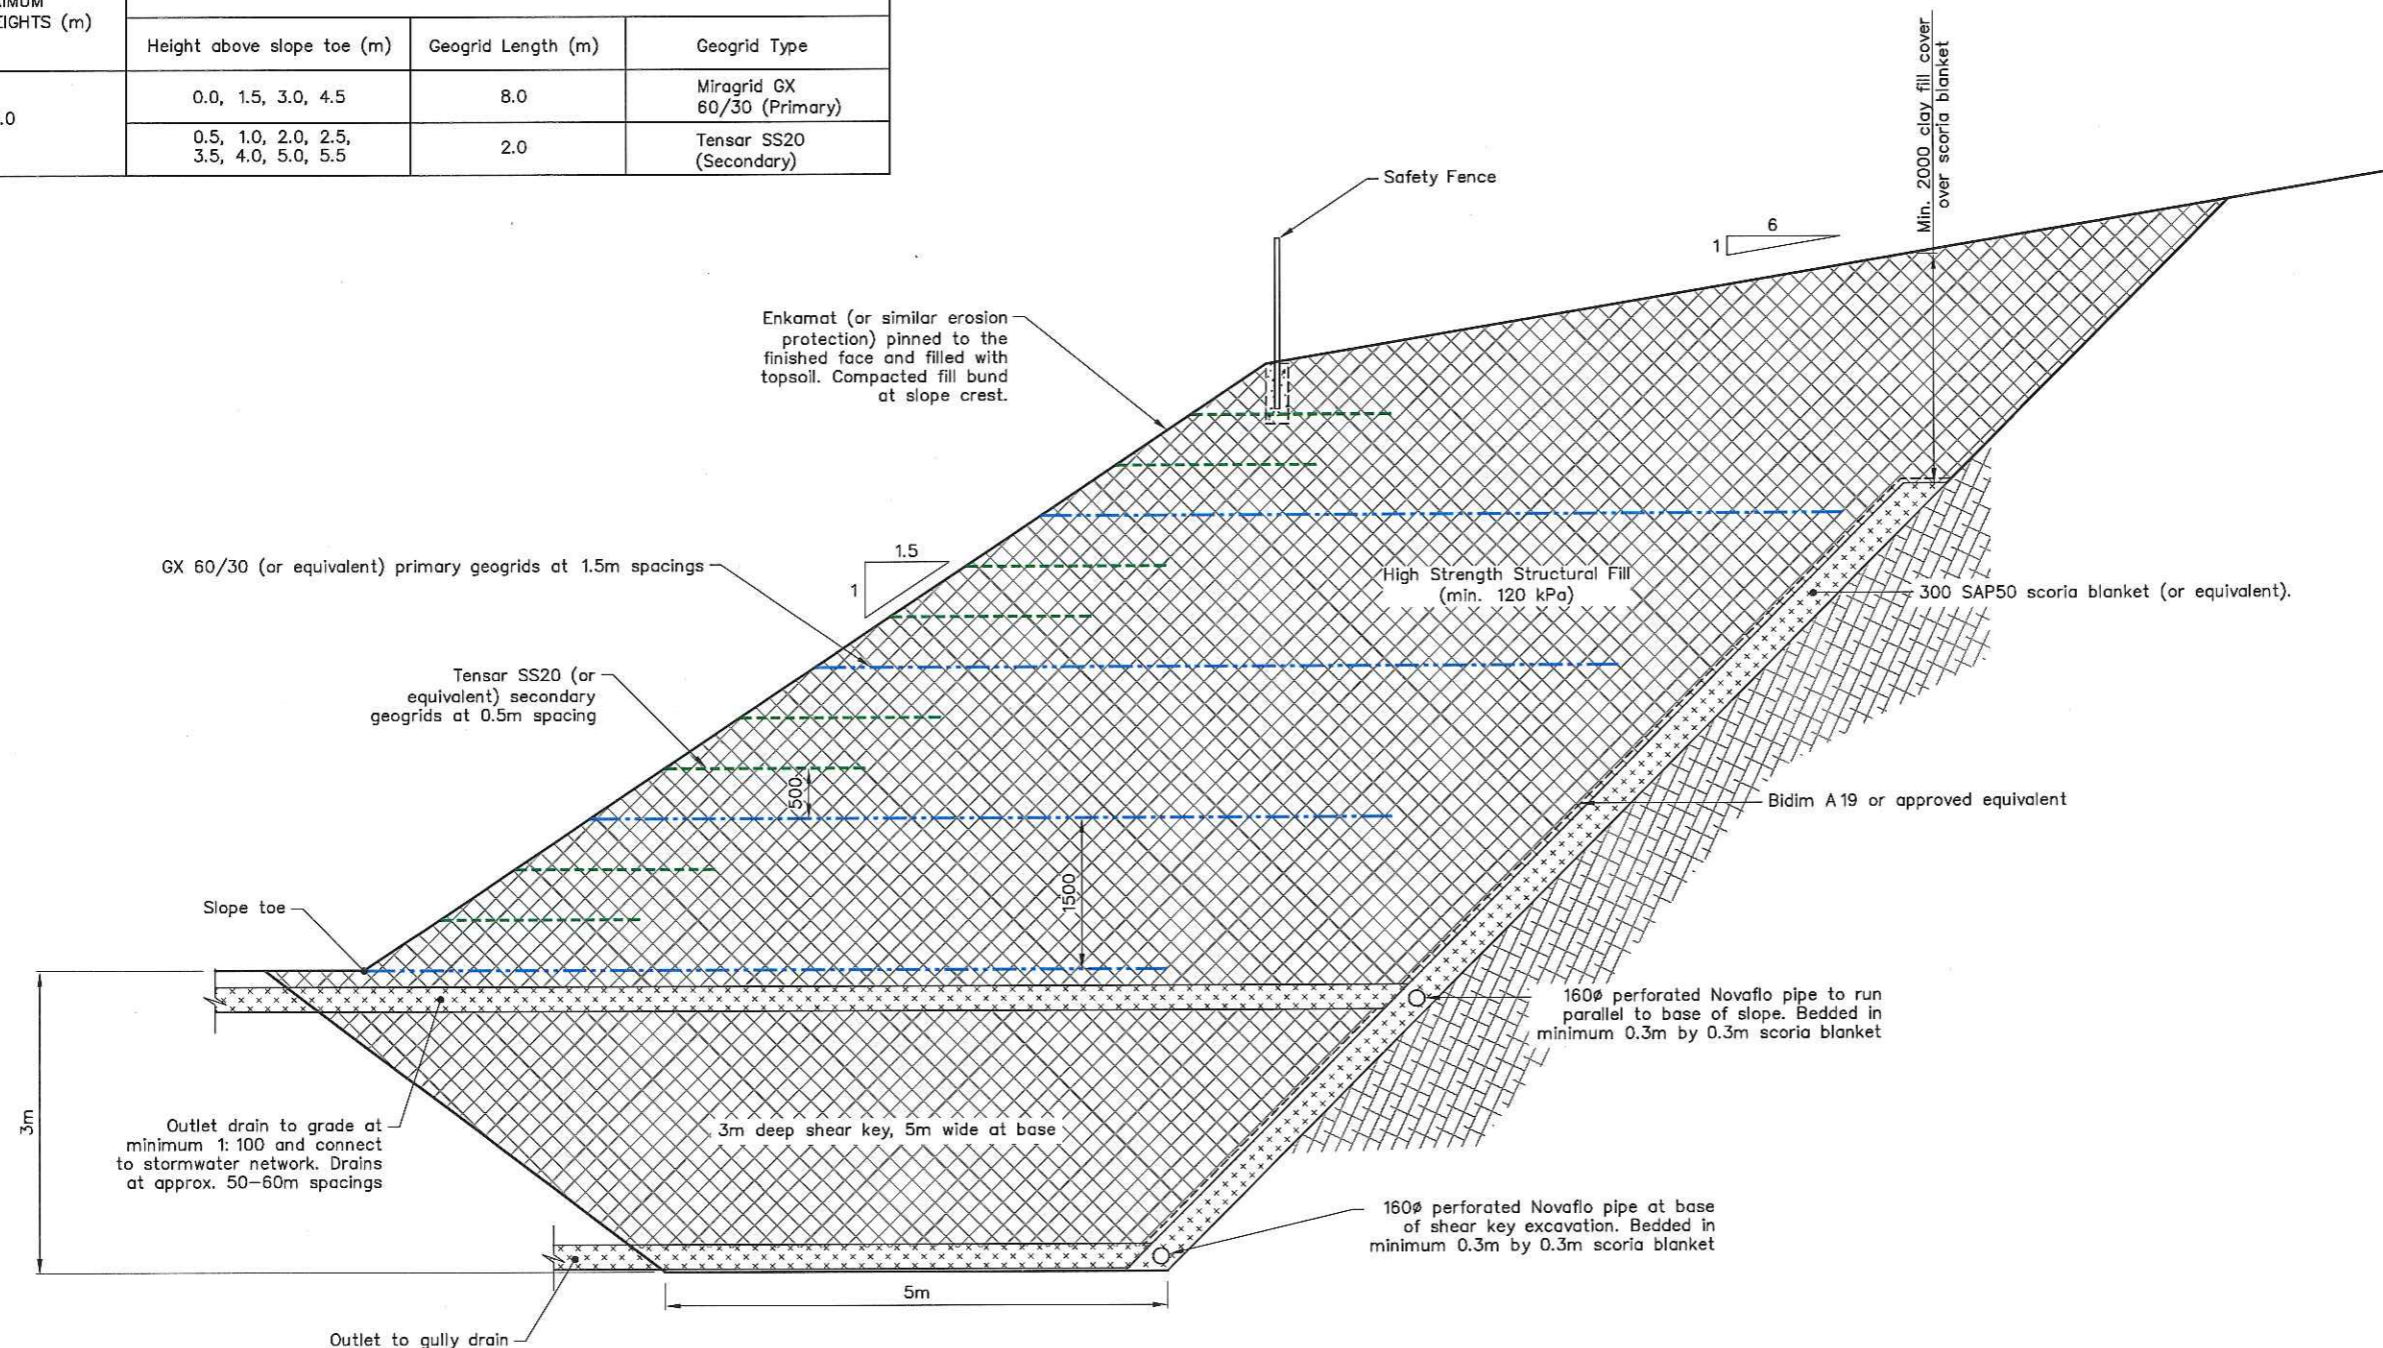
RE Slope 602, 604-606 TYPICAL SECTION DETAILS
SCALE 1:75

GEOGRIDS REQUIREMENTS FOR RE SLOPE 605 & 606

MAXIMUM SLOPE HEIGHTS (m)	GEOGRID REQUIREMENTS		
	Height above slope toe (m)	Geogrid Length (m)	Geogrid Type
6.0	0.0, 1.5, 3.0, 4.5	8.0	Miragrid GX 60/30 (Primary)
	0.5, 1.0, 2.0, 2.5, 3.5, 4.0, 5.0, 5.5	2.0	Tensor SS20 (Secondary)

- a Foundation preparation;
- b Placement and compaction of fill to the required levels;
- c Placement of the geogrid layers, ensuring that the grid is held tightly in place;
- d Spreading of fill across the surface of the geogrid with lightweight plant;
- e Compaction and placement of further fill up to the level of the next grid layer;

The fill was placed and compacted beyond the limit of the final slope face and then trimmed back to ensure full compaction of the slope face was achieved, taking care not to damage the geogrid.

As noted in Section 3.1, a drainage blanket was installed at the rear of the reinforced block of soil and comprised a minimum of 300mm thickness of SAP50 scoria, covered in Bidim A19 geotextile filtercloth and a cap of cohesive fill 2.0m in thickness. A 160mm diameter perforated Nexus pipe at the base of the drainage blanket provides a discharge outlet for any groundwater captured in the drainage blanket. The drainage pipe is connected into the stormwater system.

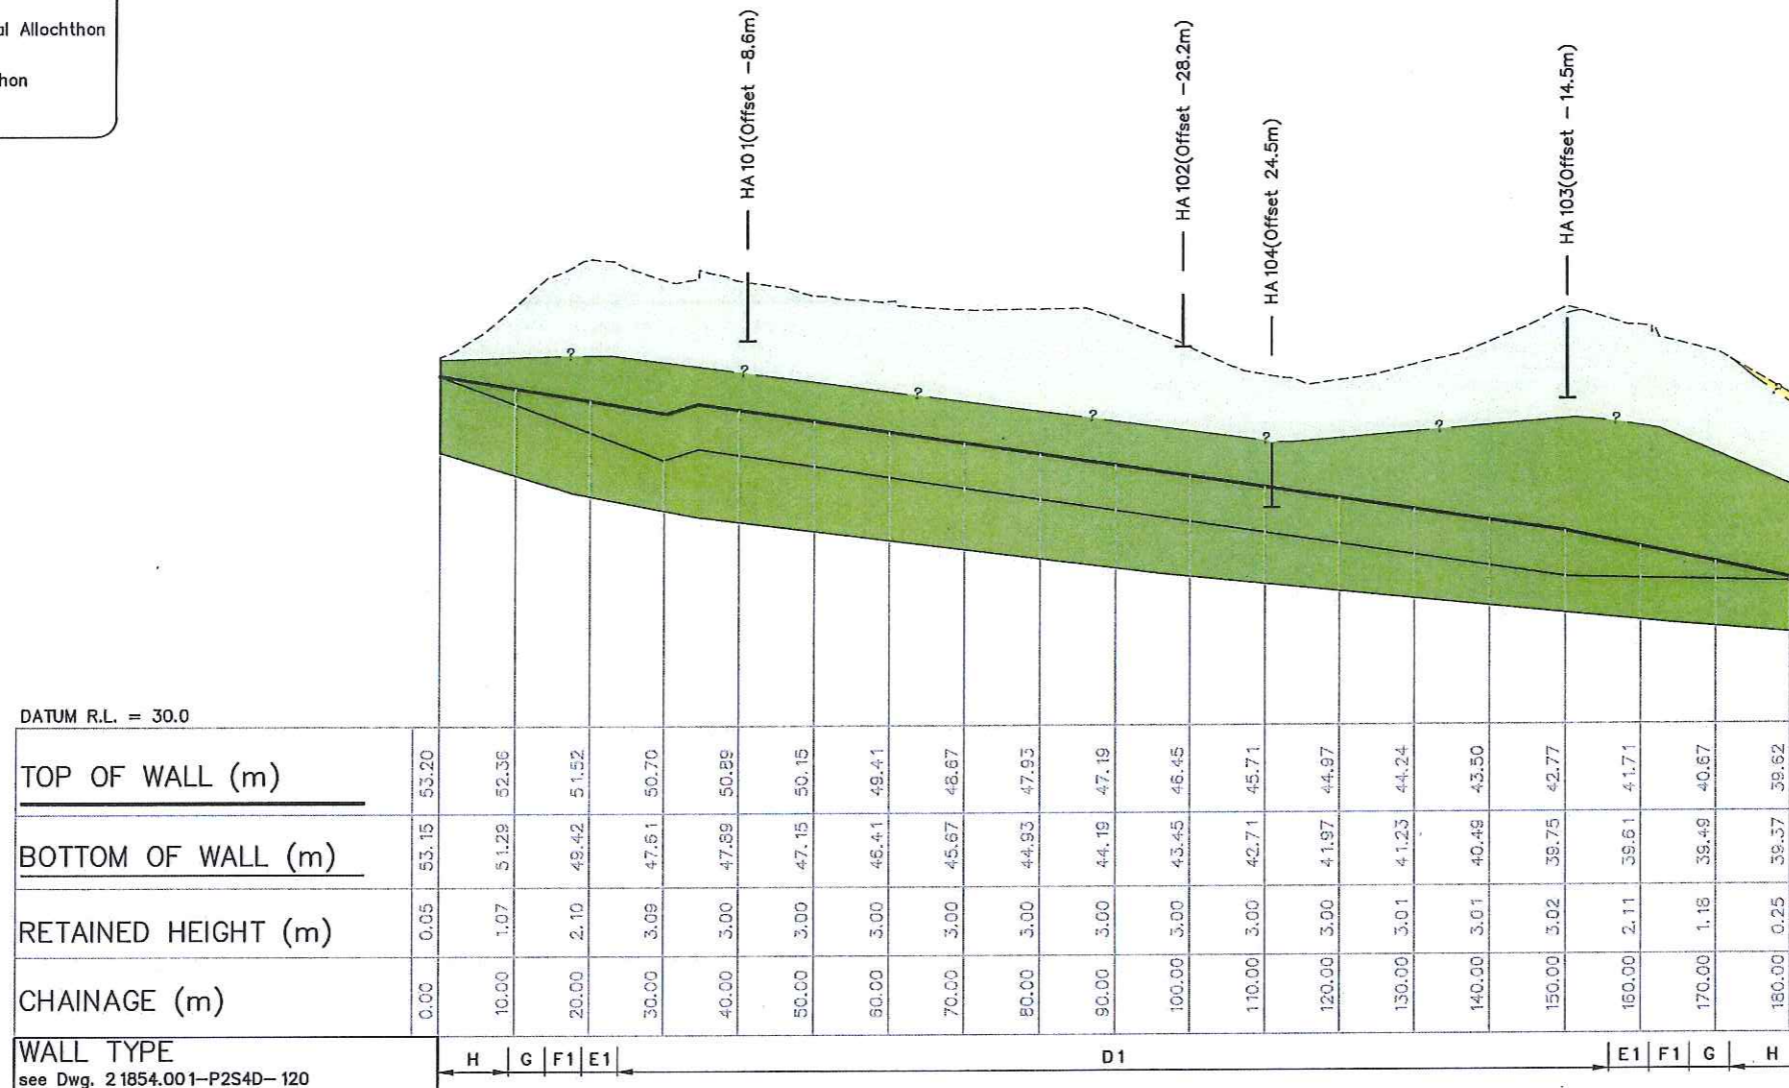
RETAINING WALL 320 LONGITUDINAL SECTION
 SCALE 1: 1000(H), 1: 500(V)

----- Original ground level
 ——— Top of retaining
 ——— Bottom of retaining
 — ? — Inferred Geological Boundary

One timber pole retaining wall was constructed across this stage of the subdivision, comprising Wall 320 at the location shown on T+T Drawing 21854.001–P2S4D–101. This wall was designed by T+T and allow for the various design conditions encountered across the stage, including toe slopes, slope surcharges and vehicle surcharges, as appropriate. Construction drawings for Wall 320 were issued in September 2016 and a copy of these are included in Appendix A2. This wall was constructed during the Civils construction stage by ICB under Hoppers' control.

The wall comprises high density timber poles installed to various depths dependent on design conditions. Inspections for this wall was undertaken by T+T staff to confirm pile hole diameter, depth and spacing, pile sizes, and installation of drainage materials and lagging, in accordance with the design drawings.

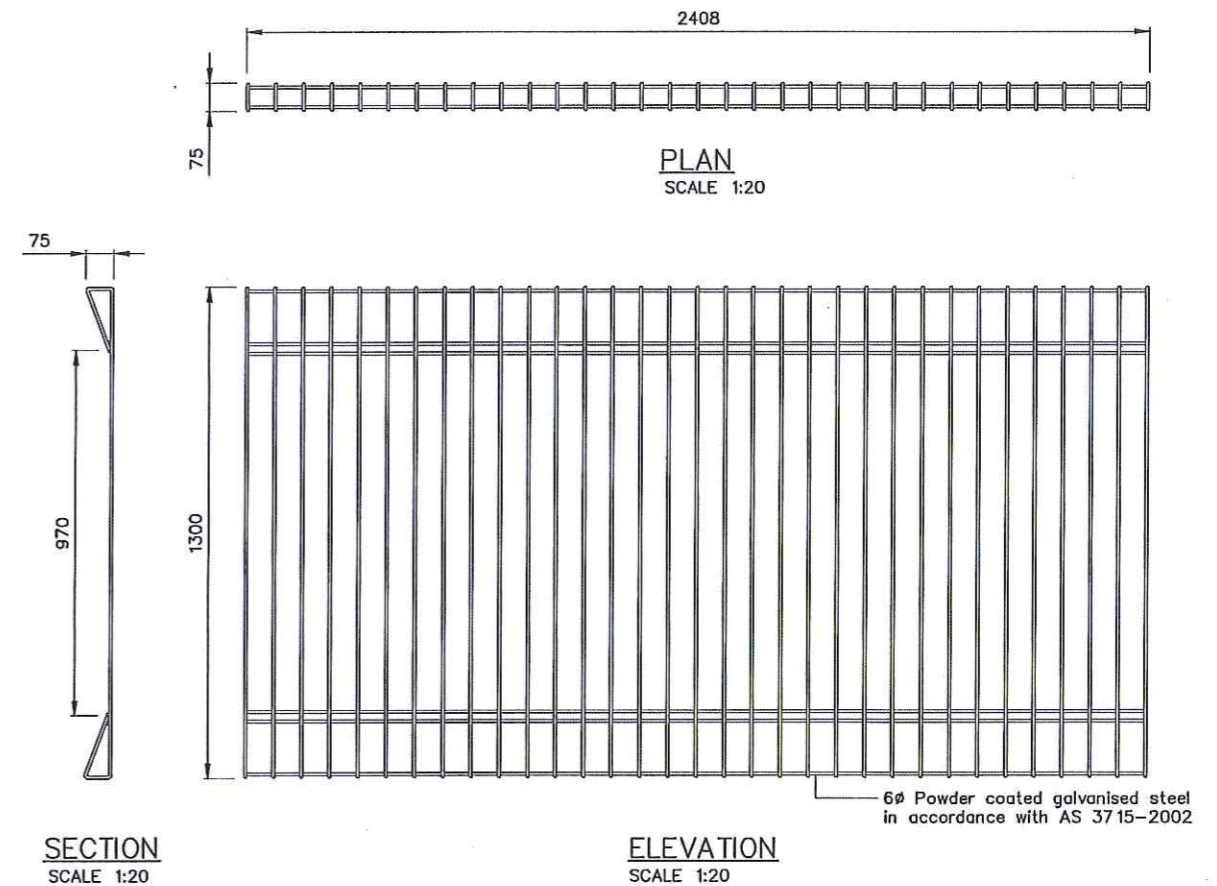
DETAIL A POST DETAIL
SCALE 1:20

- NOTES :
1. All dimensions are in millimetres unless noted otherwise.
 2. Fence panels to be hot dip galvanised and black powder coated.
 3. Fence panels must not have more than 100mm gap from ground level to base of installed panel.
 4. Posts to be 50mm hot dip galvanised pipe and black powder coated.
 5. Posts to be installed vertically and packed out appropriately.
 6. Fence panels & posts to be installed in accordance with manufacturers specifications.

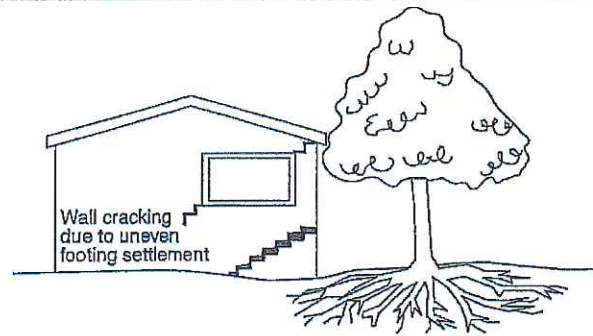
Trees can cause shrinkage and damage

As the weather pattern changes and the soil begins to dry out, the external footings will be first affected, beginning with the locations where the sun's effect is strongest. This has the effect of lowering the external footings. The doming is accentuated and cracking reduces or disappears where it occurred because of dishing, but other cracks open up. The roof lines may become convex.

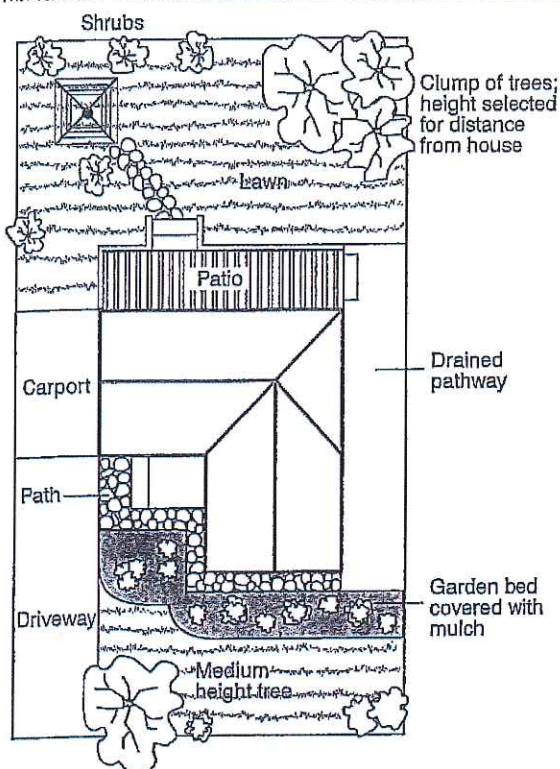
Gardens for reactive soil

should extend outwards a minimum of 900 mm (more in highly reactive soil) and should have a minimum fall away from the building of 1:60. The finished paving should be no less than 100 mm below brick vent bases.

It is prudent to relocate drainage pipes away from this paving, if possible, to avoid complications from future leakage. If this is not practical, earthenware pipes should be replaced by PVC and backfilling should be of the same soil type as the surrounding soil and compacted to the same density.
