**MILLWATER SUBDIVISION -
ARRANS POINT PRECINCT 7
STAGE 1**

Geotechnical Completion Report

Prepared for
WFH Properties Ltd
Prepared by
Tonkin & Taylor Ltd
Date
October 2016
Job Number
21854.0037/APP7S1.v1

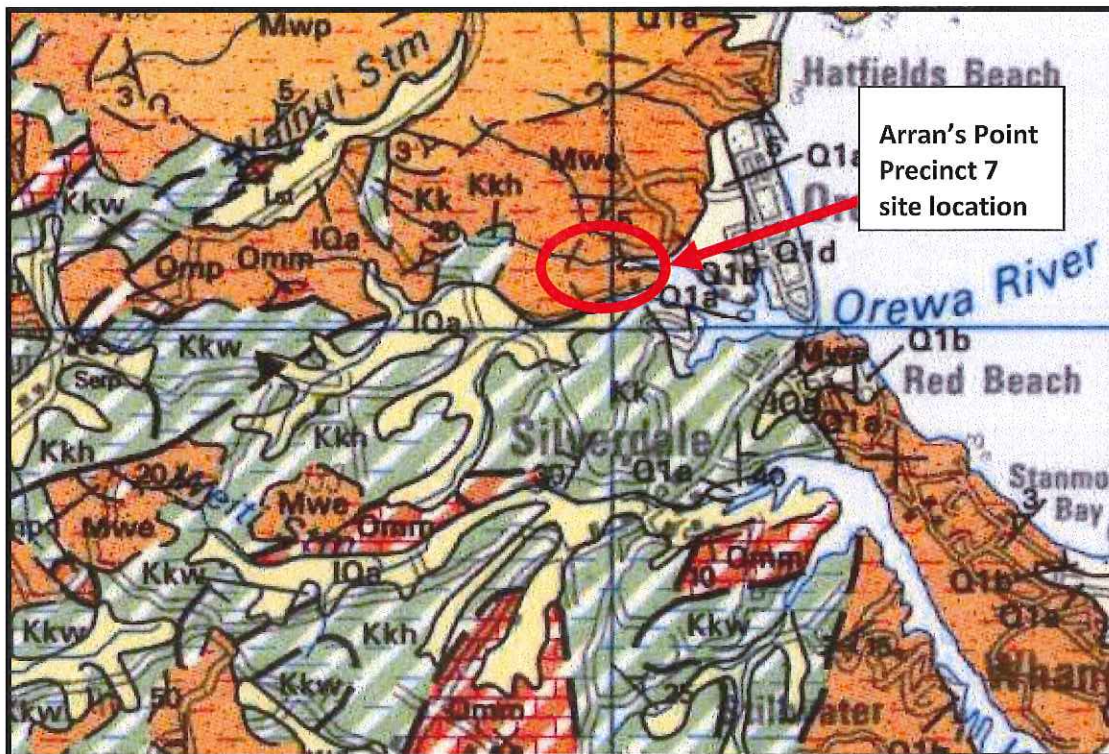
Figure 1 - Local Geology (from Edbrooke)

Published geological mapping and information indicates the Arran's Point Precinct 7 area is underlain by East Coast Bays materials. In addition to the East Coast Bays materials, our investigations identified the presence of alluvial materials on site.

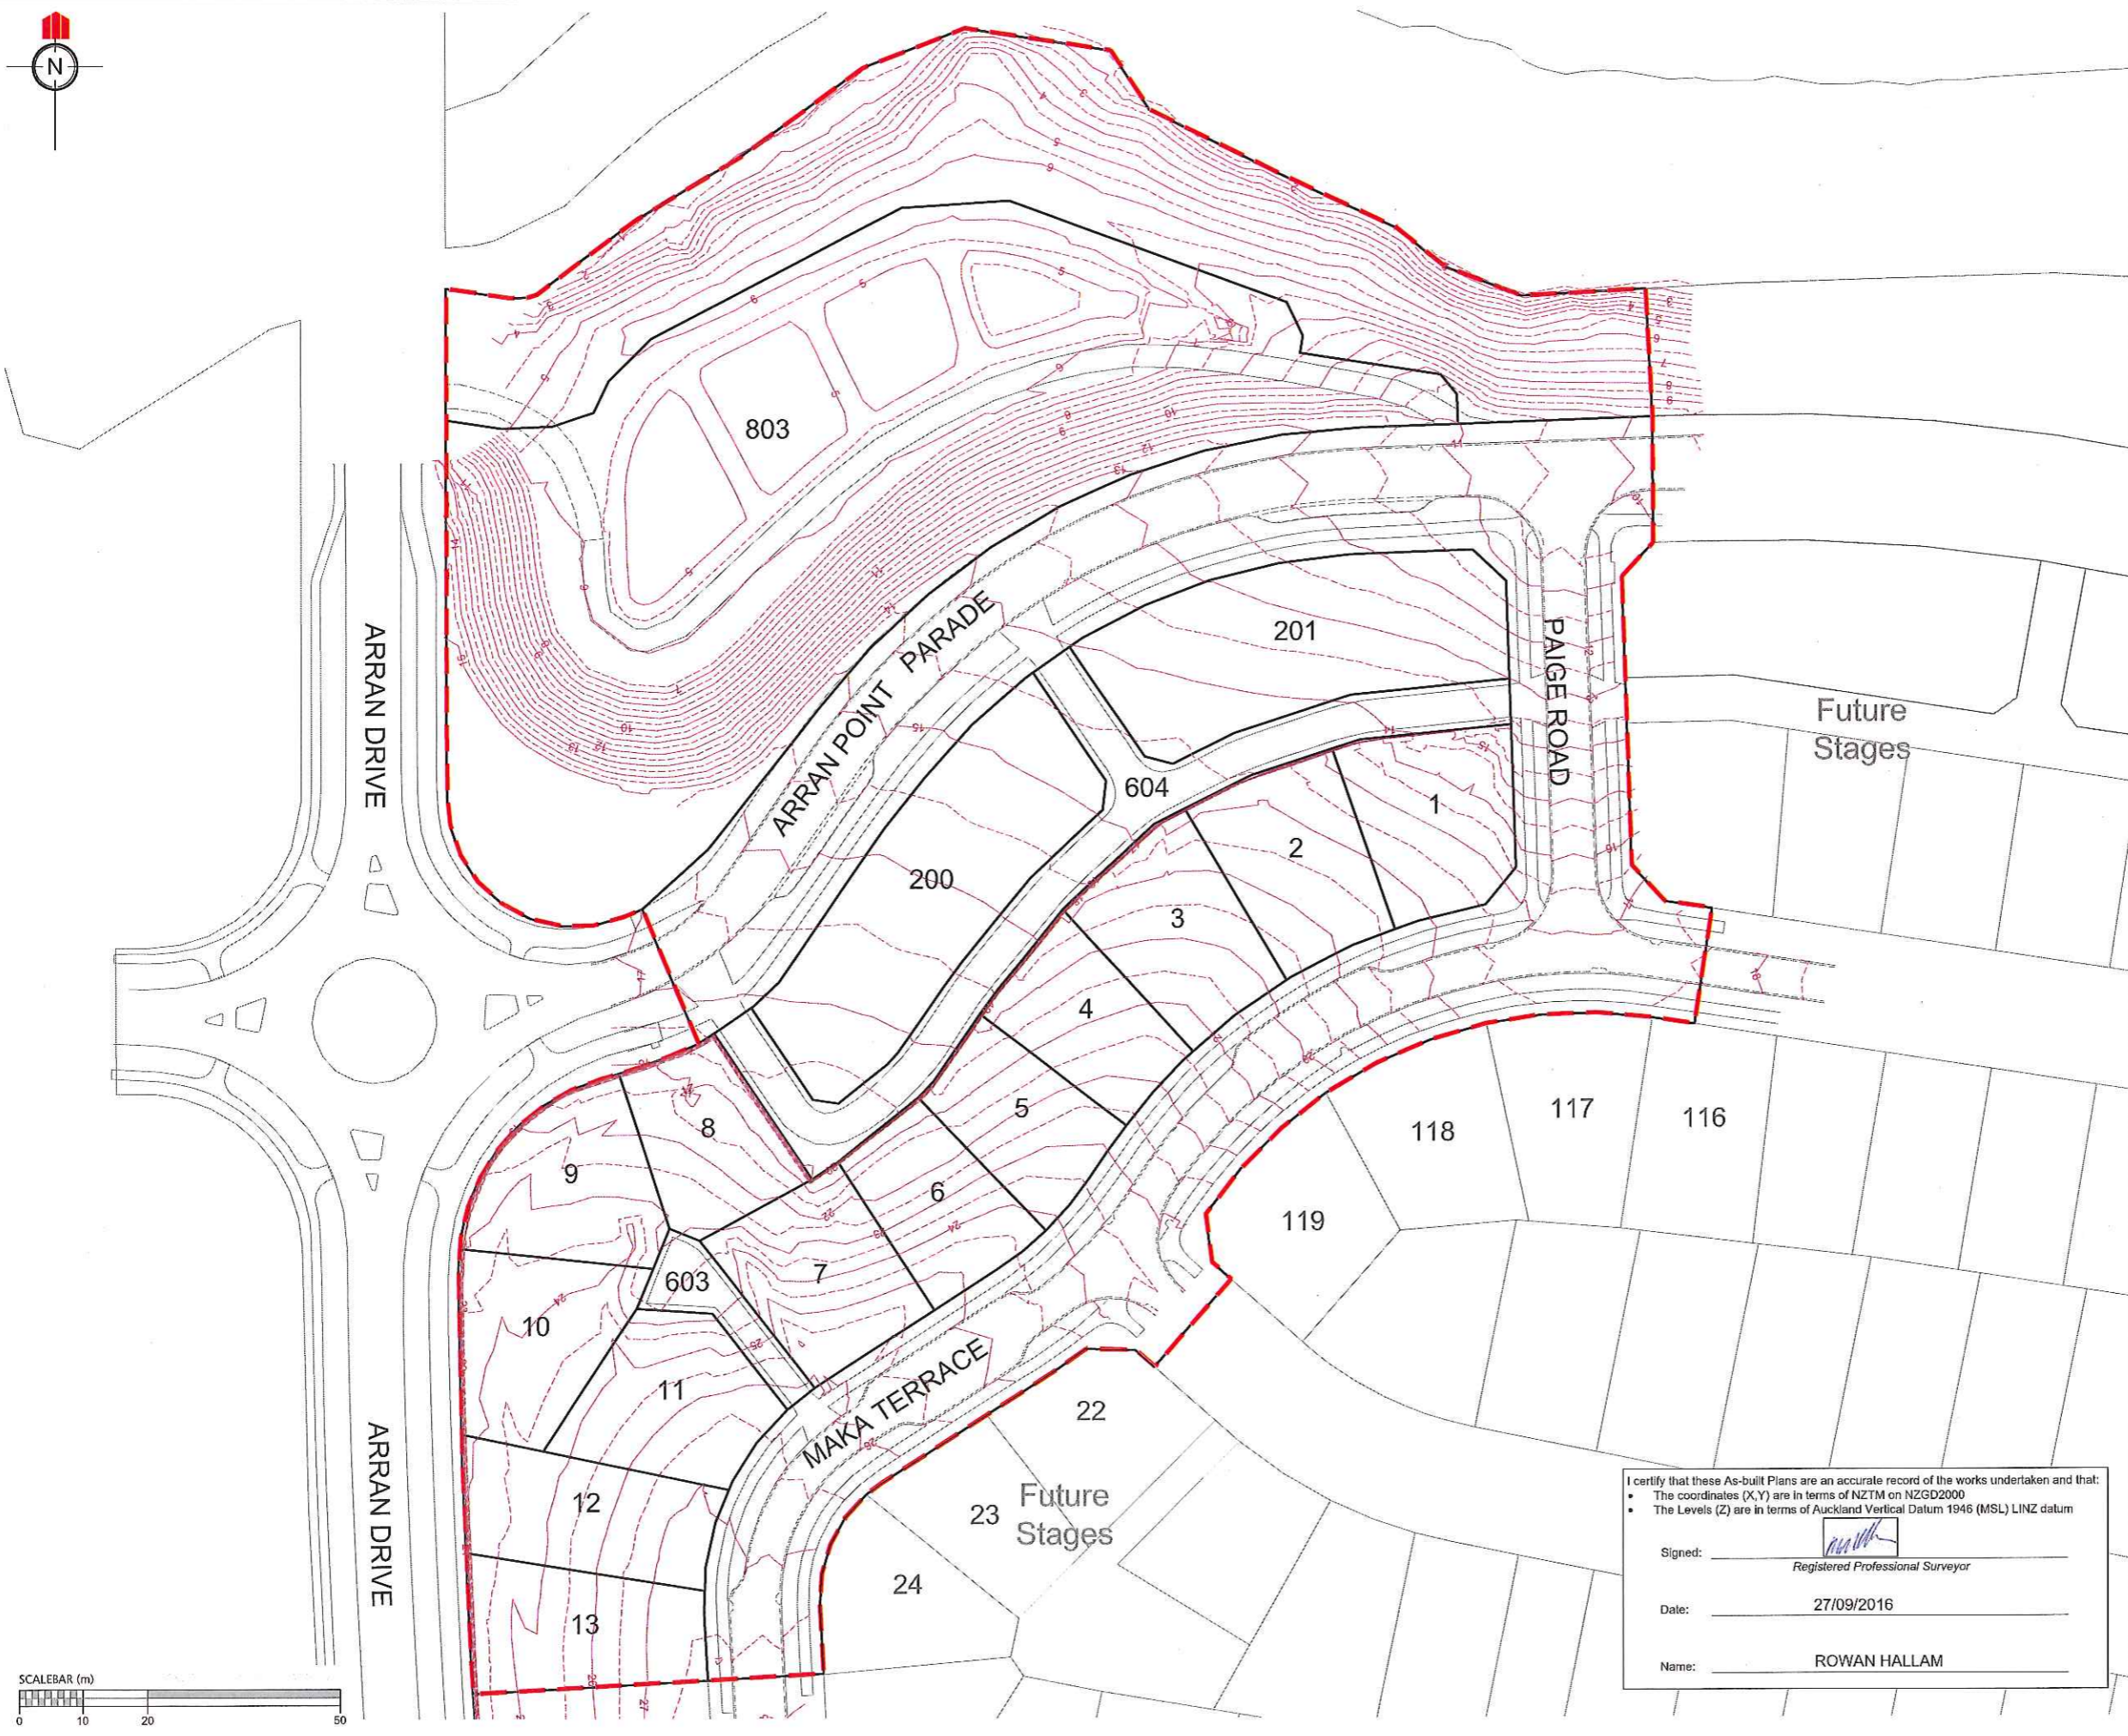
NOTES
1. CONTOURS ARE AT 0.5 METRE INTERVALS

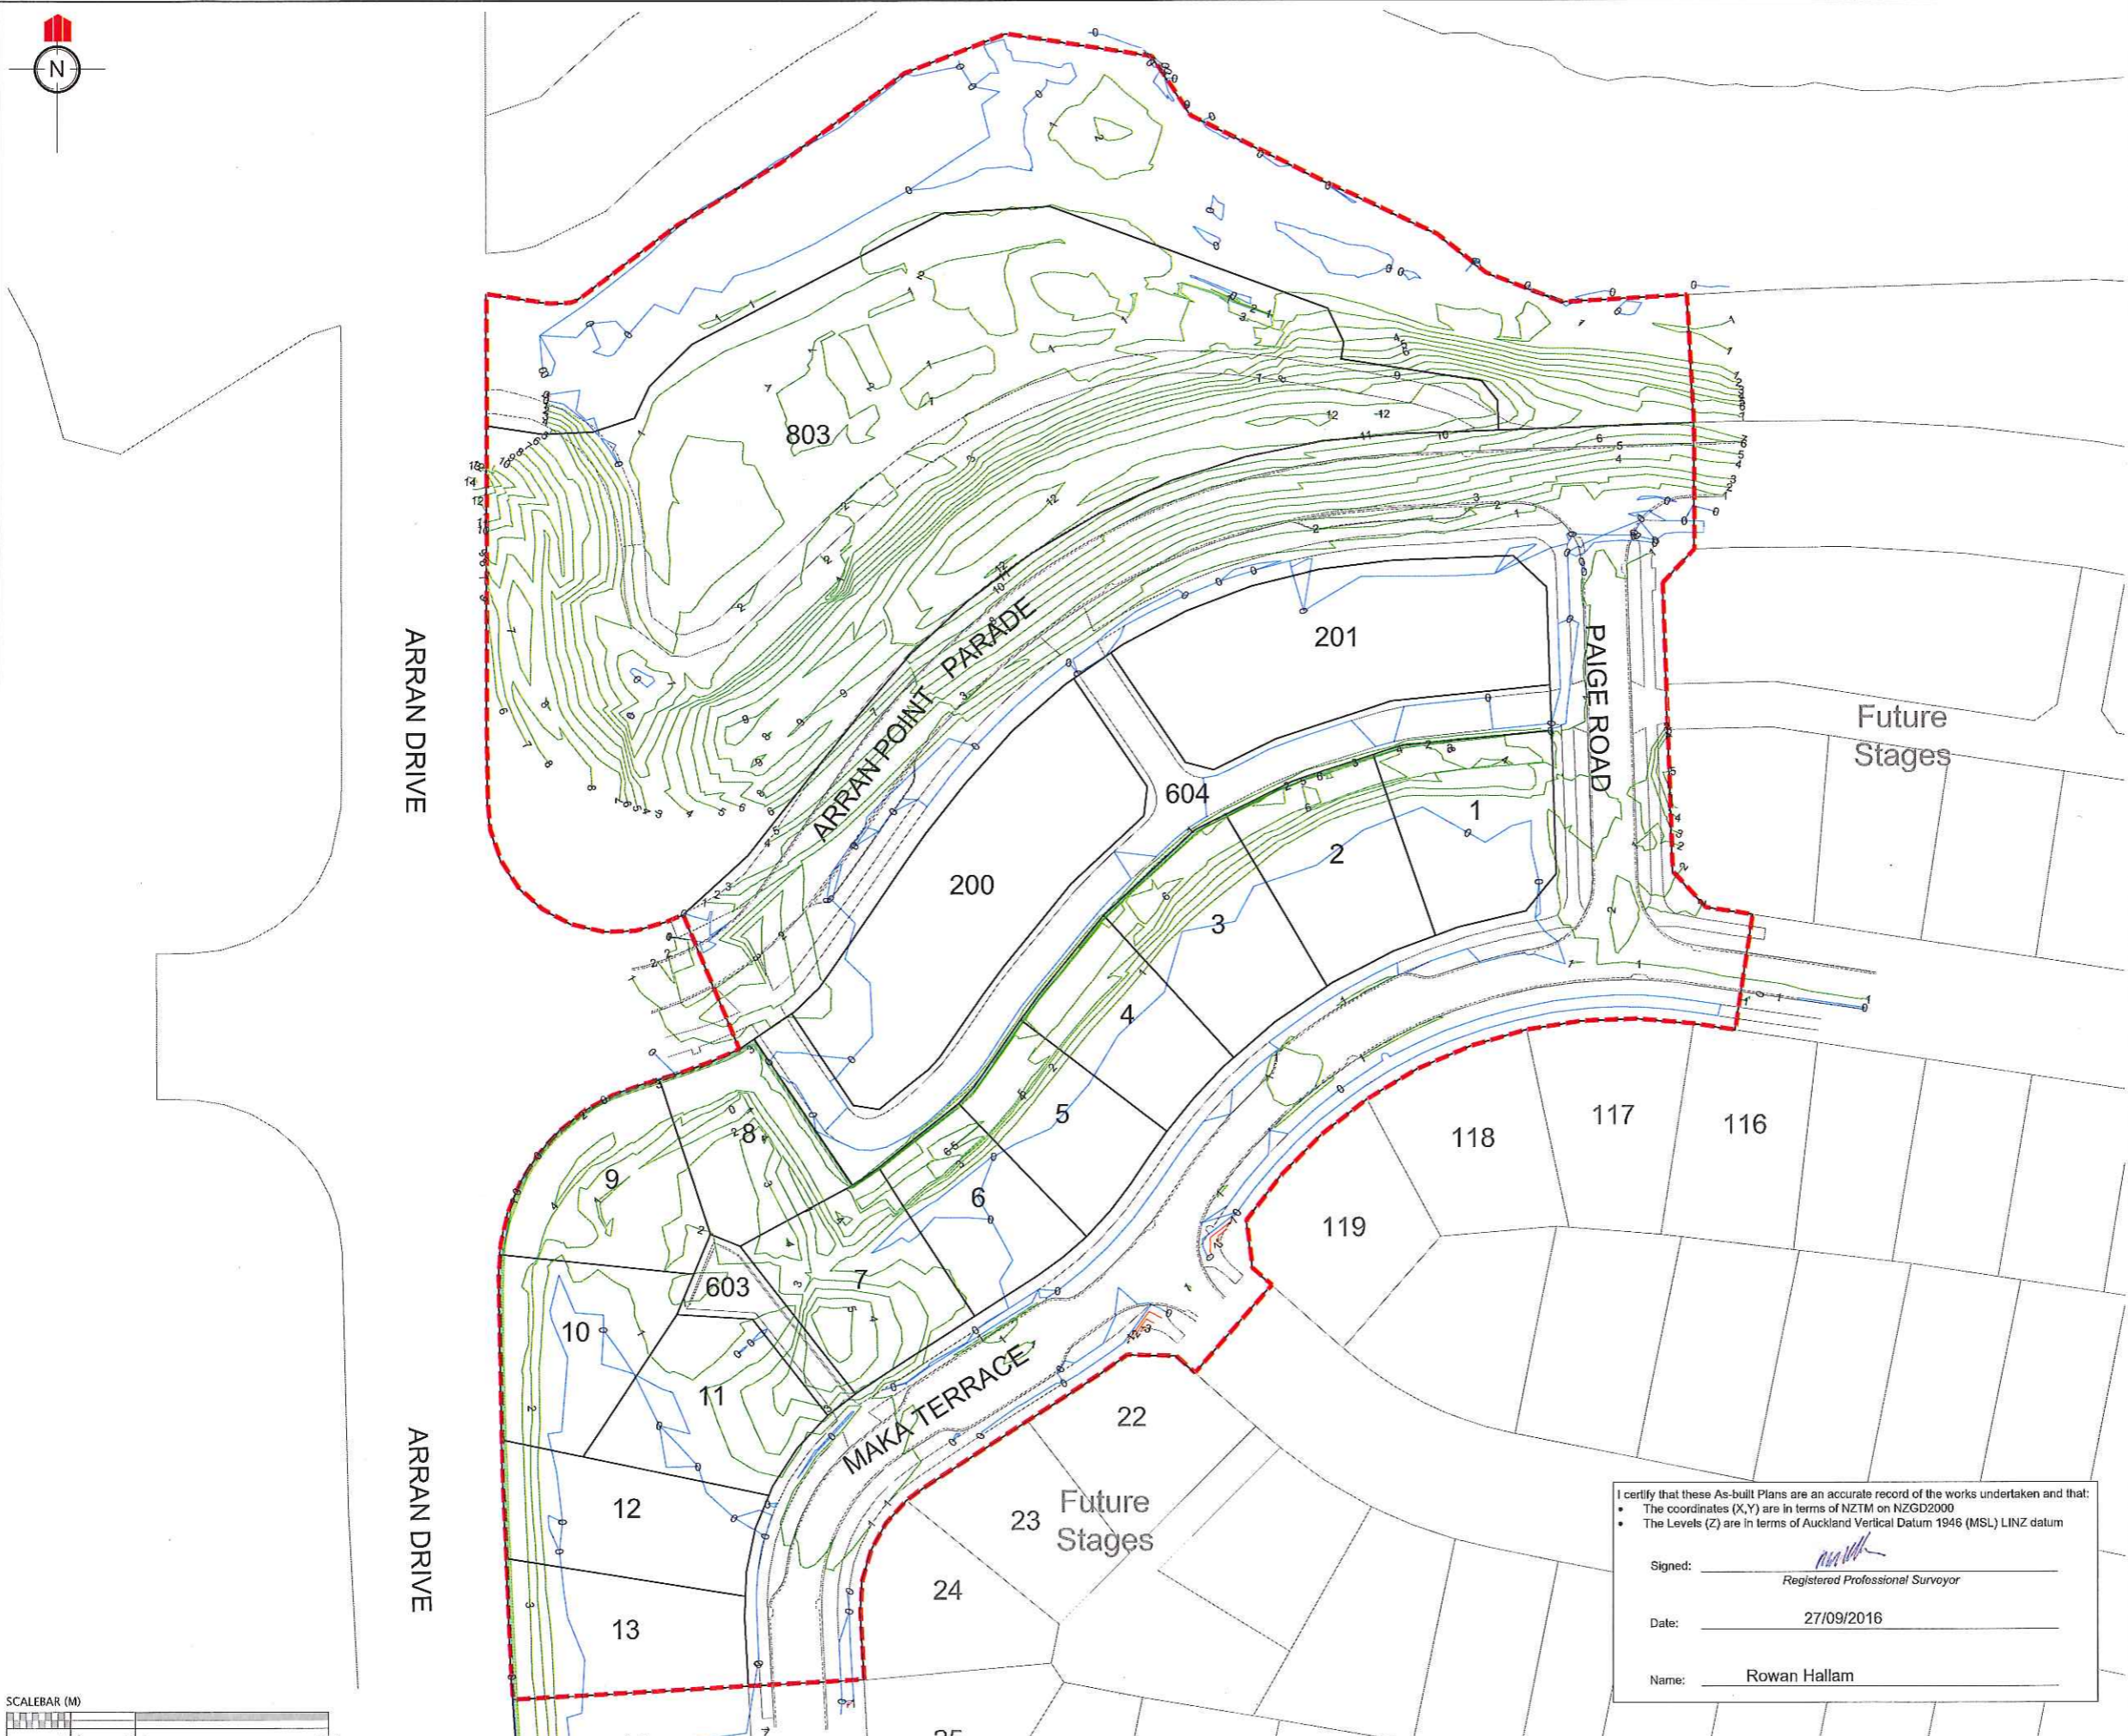
DESIGNED: MB	AS-BUILT
CHECKED: RDC	DRAWN: RDC
APPROVED: MRH	SURVEYED: PK
JOB NUMBER: 37001	SCALE: 1:1000 @ A3
ISSUED: SEPT 2016	
DWG. NO. 37001-01-AB-110	REV. 1.

NOTES
1. CONTOURS ARE AT 1.0 METRE INTERVALS

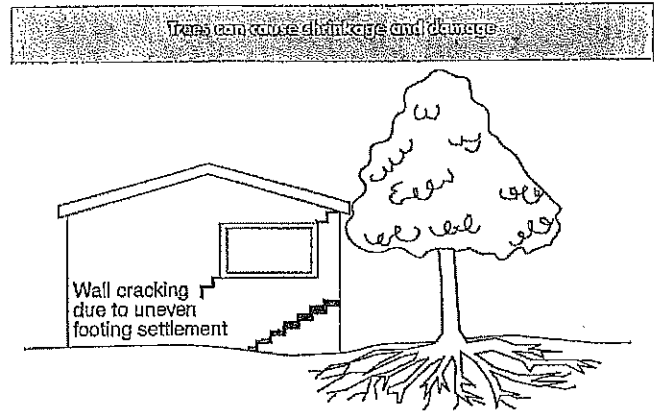
As the moisture absorption process completes its journey to the innermost areas of the building, the internal footings will rise. If the spread of moisture is roughly even, it may be that the symptoms will temporarily disappear, but it is more likely that swelling will be uneven, creating a difference rather than a disappearance in symptoms. In buildings with timber flooring supported by bearers and joists, the isolated piers will rise more easily than the strip footings or piers under walls, creating noticeable doming of flooring.

As the weather pattern changes and the soil begins to dry out, the external footings will be first affected, beginning with the locations where the sun's effect is strongest. This has the effect of lowering the external footings. The doming is accentuated and cracking reduces or disappears where it occurred because of dishing, but other cracks open up. The roof lines may become convex.

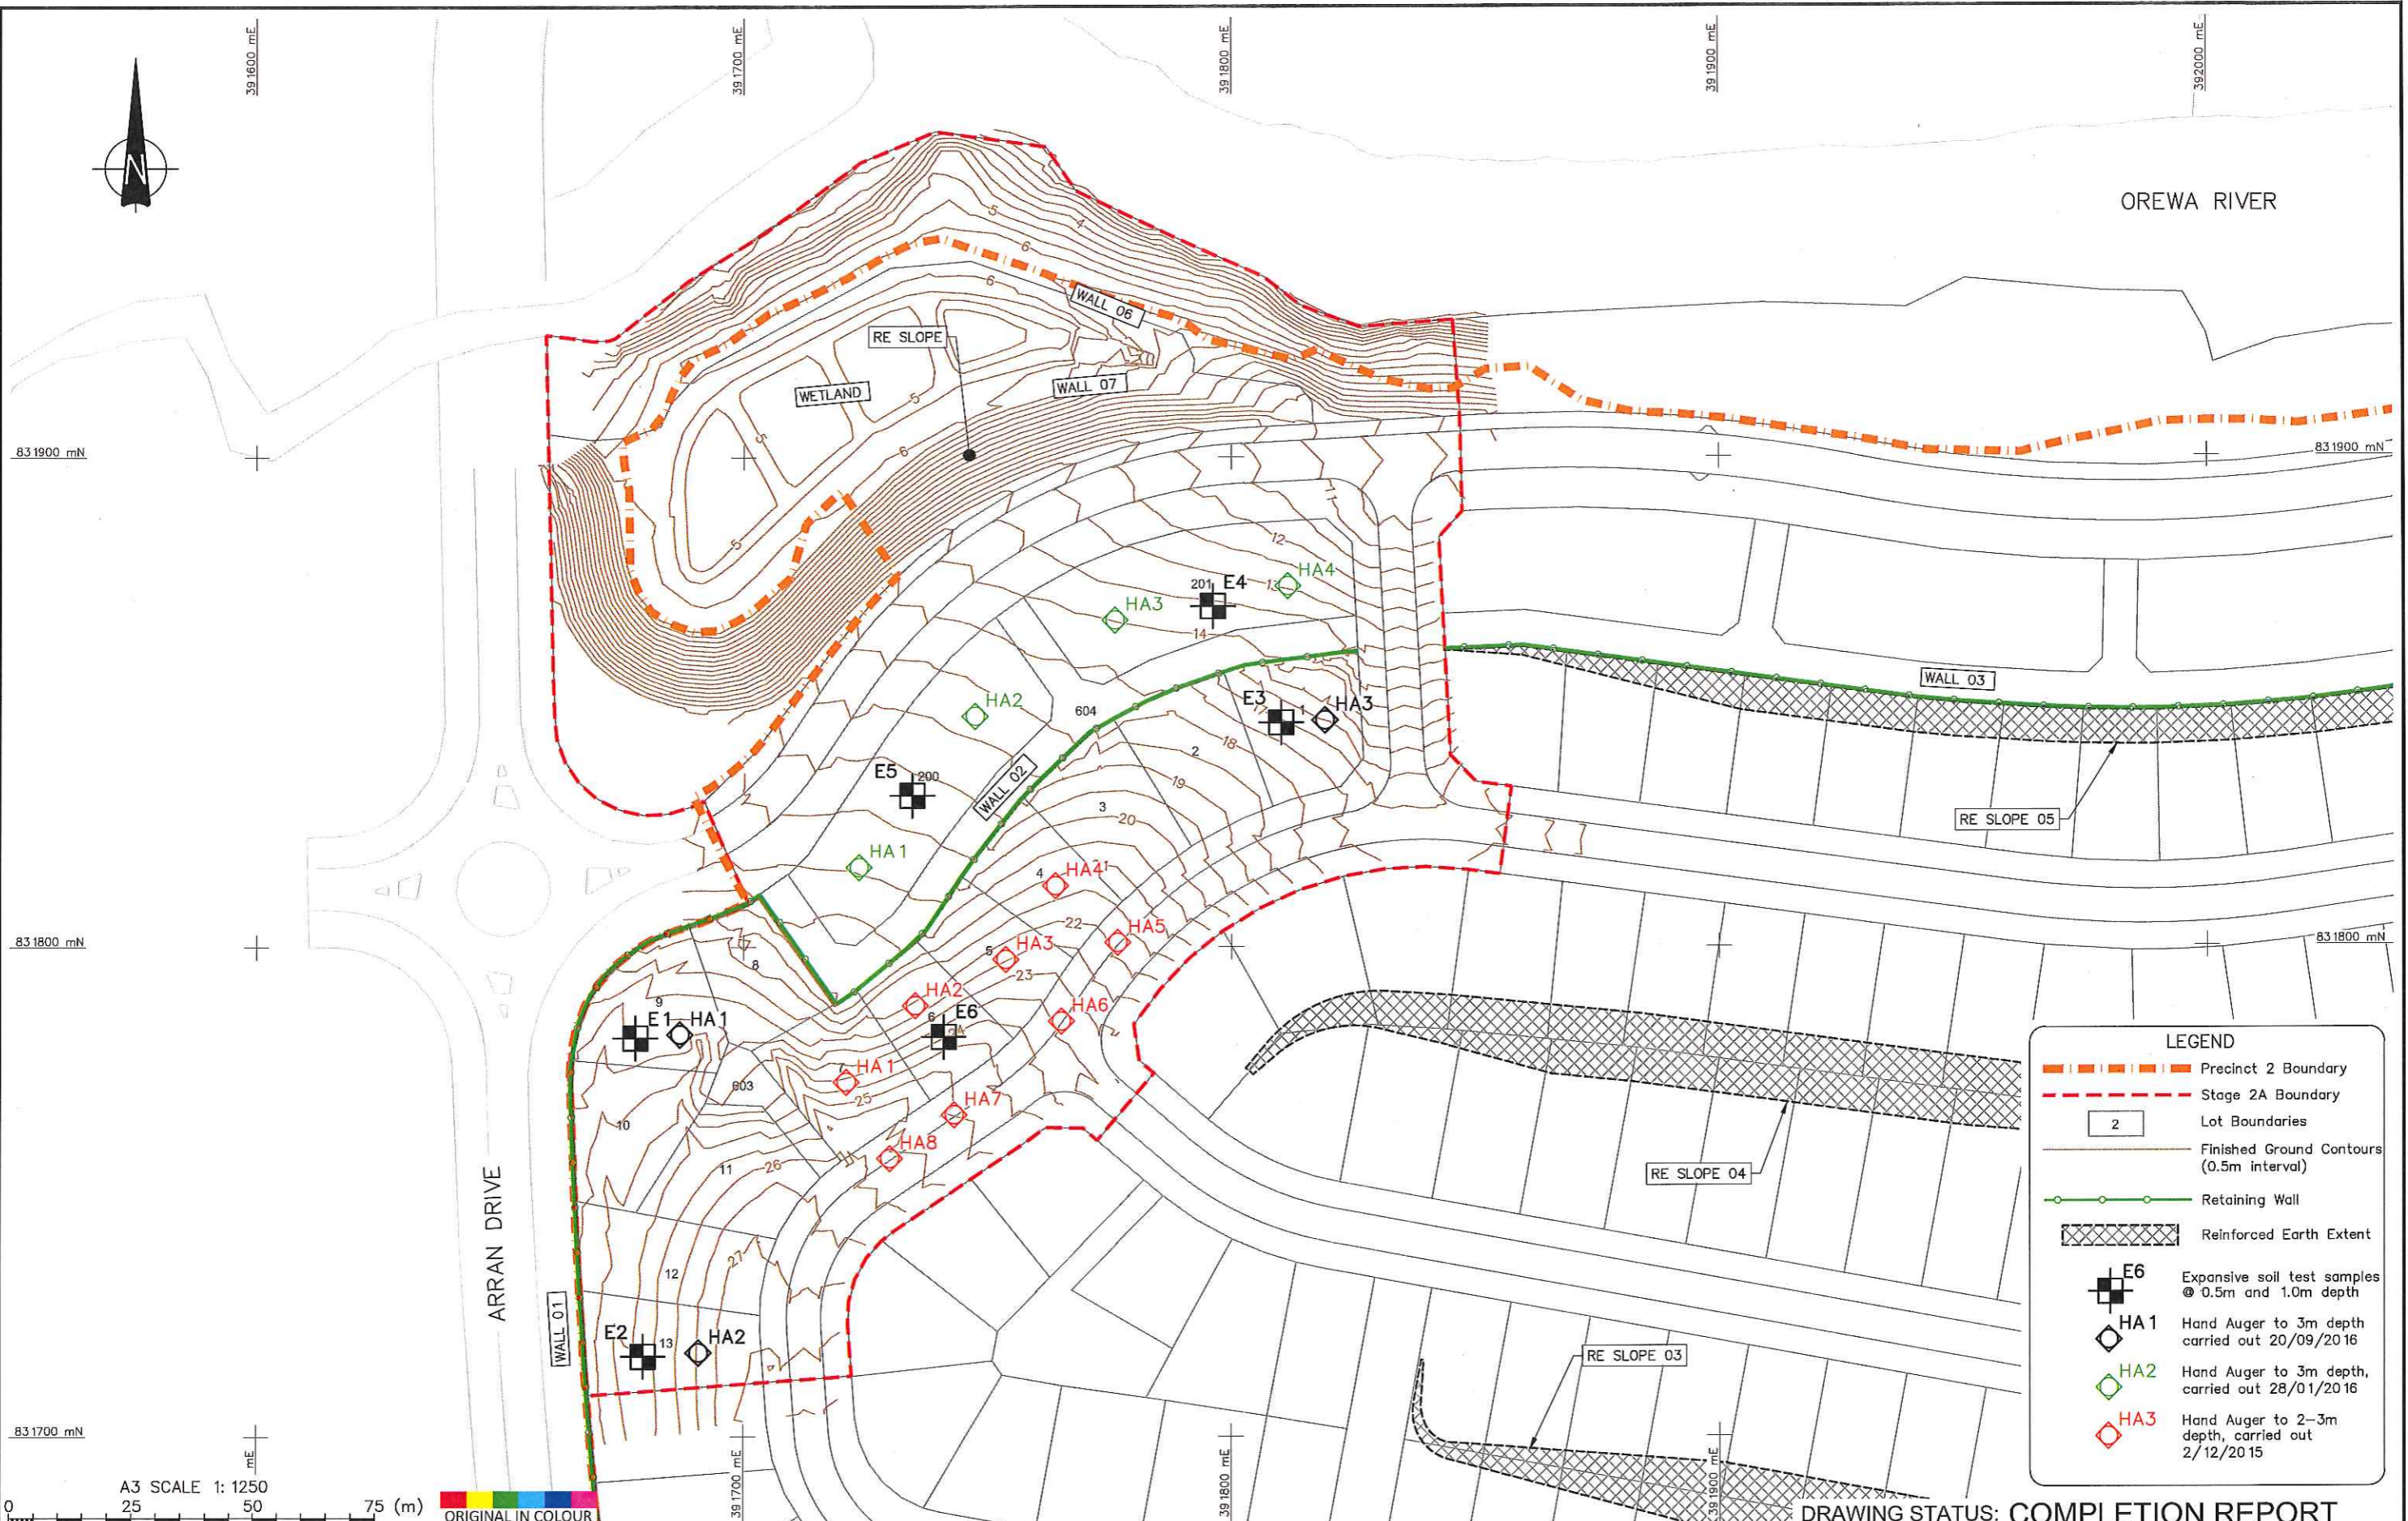
- Precinct 2 Boundary
- Stage 2A Boundary
- Lot Boundaries
- Finished Ground Contours (0.5m interval)
- Retaining Wall
- Reinforced Earth Extent
- E6 Expansive soil test samples @ 0.5m and 1.0m depth
- HA1 Hand Auger to 3m depth carried out 20/09/2016
- HA2 Hand Auger to 3m depth, carried out 28/01/2016
- HA3 Hand Auger to 2-3m depth, carried out 2/12/2015

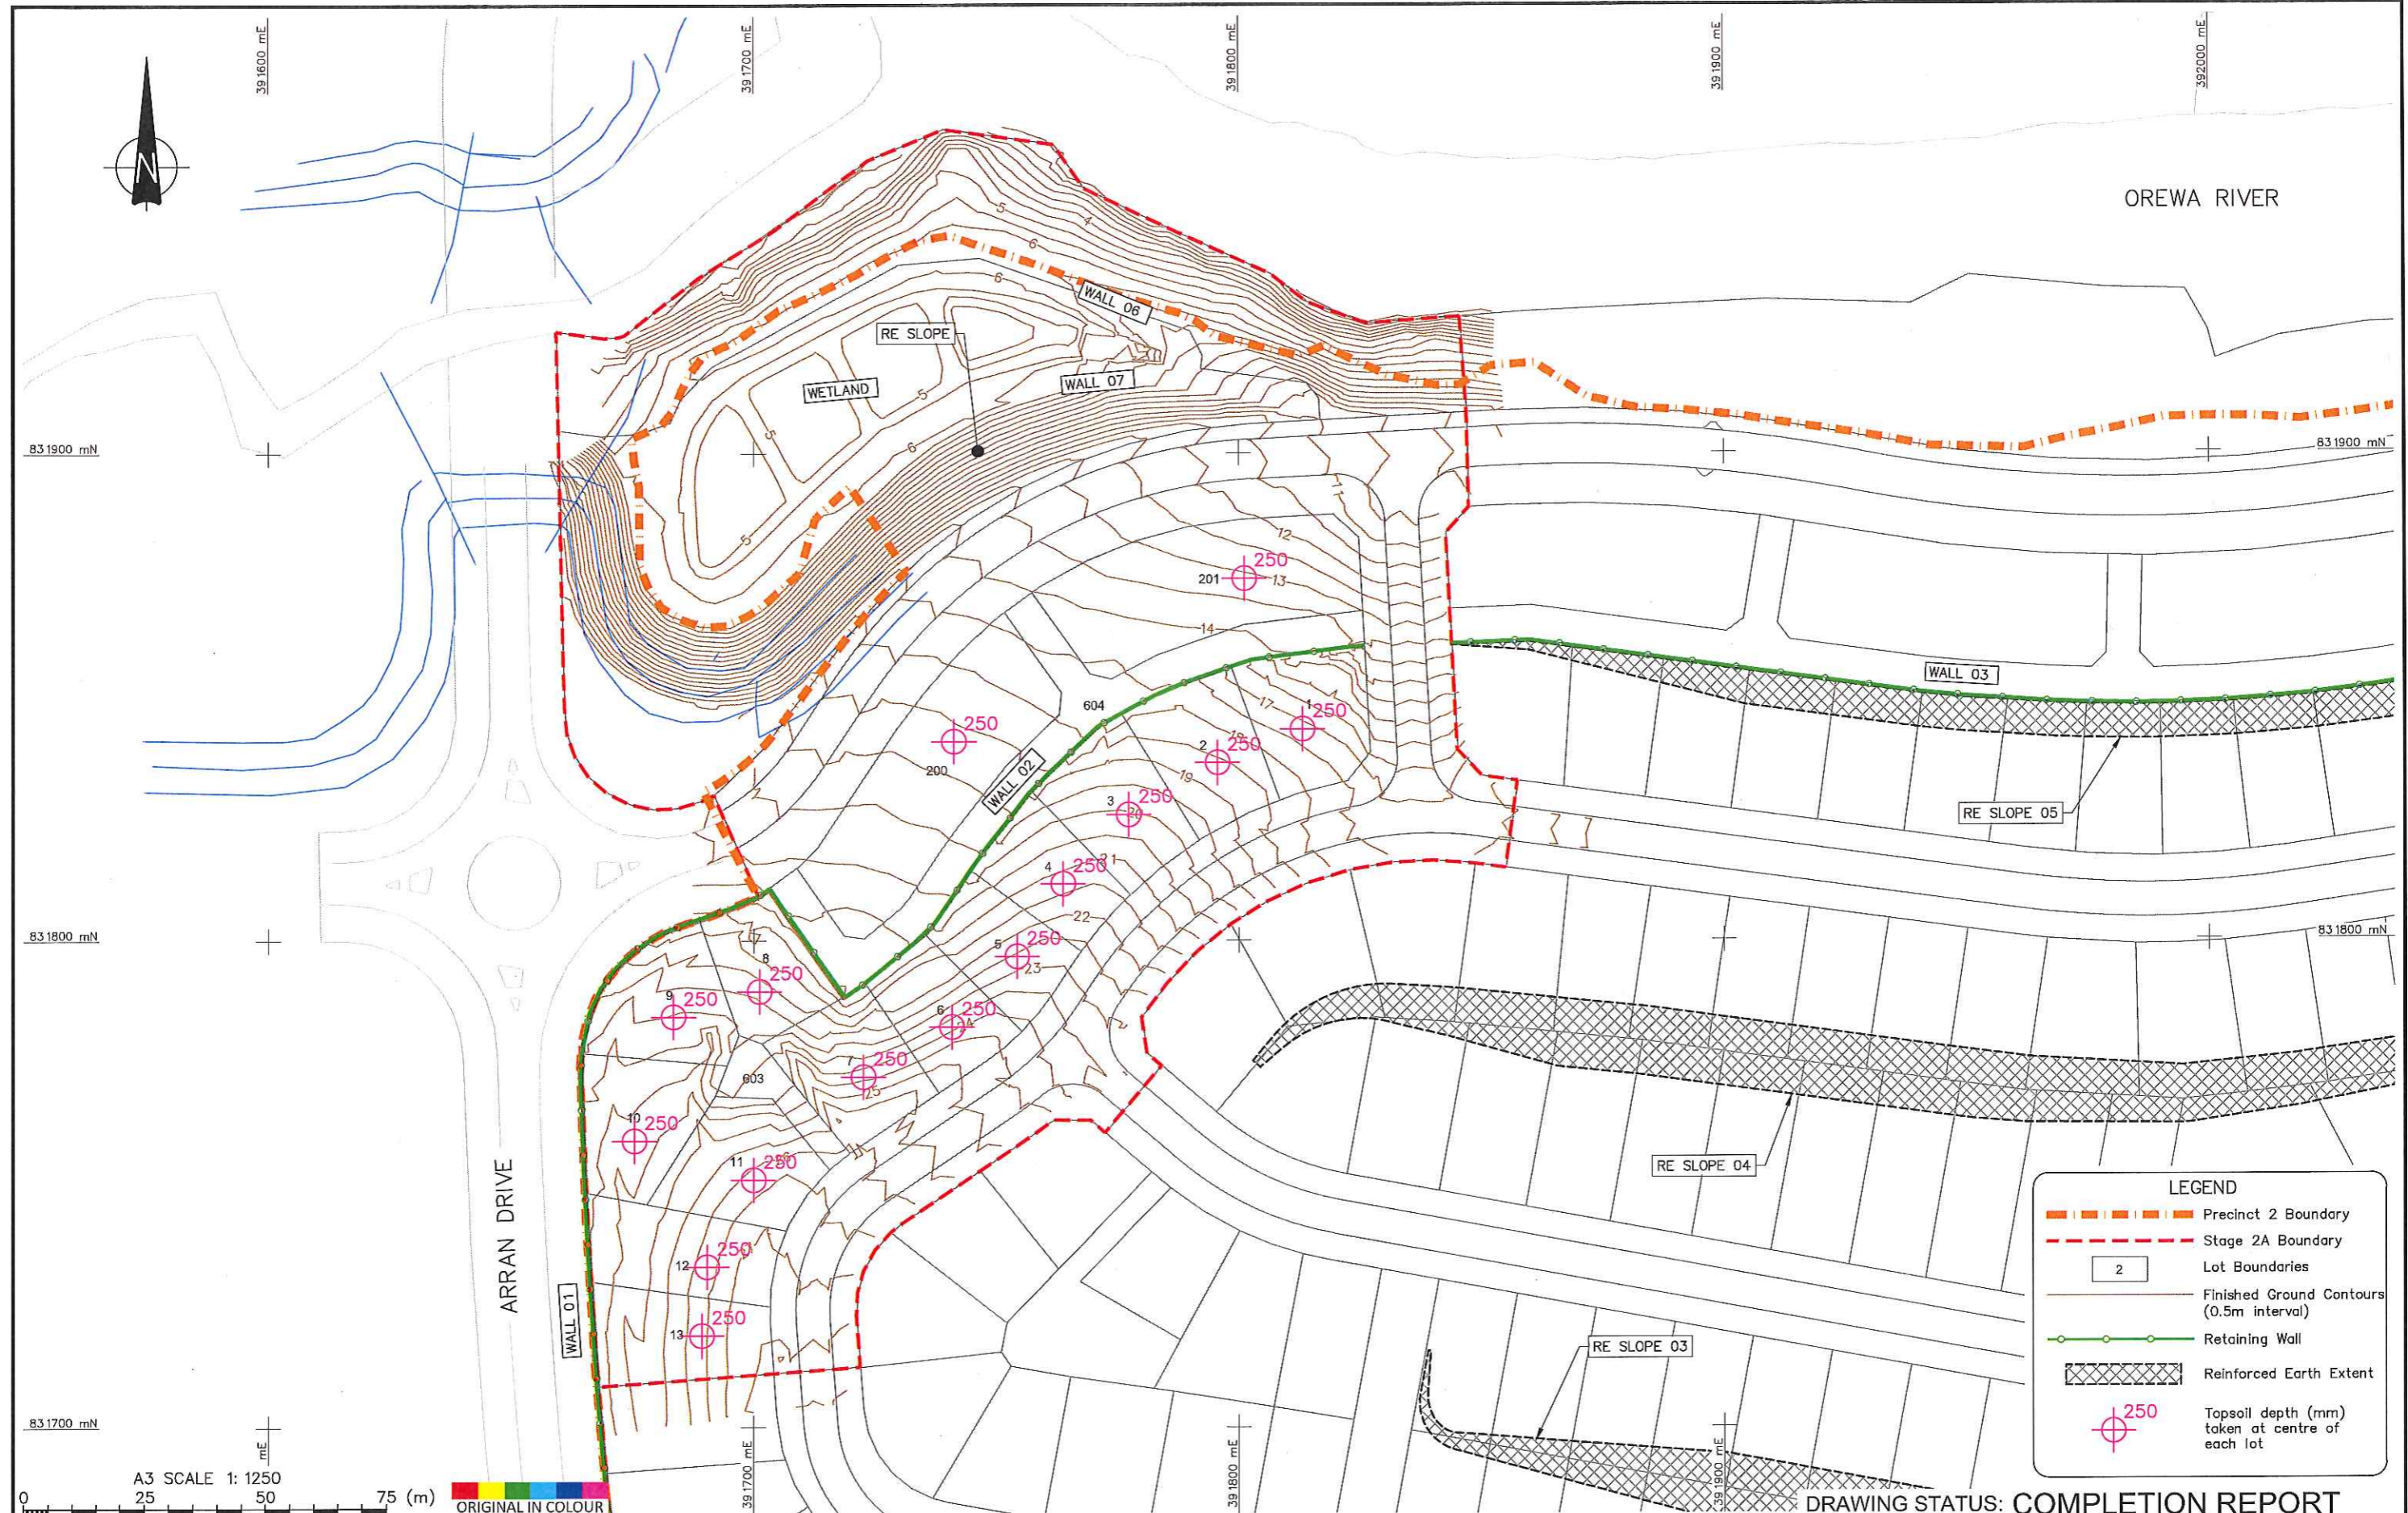
CLIENT, PROJECT	WFH PROPERTIES LTD RESIDENTIAL SUBDIVISION
TITLE	MILLWATER - ARRANS POINT PRECINCT 7 (STAGE 1) Topsoil Depths Plan
SCALES (AT A3 SIZE)	1: 1250
DWG. No.	21854.0037-APP7S1-113
REV.	1

- Precinct 2 Boundary
- Stage 2A Boundary
- Lot Boundaries
- Finished Ground Contours (0.5m interval)
- Retaining Wall
- Reinforced Earth Extent
- Topsoil depth (mm) taken at centre of each lot
