**MILLWATER - PRECINCT 2  
STAGE 3A**

**Geotechnical Completion Report**

Prepared for  
WFH Properties Ltd

Prepared by  
Tonkin & Taylor Ltd

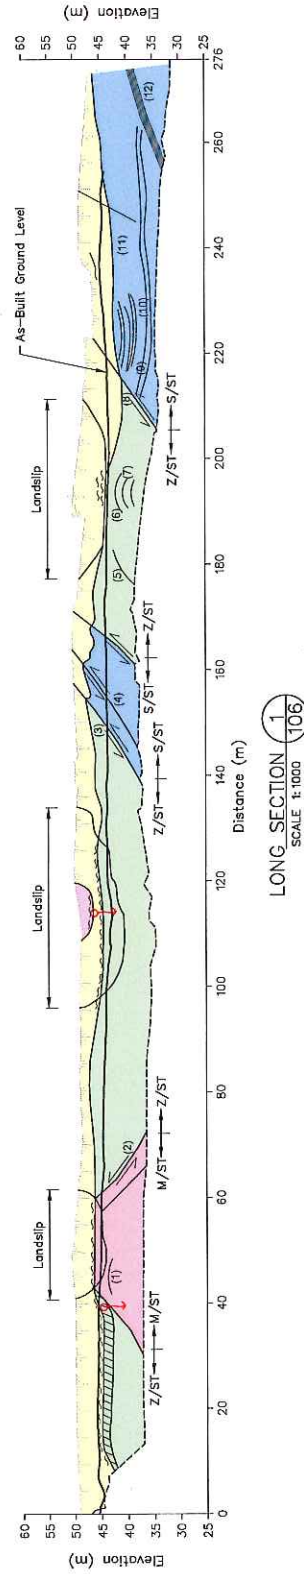
- (1) B 5°/337' PL, SM, T, CN
- (2) F 18°/47°/0'10" UN, SL, T, CN
- (3) F 14°/194' UN, SL, T, CV
- (4) F 14°/192' PL, SL, T, CV
- (5) B 15°/337' UN, SM, VT, CN
- (6) B 20°/285' PL, SM, VT, CN
- (7) B 21°/0'12' PL, SM, VT, CN
- (8) F 12°/336' PL, SL, T, CV
- (9) B 15°/334' UN, RO, T, CN
- (10) B 6°/253' UN, RO, T, CN
- (11) B 11°/285' PL, RO, VT, CN
- (12) SZ 14°/260' UN, SL, T, CV

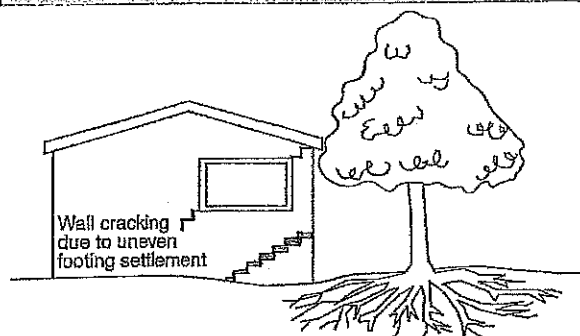
Trees can cause shrinkage and damage

As the weather pattern changes and the soil begins to dry out, the external footings will be first affected, beginning with the locations where the sun's effect is strongest. This has the effect of lowering the external footings. The doming is accentuated and cracking reduces or disappears where it occurred because of dish, but other cracks open up. The roof lines may become convex.
