**MILLWATER - PRECINCT 2  
STAGE 3B**

**Geotechnical Completion Report**

Tonkin & Taylor Ltd

September 2016

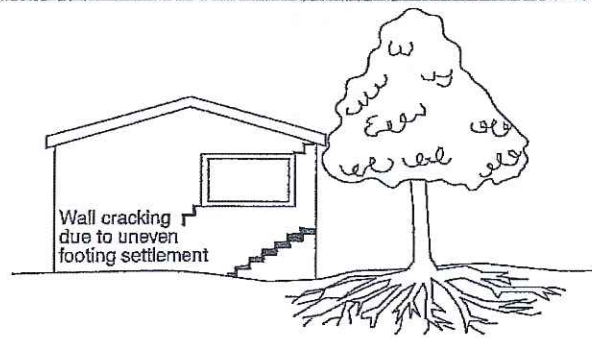
### Trees can cause shrinkage and damage

As the weather pattern changes and the soil begins to dry out, the external footings will be first affected, beginning with the locations where the sun's effect is strongest. This has the effect of lowering the external footings. The doming is accentuated and cracking reduces or disappears where it occurred because of dishing, but other cracks open up. The roof lines may become convex.
