WFH PROPERTIES LTD

**MILLWATER - PRECINCT 3 STAGE 2B
Geotechnical Completion Report**

Tonkin & Taylor Ltd

February 2015

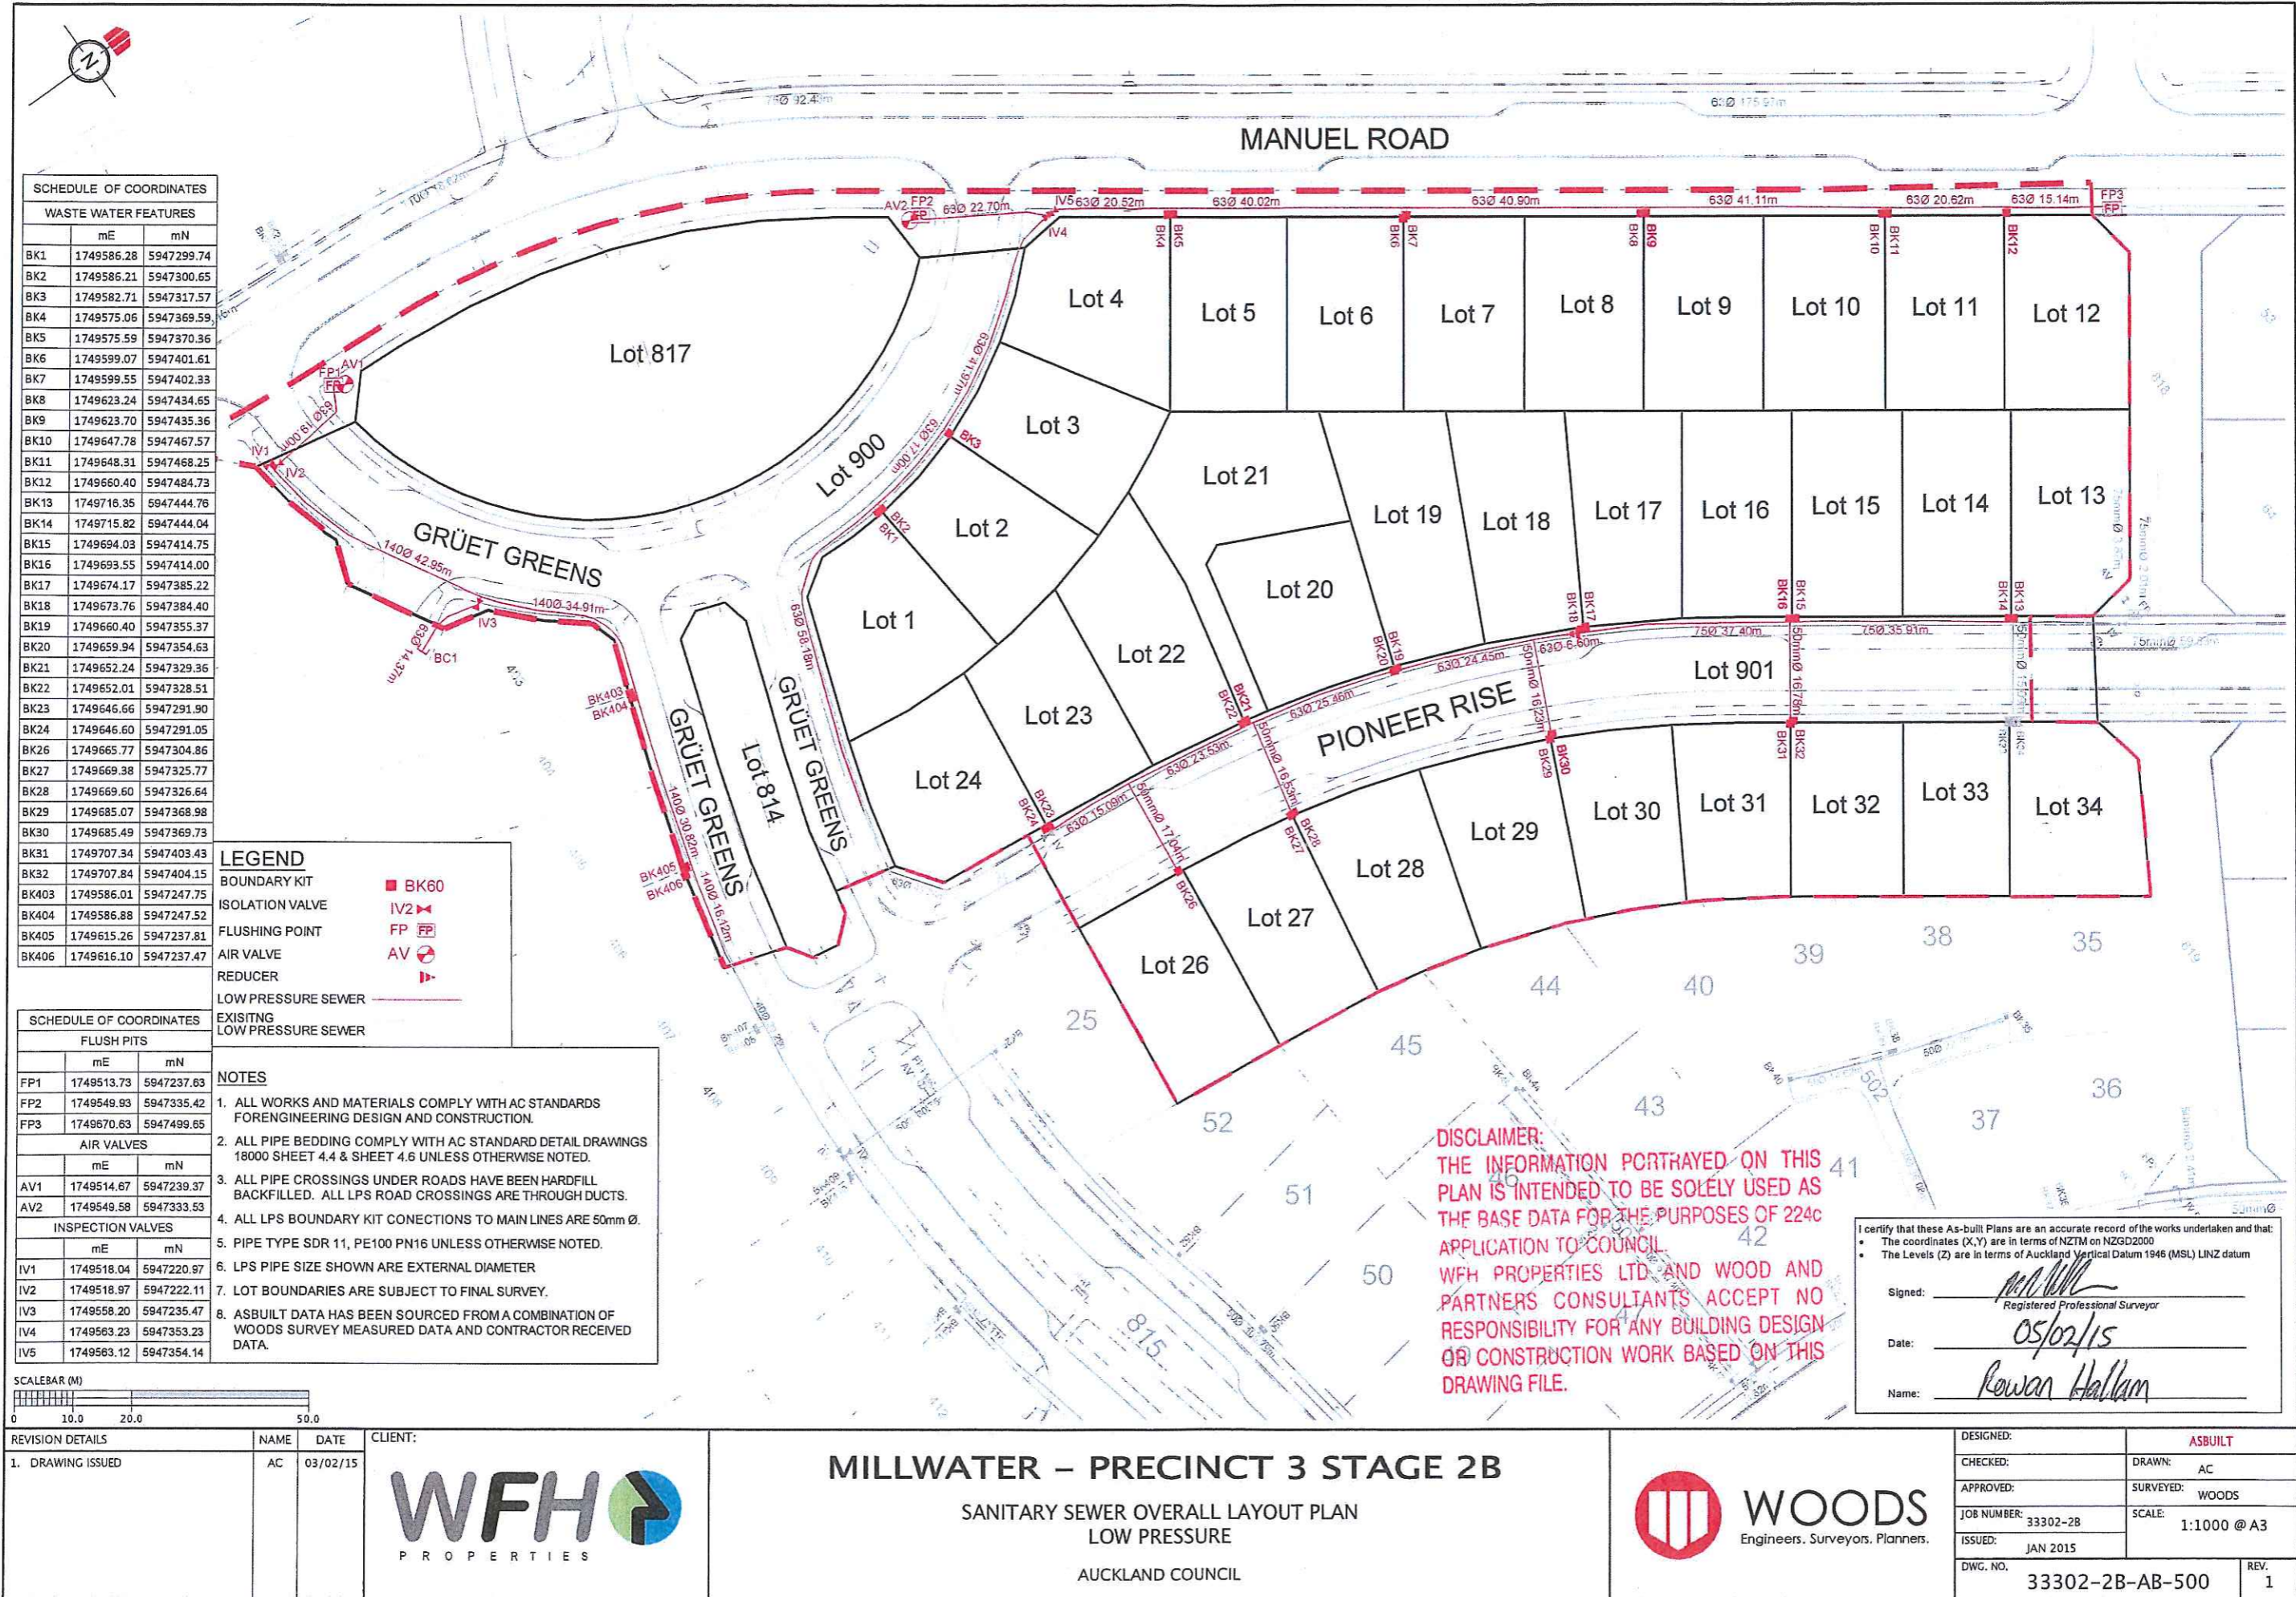
- NOTES**
1. ALL WORKS AND MATERIALS COMPLY WITH AC STANDARDS FORENGINEERING DESIGN AND CONSTRUCTION.
 2. ALL PIPE BEDDING COMPLY WITH AC STANDARD DETAIL DRAWINGS 18000 SHEET 4.4 & SHEET 4.6 UNLESS OTHERWISE NOTED.
 3. ALL PIPE CROSSINGS UNDER ROADS HAVE BEEN HARDFILL BACKFILLED. ALL LPS ROAD CROSSINGS ARE THROUGH DUCTS.
 4. ALL LPS BOUNDARY KIT CONECTIONS TO MAIN LINES ARE 50mm Ø.
 5. PIPE TYPE SDR 11, PE100 PN16 UNLESS OTHERWISE NOTED.
 6. LPS PIPE SIZE SHOWN ARE EXTERNAL DIAMETER
 7. LOT BOUNDARIES ARE SUBJECT TO FINAL SURVEY.
 8. ASBUILT DATA HAS BEEN SOURCED FROM A COMBINATION OF WOODS SURVEY MEASURED DATA AND CONTRACTOR RECEIVED DATA.

- **33302-2B-AB-100** **Final Contour Plan**
- **33302-2B-AB-120** **Original Surface – Earthwork Surface, Cut/Fill**
 Contour Plan
- **33302-2B-AB-121** **Earthwork Surface – Final Surface, Cut/Fill**
 Contour Plan
- **33302-2B-AB-150 to -152** **Retaining Wall As-Built Plans**
- **33302-2B-AB-300 to 303** **Stormwater As-Built Plans**
- **33302-2B-AB-500** **Sanitary Sewer As-Built Plan**

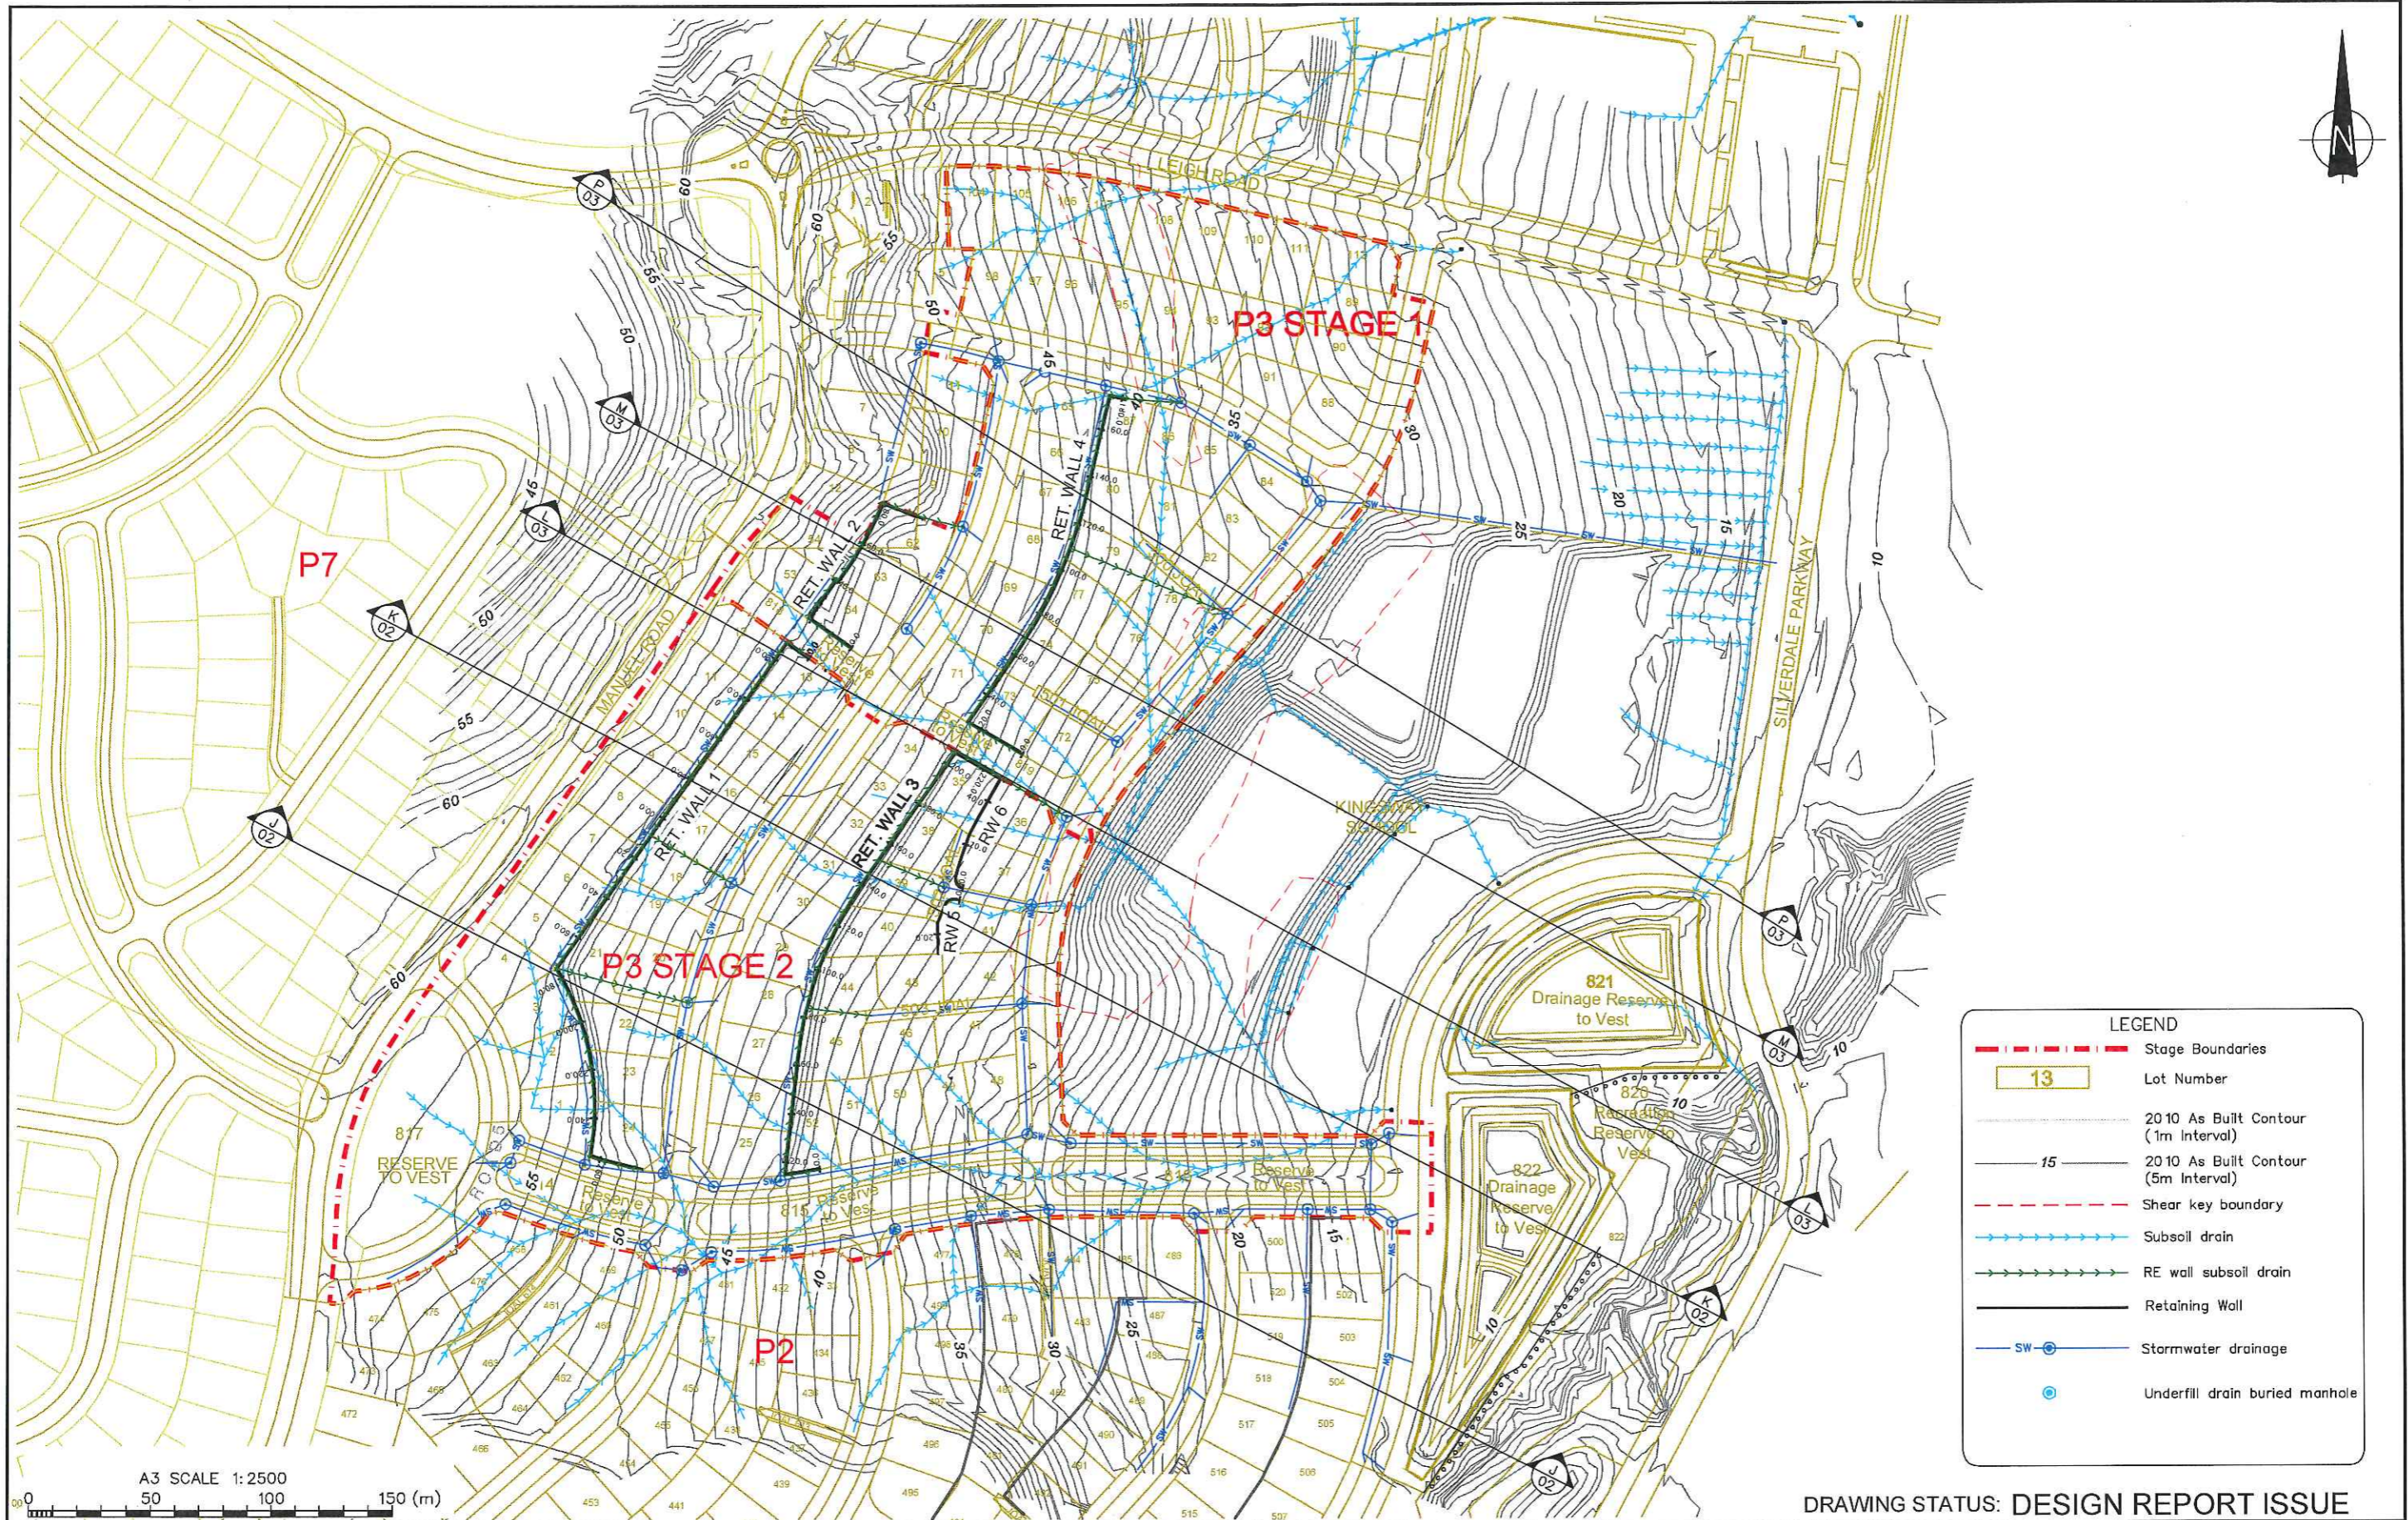
- 21854.008 – RW - 01 Stage 1 & 2 Retaining Walls – Layout Plan
- 21854.008 – RW - 02 Geological Cross Sections J and K
- 21854.008 – RW - 04 Retaining Wall 1 – Long Section
- 21854.008 – RW - 05 Retaining Wall 3 – Long Section
- 21854.008 – RW - 07 Retaining Walls – Typical Details

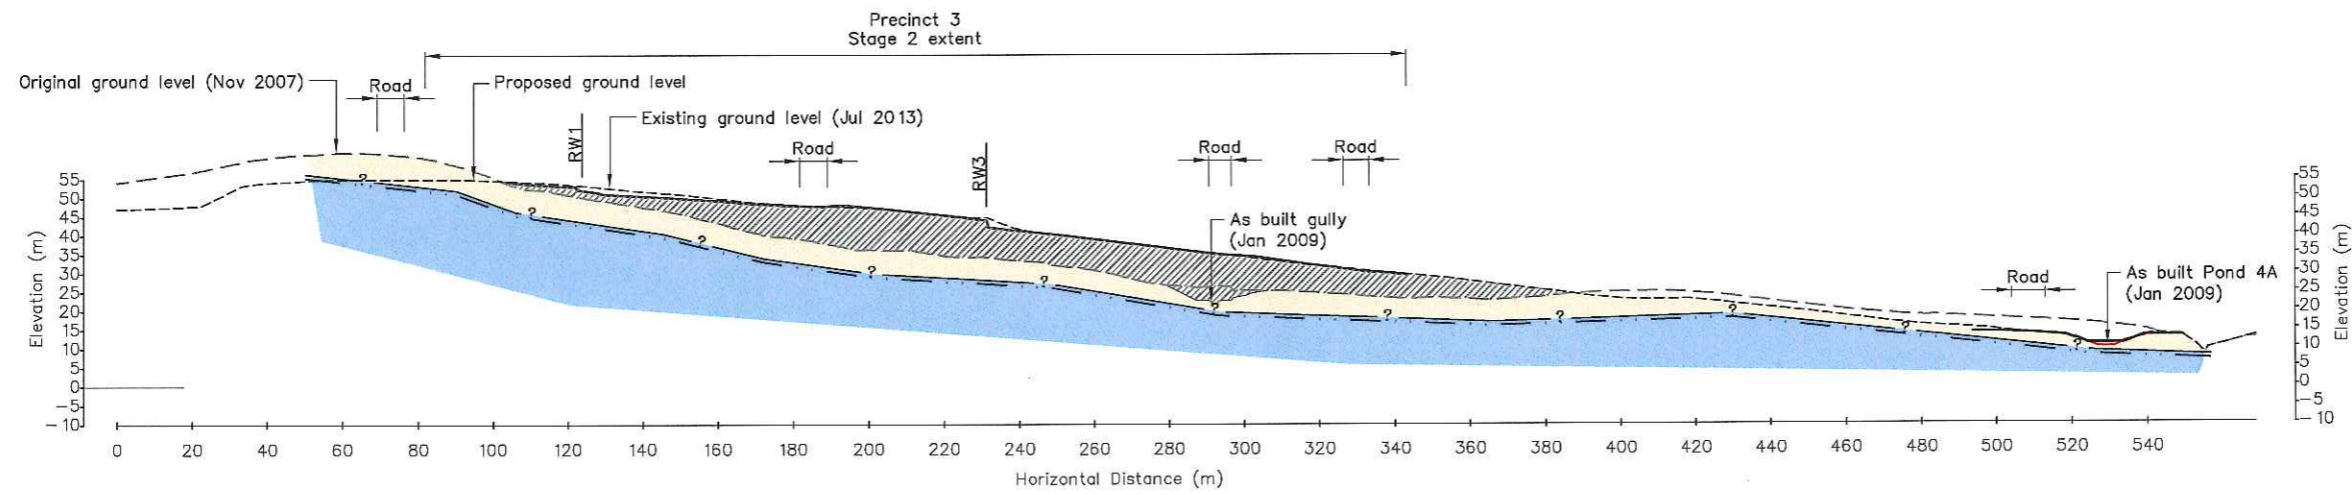
SECTION J
SCALE 1:2000

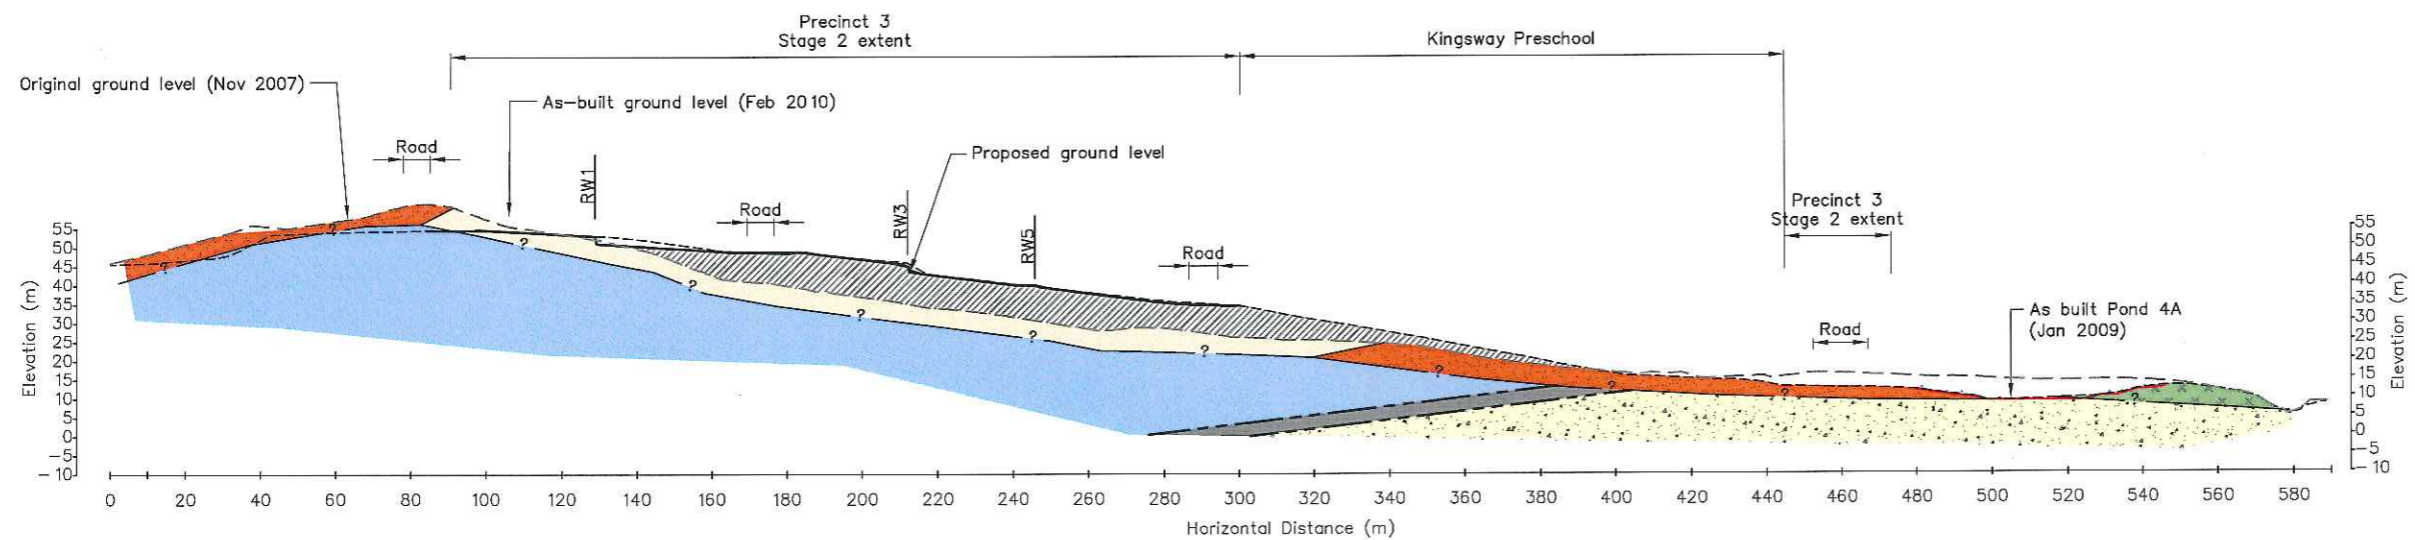
SECTION K
SCALE 1:2000

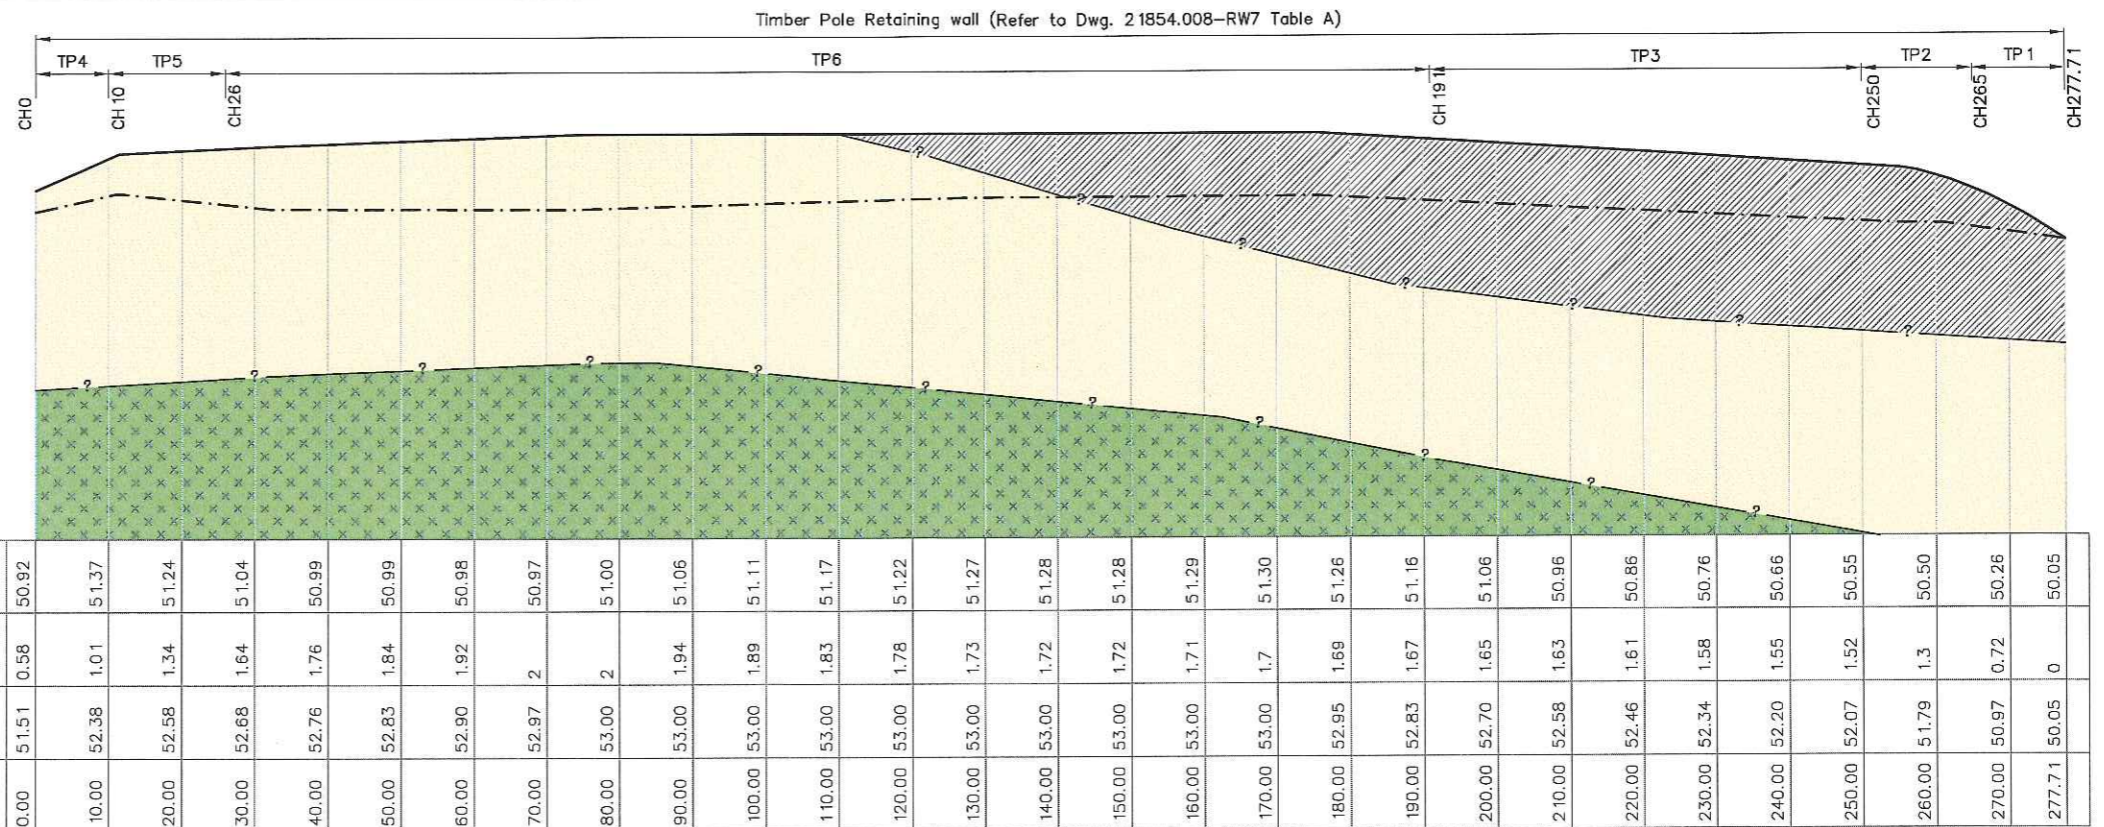
WALL 1 LONGITUDINAL SECTION
SCALE 1: 1000 (H), 1: 200 (V)

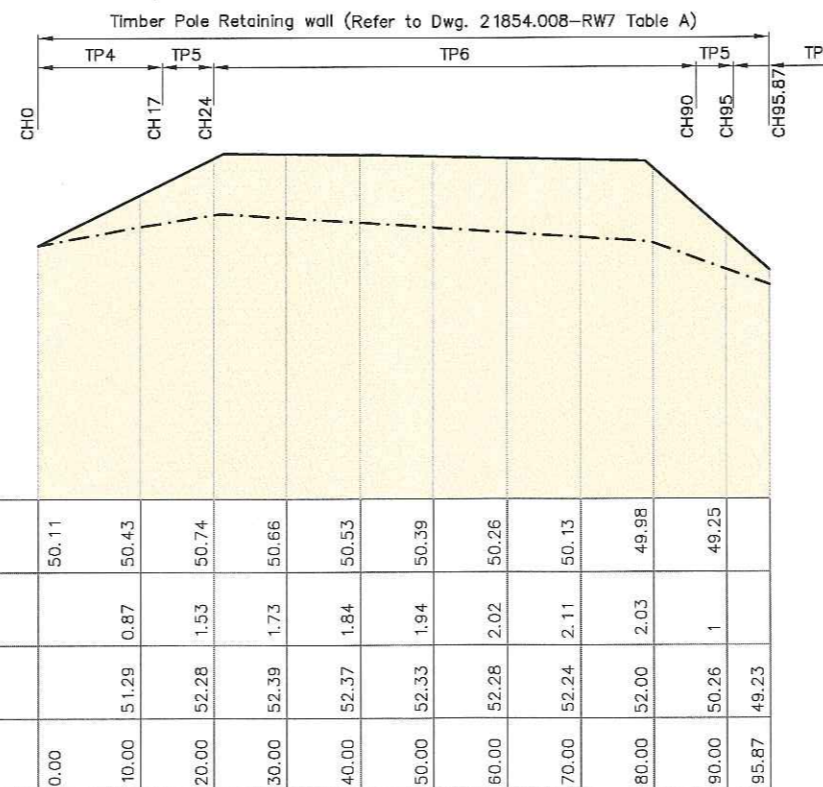
WALL 2 LONGITUDINAL SECTION
SCALE 1: 1000 (H), 1: 200 (V)

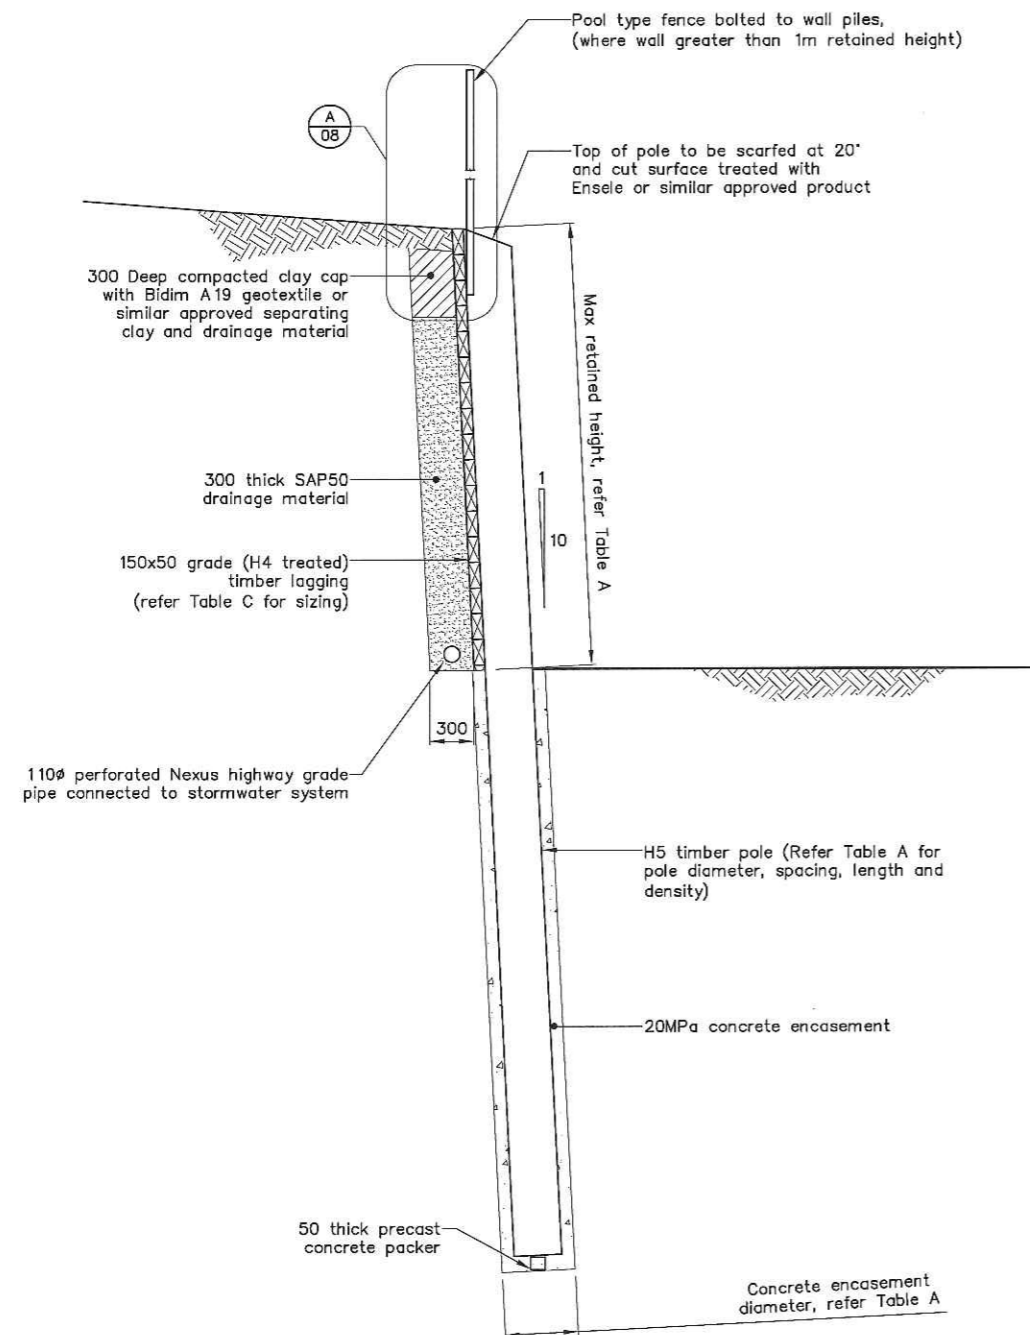
TYPICAL DETAIL — TIMBER POLE RETAINING WALL (TP)
SCALE 1:50

1. All poles shall be sourced from the same region and documentation shall be provided supporting this
2. For each pole size, 10% of all poles shall be tested in accordance with the specification.

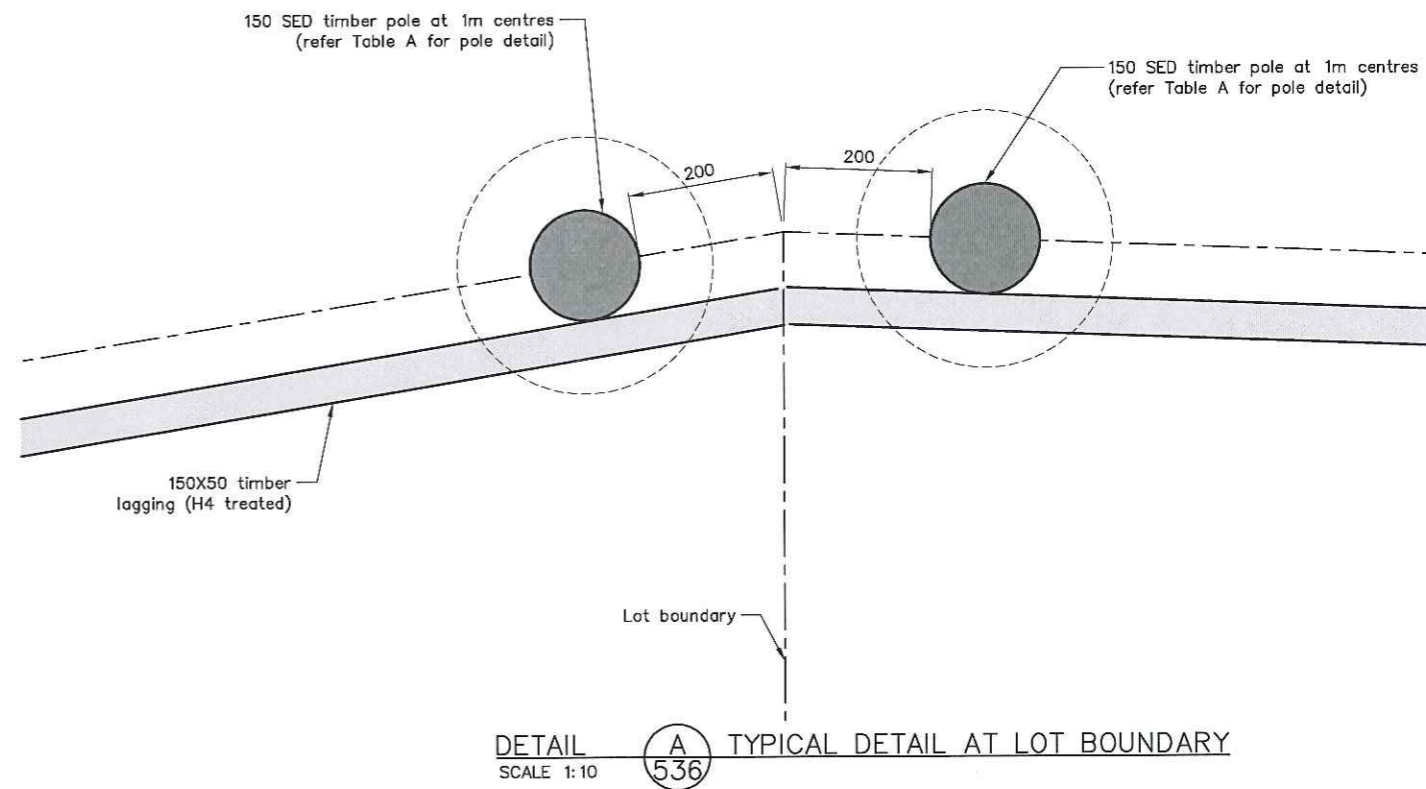
DETAIL A TYPICAL DETAIL AT LOT BOUNDARY
SCALE 1:10

- NOTES :
1. All dimensions are in millimetres unless noted otherwise.
 2. Wall setout to be provided by WOODS
 3. Small end diameter to be placed at top of wall.
 4. All cut surfaces to be treated with ensile or similar approved timber sealant.

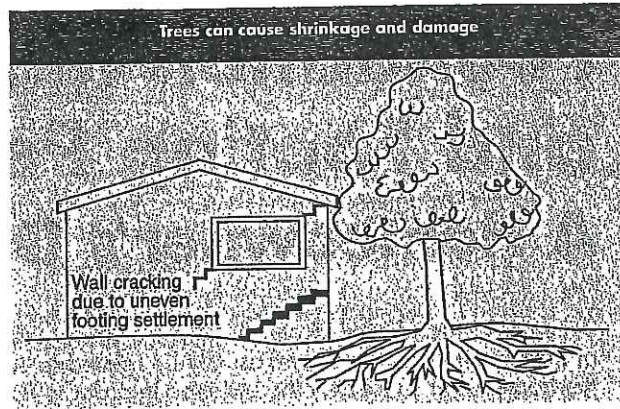
As the moisture absorption process completes its journey to the innermost areas of the building, the internal footings will rise. If the spread of moisture is roughly even, it may be that the symptoms will temporarily disappear, but it is more likely that swelling will be uneven, creating a difference rather than a disappearance in symptoms. In buildings with timber flooring supported by bearers and joists, the isolated piers will rise more easily than the strip footings or piers under walls, creating noticeable doming of flooring.

As the weather pattern changes and the soil begins to dry out, the external footings will be first affected, beginning with the locations where the sun's effect is strongest. This has the effect of lowering the external footings. The doming is accentuated and cracking reduces or disappears where it occurred because of dishing, but other cracks open up. The roof lines may become convex.

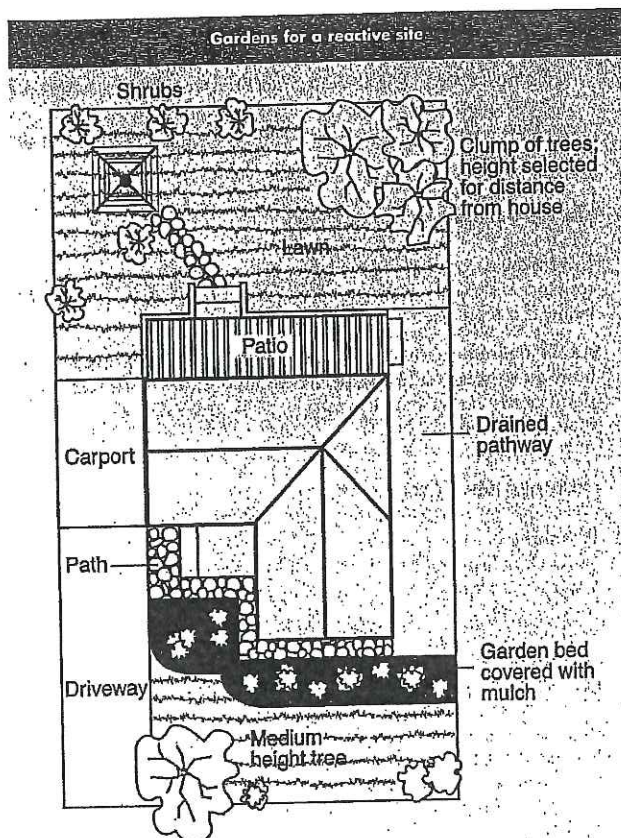
should extend outwards a minimum of 900 mm (more in highly reactive soil) and should have a minimum fall away from the building of 1:60. The finished paving should be no less than 100 mm below brick vent bases.

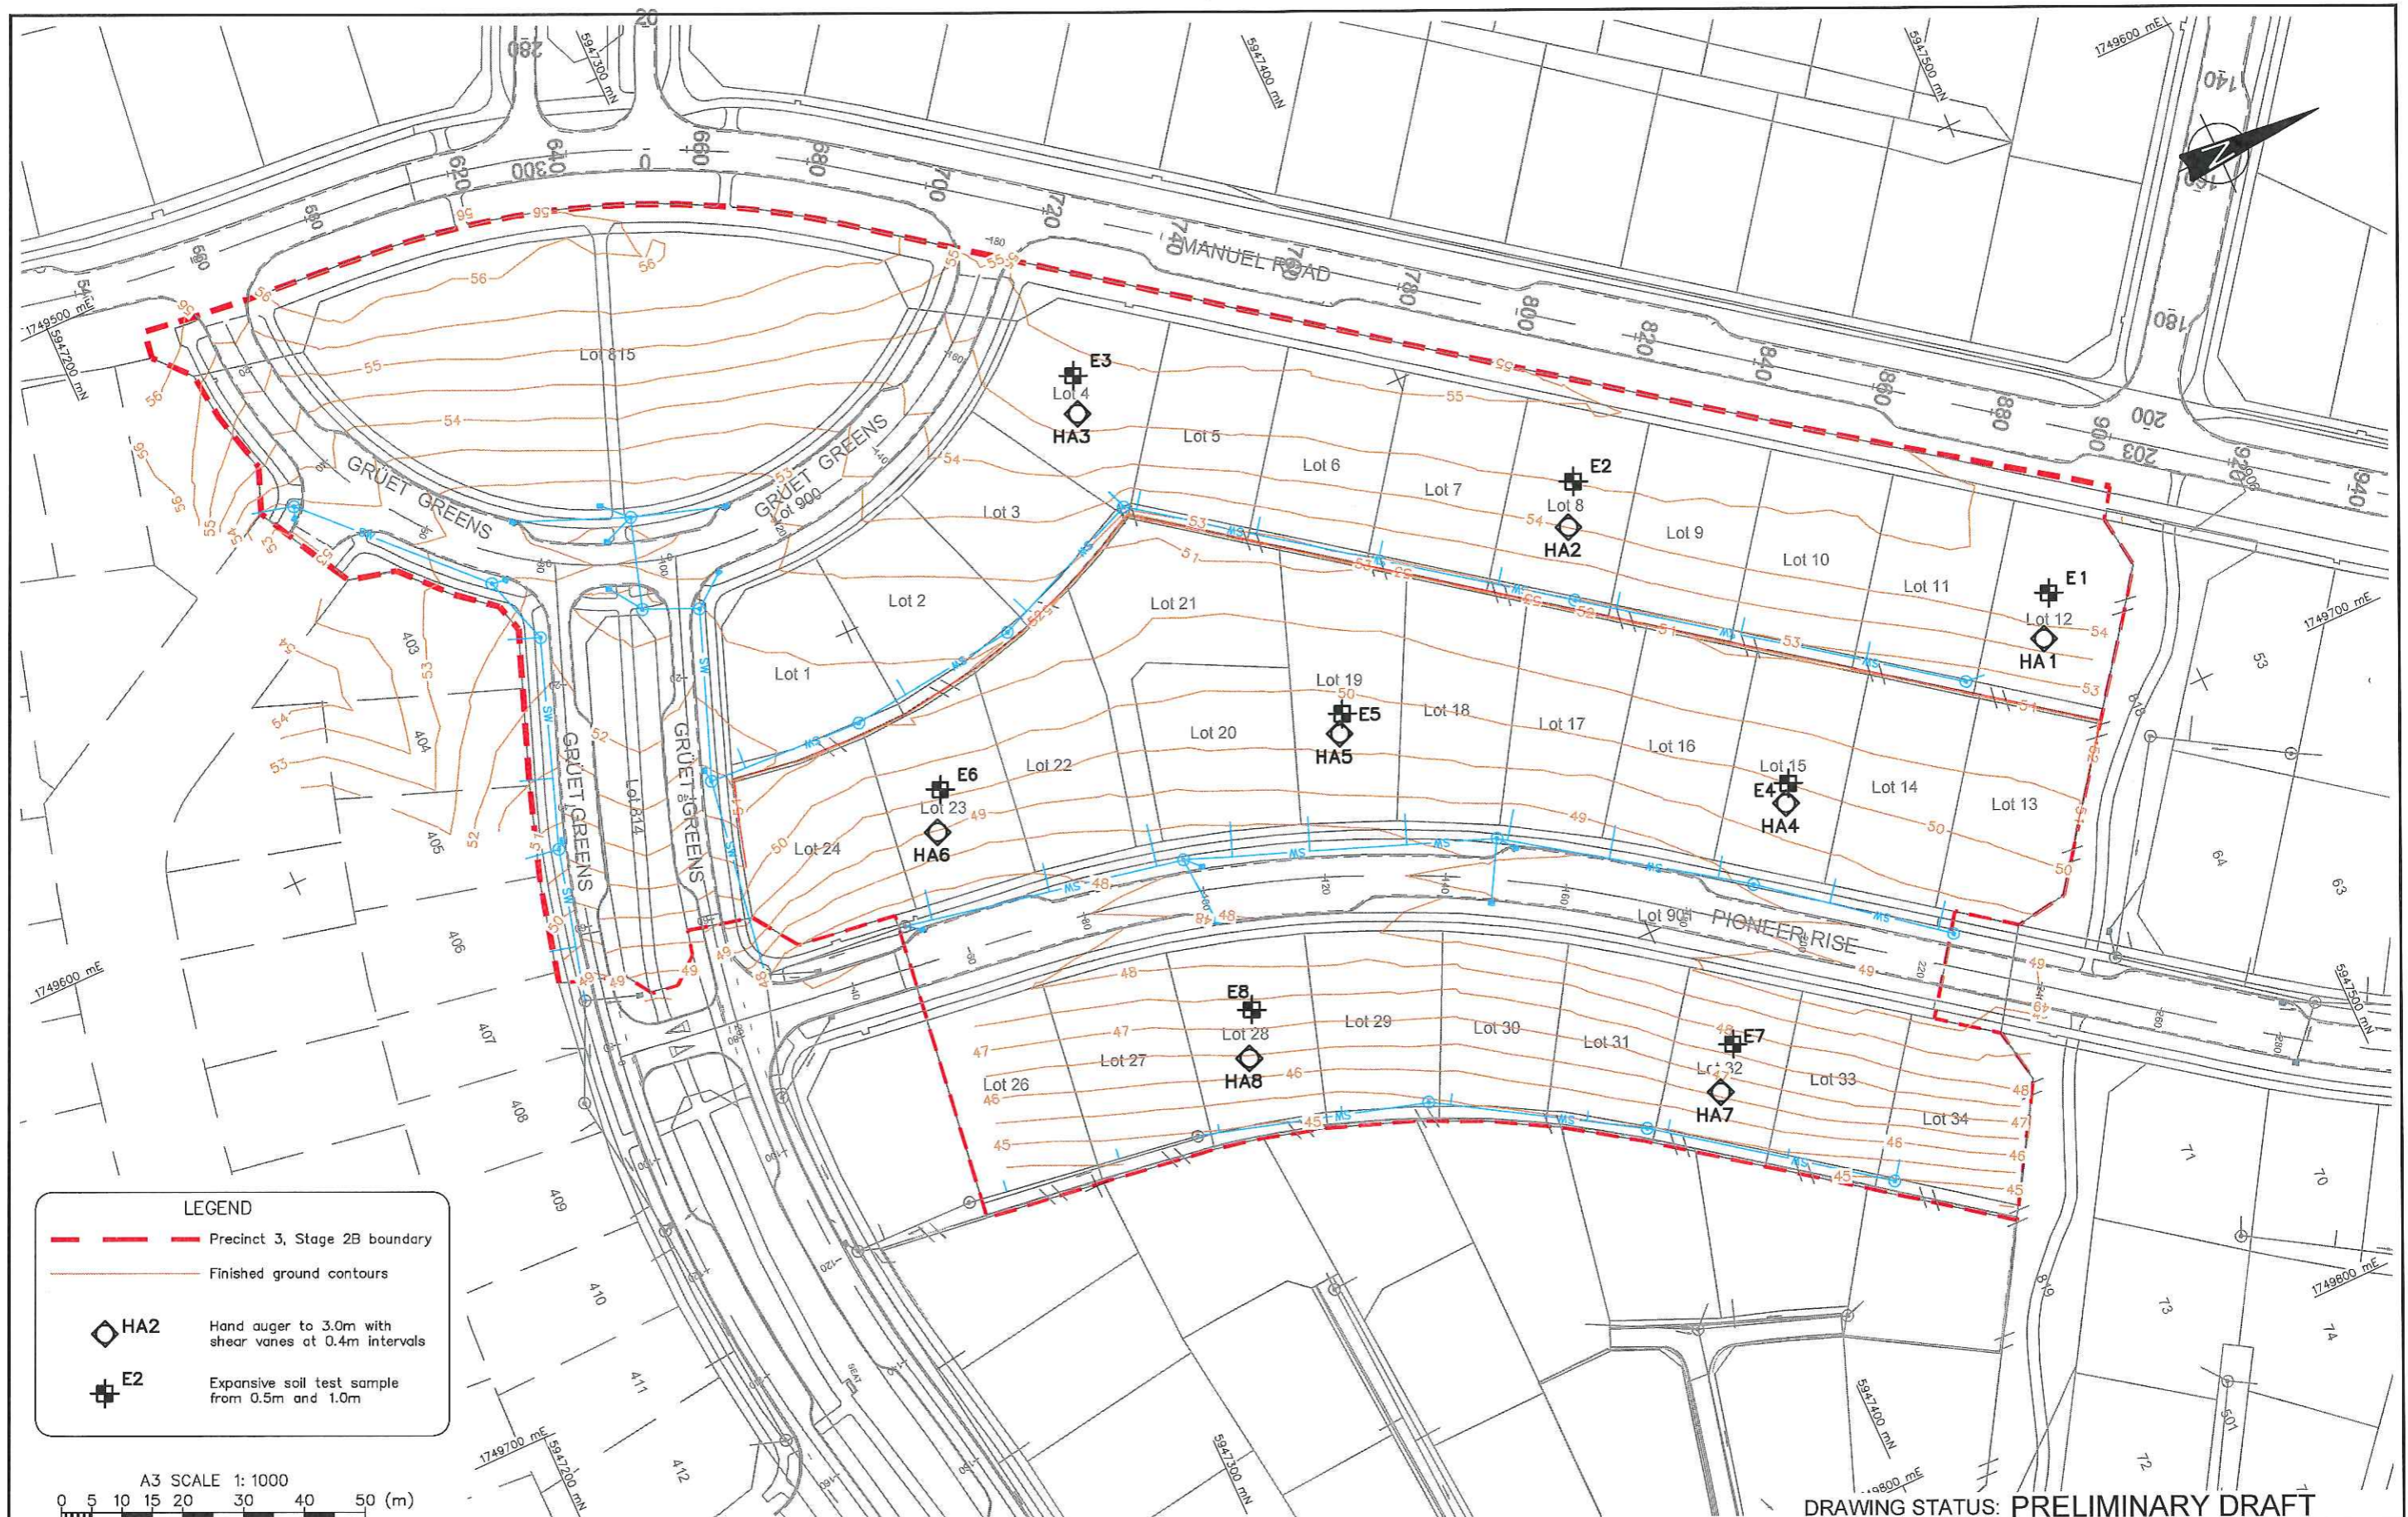
| 1: 1000 | 21854.008-2B-101 | 0 |

- **21854.008 - 2B - 101 Stage 2A Post Earthworks Investigation Plan**
- **21854.008 - 2B - 102 Stage 2A Topsoil Depths Plan**
- **Soil Expansion Test Results**
- **Post Earthworks Investigation Borehole Logs**
